M-1609

Progress Report 13

NAVAL RESEARCH LABORATORY

Use of Chaplets in Steel Castings

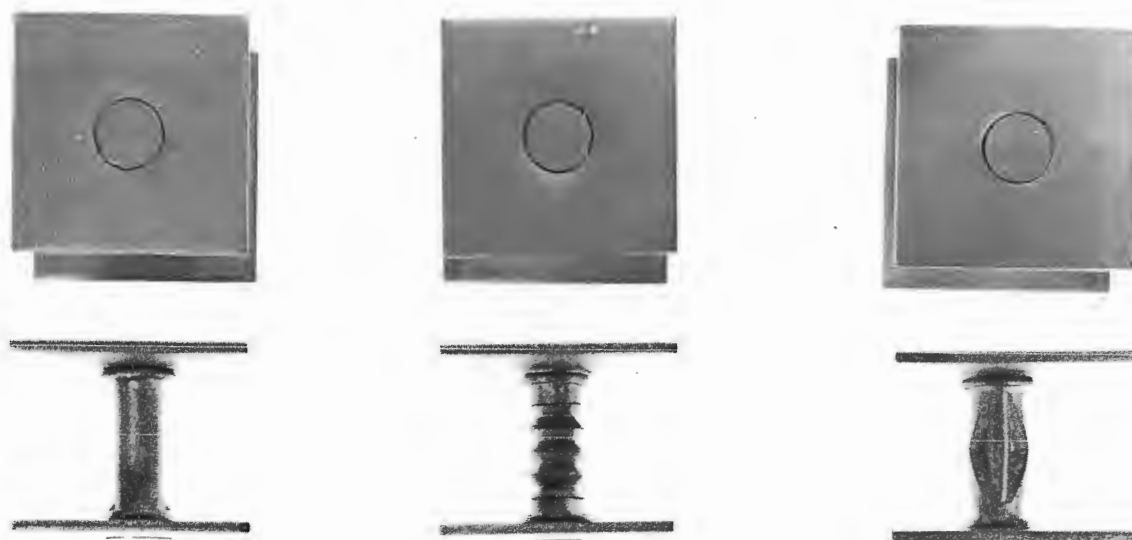
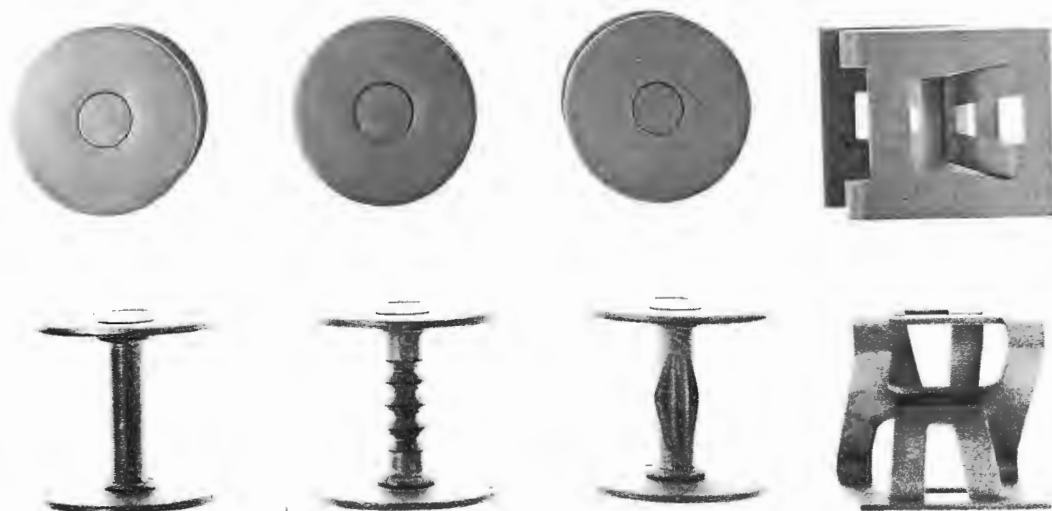
PLATE 2

4. The basic material, in the form of bare, uncoated, chaplets, was again donated by the Fanner Manufacturing Company. These were of the coarse thread, superstem, and plain stem styles of both 1/4" and 3/16" stem diameter. Plate 2 shows these together with a Reeder type which was not received in time for testing.
