AFCEC-CX-TY-TR-2022-0010

## **Fuel Spill Fire Testing of an Ignitable Liquid Drainage Floor Assembly (ILDFA) for Chemical-Free Fire Control/Suppression**

**AIR FORCE CIVIL ENGINEER CENTER  
READINESS DIRECTORATE**

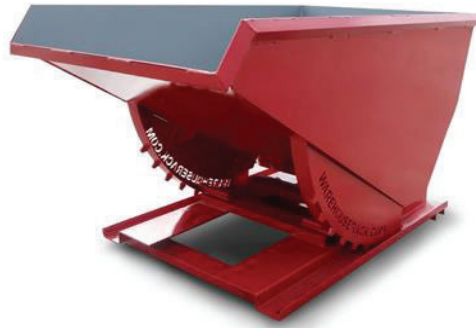
**Figure 6. Fuel Spill Hopper**

Synthetic JP-4 fuel was blended for each test (kerosene and gasoline (2:1 (vol:vol)) and dispensed into a 200 gal steel hopper (Figure 6). Figure 7 shows the final test area setup with fuselage and wing mockup, spill hopper on the concrete floor, three of the four thermocouple trees, and three of the four perimeter heat flux sensors. The same locations and orientations were used for ILDFA testing.

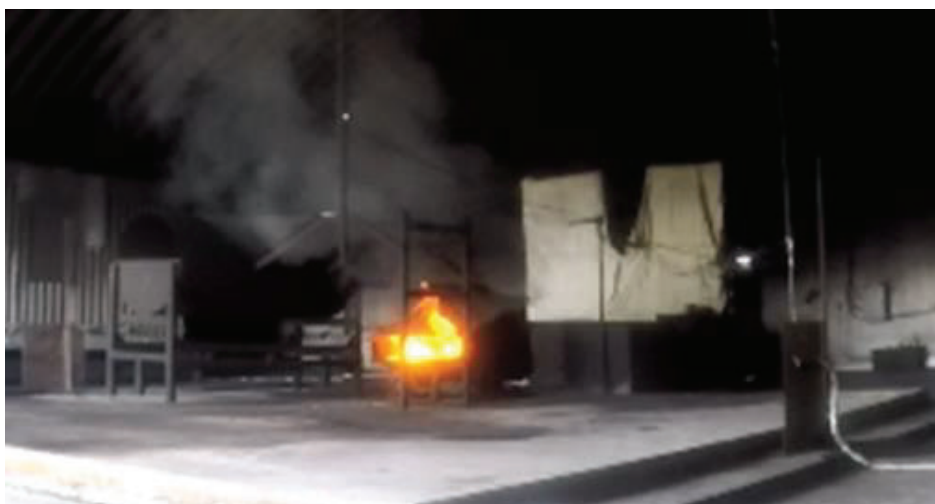
**Figure 9. Fuel “Pre-burn” Before Fuel Spill on Concrete**

Fuel was ignited and 15 s pre-burn allowed before being spilled onto the floor (Figure 9). The hopper was released by a spring mechanism and then tipped using an electric winch to consistently “spill” (pour) the fuel in each test. The same hopper tipping rate was used for all spills and resulted in a higher average flow rate as fuel volumes increased. (Table 4). On average, the fuel completely drained from the hopper in fewer than 15 s.

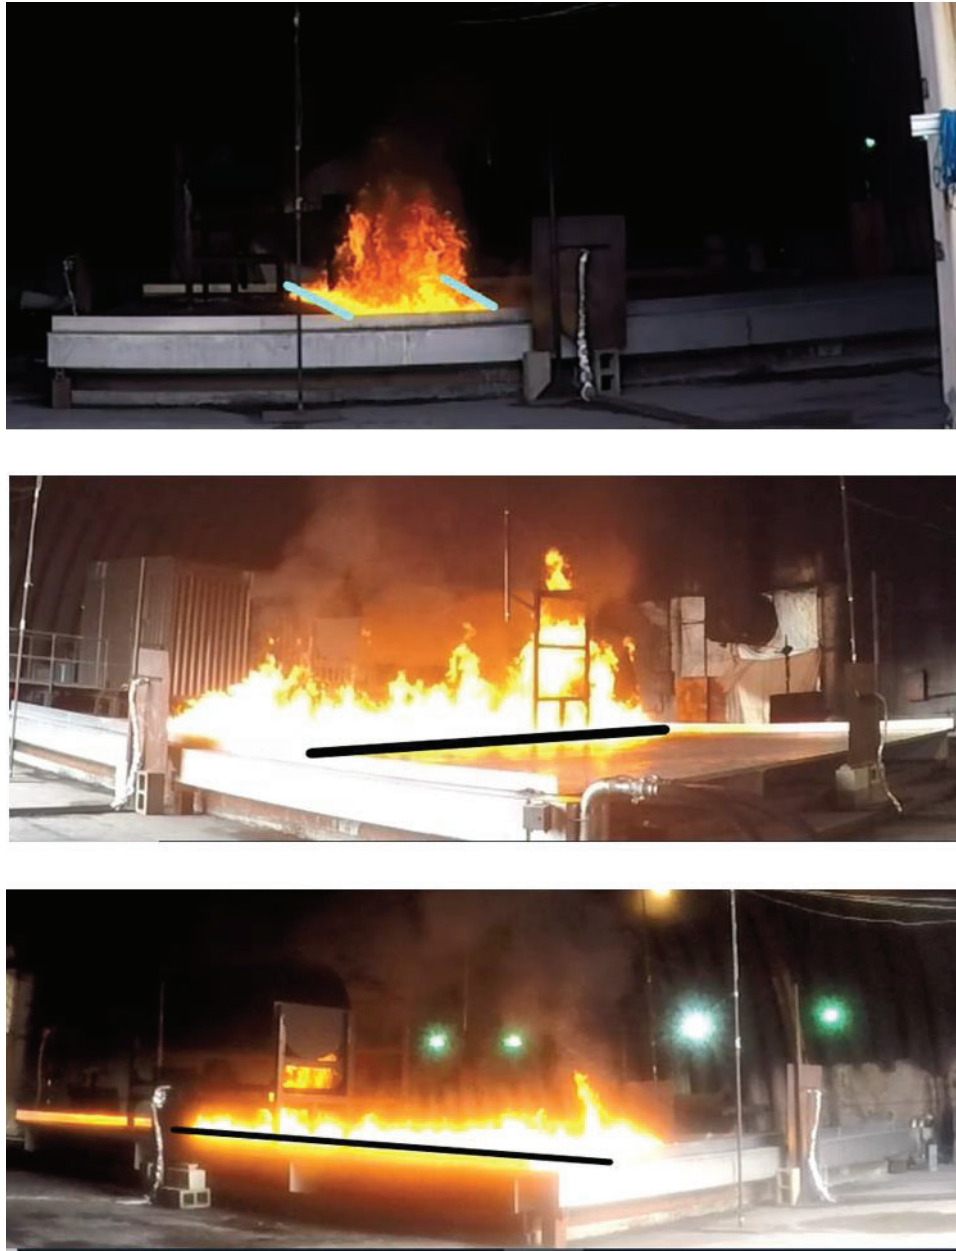
**Figure 12. Oval Shape of fire on ILDFA floor**

Fuel spill fires on the ILDFA had different general shape and progression than those on bare concrete. The ILDFA drains and captures the fuel spill rapidly (by design), so there was comparatively little radial spread of fuel compared to bare concrete spills. Also, on the ILDFA, the fuel spill spreads predominantly from North to South with relatively little spread West and East (i.e., laterally), due to the flooring surface roughness and rapid drainage on the ILDFA. The combination results in an oval fluid flow distribution as demonstrated in Figure 12. In contrast, fuel spills on concrete spread unhindered and formed a more conventional circular spill pattern.

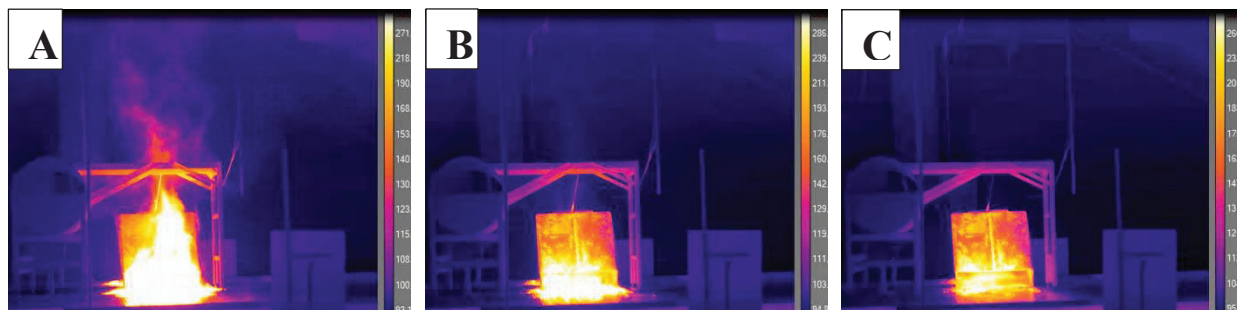
**Figure 15. Infrared Images of a 30 gal ILDFA Fuel Spill Fire at 15 s (A), 90 s (B), and 180 s (C) Time Points**

The ILDFA mitigated peak HRR estimates are much less than comparable spills on a concrete surface and the duration of the peak intensities are short as the spill volume rapidly reduces due to draining. Although not tested, it appeared the fires could have been readily extinguished or suppressed soon after the spill with a handheld, Class B fire extinguisher. The progress of the fire at three time intervals after the spill is demonstrated in Figure 15 for a 30 gal fuel spill. The primary signature in 90 s and 180 s images was the fuel hopper, likely heated while burning the fuel prior to tipping the hopper

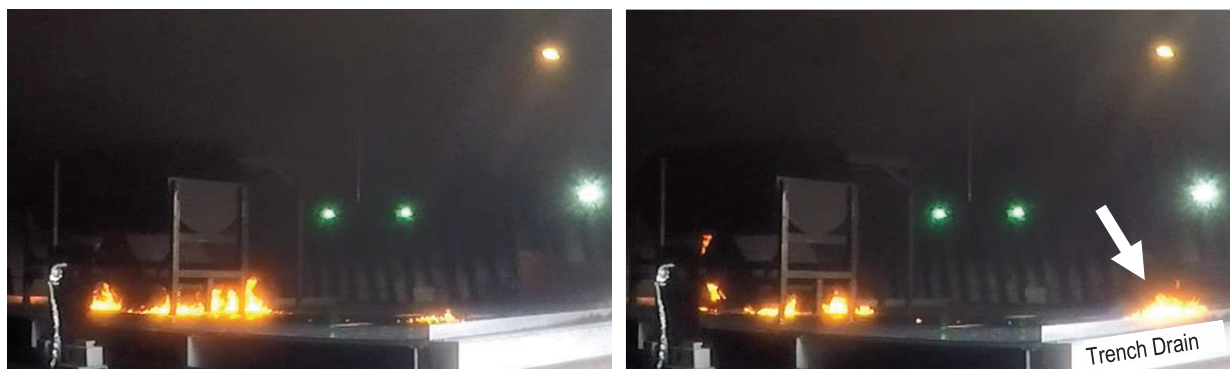
**Figure 16. Re-ignition of Fuel vapors on the ILDFA**

During the ILDFA testing of fuel spills with and without water flushing activated, re-ignition of the fuel was observed at locations several feet away from the spill location and above the ILDFA channels. After the initial spill, the fire size decreased rapidly, at the origin but as the unburned fuel drained away in the subsurface channels, flames reemerged at the random distances several feet south and north from the spill origin and typically in the direction of the fuel draining toward the floor trench drain for a swift amount of time. The ignition may be attributed to oxygen deprivation in the channels near the spill origin; then when the vapors were released from the flooring channels and exposed to air, the temperature was sufficient to reignite. The secondary flames ranged in size from small candle flames up to two feet high and of modest intensity. These secondary flames were considered for determining total burn durations. Figure 16 shows secondary flames away from the original spill location during a 110 gal spill fire test.

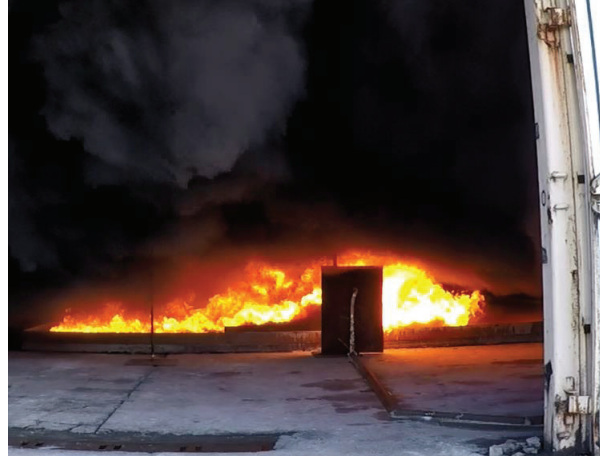
**Figure 29. Fire Vortex Adjacent to the South Perimeter Heat Flux Sensor**

The three 30 gal synthetic JP-4 fuel spills on concrete averaged 14 s preburns in the hopper before the fuel was spilled onto the floor. The smoke layer in the ceiling dropped to within five feet of the floor approximately 60 s after the spill and obscured the flames from visible spectrum video cameras. From the infrared video, the flames remained higher than 10 ft. for approximately 70 s. A fire vortex formed by the South perimeter heat flux sensor (the high intensity area on the right side of Figure 29) approximately 45 s after the spill in all three tests and remained for approximately 70 s then rapidly diminished. The vortex was apparent in all tests larger than 30 gal and resulted in high measured heat flux at the South sensor, which is indicative of greater heat flux in flames than the heat flux adjacent to flames. The fuel spills spread lengthwise from the hopper to the South side of the 30 x 30 ft. spill area and adjacent to the North sensor. The width of the spills ranged from approximately 8 to 20 ft. wide resulting in total coverage of approximately 415 ft<sup>2</sup>. Based on this coverage, the average fuel depth was ~0.11 in. Figure 30 shows the extent of the fuel spill recorded using the IR camera located outside the South door of the test facility.

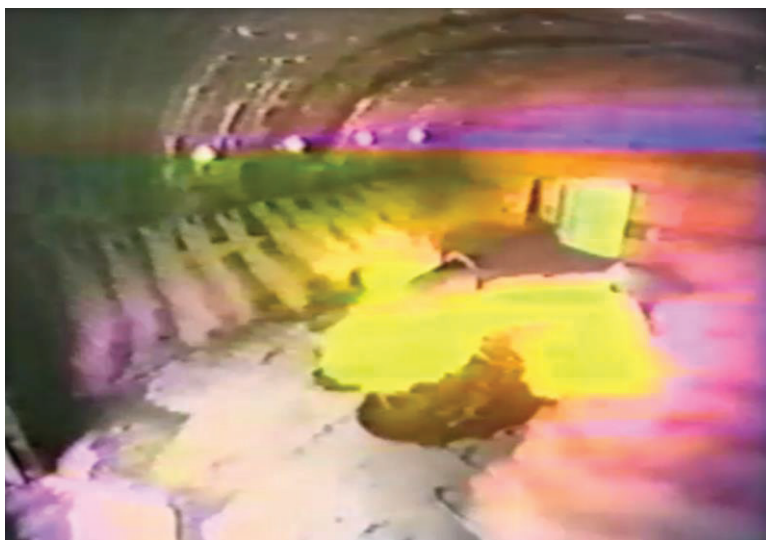
**Figure A-1. Halon System Activation to Extinguish the 165 gal JP-4 Spill Fire**

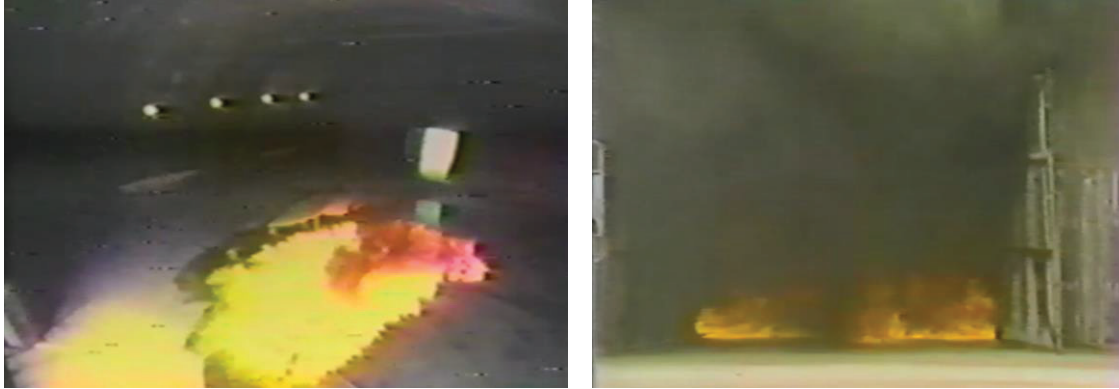
**Figure A-2. JP-4 Spill Fire Three Seconds (left) and 11 s (right) After Ignition**
