**Mechanical Properties and Tension-Tension Fatigue Behavior of a Novel Additively  
Manufactured Polymer Matrix Composite at Room and Elevated Temperature**

THESIS

Grayson M. Harber, Captain, USAF

AFIT-ENY-MS-22-S-119

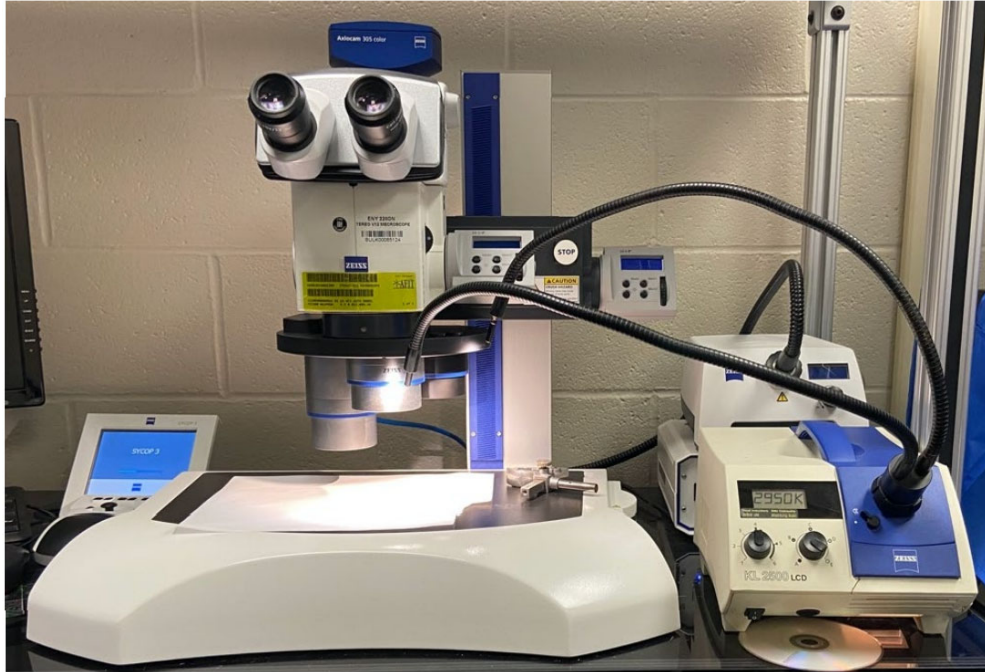
Figure 12. The optical microscope used to take optical micrographs [16]

Optical microscopy was carried out on a Zeiss SteREO Discovery V12 stereoscopic optical microscope with a Zeiss SYCOP 3 control panel and a Zeiss EMS 3 controller. The control software used was the Zeiss ZEN Core V2.7 software. Micrographs were taken at a magnification level of 8 times magnification. The microscope and peripheries are shown in Figure 12.
