# **NAVAL POSTGRADUATE SCHOOL**

## **THESIS**

**SHIPBOARD 3-M PROGRAM SUPPLEMENTED  
BY AR TECHNOLOGY**

September 2022

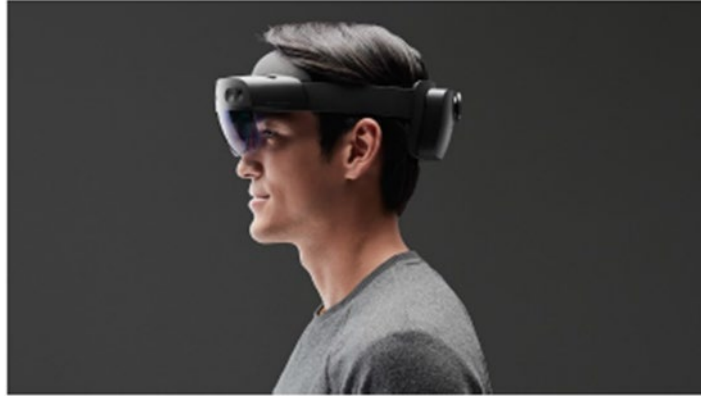
Figure 6. Microsoft HoloLens 2. Source: Microsoft (2020).

The AR headset used was a Microsoft HoloLens 2 (Figure 6). This headset was chosen due to its availability through the NPS Modeling Virtual Environments and

Simulation (MOVES) department and the prior work that had been completed creating the virtual interface and back-end software to support the AR search task (Wiltshire, 2021).
