STRESS-RELIEF HEAT TREATMENT OF  
MANGANESE-NICKEL-ALUMINUM BRONZE  
AND MANGANESE-BRONZE WELDMENTS

Charles A. Zanis

Naval Ship Research and Development Center  
Annapolis, Maryland

January 1975

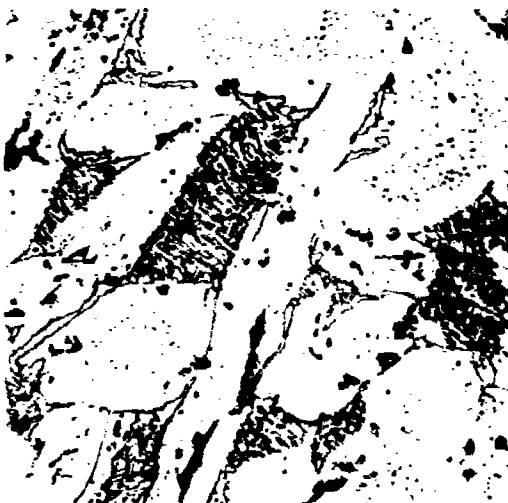
Figure 5  
Heat-Affected Zone Microstructures of  
Mn-Ni-Al Bronze Weldments (500X)

Item (a)  
As-Welded

Item (b)  
700° F, 2 Hours  
Air Cooled

Item (c)  
350° F, 2 Hours  
Air Cooled

Item (d)  
1200° F Furnace Cooled to  
350° F Air Cooled

The above observation may be explained by examining the microstructure in the HAZ of the Mn-Ni-Al bronze weldment in each of the conditions tested. As shown in item (a) of figure 5, the as-welded HAZ microstructure contains alpha-phase particles in a continuous matrix of darker etching beta phase. The beta phase is susceptible to both selective phase corrosion and to stress-corrosion cracking. Heat treatment of 700° F, item (b) of figure 5, did not markedly reduce the amount of beta phase, but did produce a fine precipitate within the beta matrix. This phase is a complex Cu-Mn-Al compound which forms on prolonged heating in the temperature range of 600° to 900° F. Heat treatment at 1050° or at 1200° F followed by a furnace cool to 930° F, produced significant amounts of alpha phase in the beta matrix, as shown in items (c) and (d). The presence of large quantities of alpha phase improves the resistance of the HAZ to selective phase corrosion and to stress-corrosion cracking.
