DEVELOPMENT OF URETHANE ROADWHEEL TIRES  
WITH EMPHASIS ON METHOD OF BONDING

U.S. ARMY TANK AUTOMOTIVE COMMAND Warren, Michigan

FINAL REPORT

DEVELOPMENT OF URETHANE ROADWHEEL TIRES  
WITH EMPHASIS ON METHOD OF BONDING  
(FIRST SIX SAMPLES)

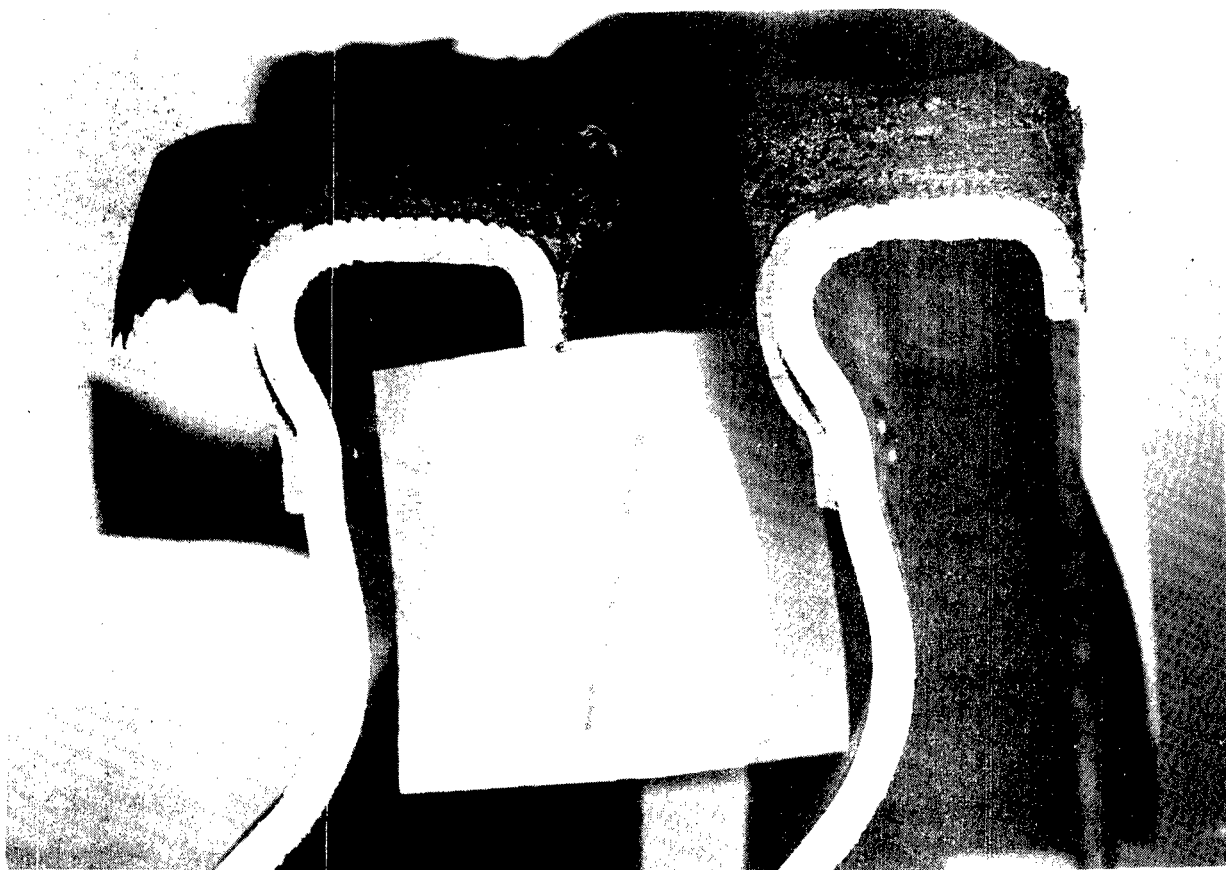
FIGURE 2 - WHEEL NUMBER 1 AFTER TEST

Wheel Number One - The construction was wound cord. The urethane was black and opaque. Durometer hardness was 66-73. The low hardness was probably due to the cord not being thoroughly impregnated with urethane. The wheel was put on the drum and run at 10 mph with a load of 2095 pounds. The standard M113 rubber tired roadwheel is considered to have successfully passed this test if it goes 48 hours without bond failure or blowout. This urethane tired wheel failed after 0.9 hour. Upon examination of the wheel, several areas of separation of tread and wheel were found. They were similar to blowout of standard rubber tires. This wheel ran with excessive vibration due to .045 inch radial runout and also probably caused by the screw posts used to guide the wound cord and also contributed to by variations in hardness of tire. Test was stopped due to extreme bumping. The wheel showed a blowout upon examination (see Figure 2). The ambient

temperature was 97°F. The wheel temperature was 125°F and the tread temperature was 160°F.

| WHEEL # | COLOR | CONSTRUCTION | DUROMETER | WEIGHT in lbs | 10 mph @ 2095 lbs | 30 mph<br>2 hrs @ 925 lbs<br>2 hrs @ 1015 lbs<br>2 hrs @ 1110 lbs | 10 mph 2095 lbs | FINAL CONDITION OF TIRE |
|---|---|---|---|---|---|---|---|---|
| 1 | Black Opaque | Cord | 66-73 | 33.4 | 0.9 hrs | | | Failed (see photo)<br>Excessive vibration.<br>Tread Temp: 160° F. |

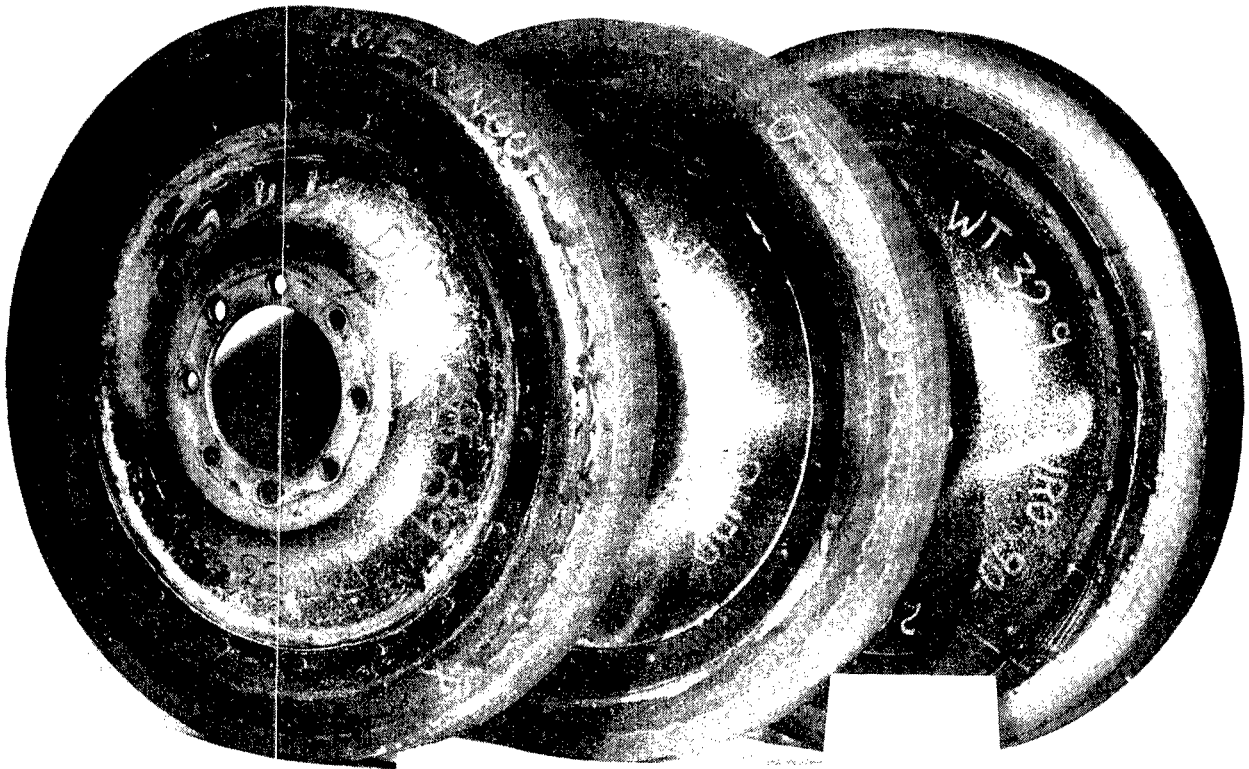
FIGURE 4 - WHEELS NUMBER 2, 3, AND 5  
(LEFT TO RIGHT) AFTER  
TESTING

Wheel Number Two - The construction was yellow translucent urethane cast over expanded metal welded to the wheel rim. The durometer reading was 88-89. The wheel was put on the drum tester at 10 mph and 2095 pound load. It ran with some vibration and wheel tramp due to .015 inch radial runout. There was also excessive lateral runout. The wheel completed 48 hours with no degradation or damage. The ambient temperature was 97°F, and the highest tread temperature reached was 110°F. A decision was made to continue the drum test for another 48 hours. After the 96 hours no degradation or defects were observed. (See figures 3 and 4.)

Wheel Number Three - The construction was yellow translucent urethane cast over expanded metal welded to the wheel rim. The durometer reading was 91-92. The wheel was put on the drum tester at 10 mph and 2095 pound load. It ran with slight vibration. There was .010 inch radial runout. The wheel completed 48.75 hours without any degradation or defect. The highest temperature reached by the tread was 110°F. The ambient varied from 95°F to 100°F. This wheel was then subjected to a drum test at 30 mph with the load at 925 pounds for two hours, at 1015 pounds for two hours, and at 1110 pounds for the next two hours. The wheel showed no defects after this test. The ambient

temperature varied from 95°F to 102°F. The tread temperature reached 107°F. (See figures 3 and 4).

Wheel Number Five - The construction was wound cord. The urethane was yellow and translucent. The durometer hardness was 90-91. Radial runout was .028 inch. The wheel was run on the drum tester at 10 mph and at 2095 pound load. There was moderate vibration. The test was continued for 97.9 hours. Maximum tread temperature was 117°F, and the ambient was 105°F. There was no noticeable degradation of the urethane compound or defect in the roadwheel at the conclusion of the test. (See figures 3 and 4.)

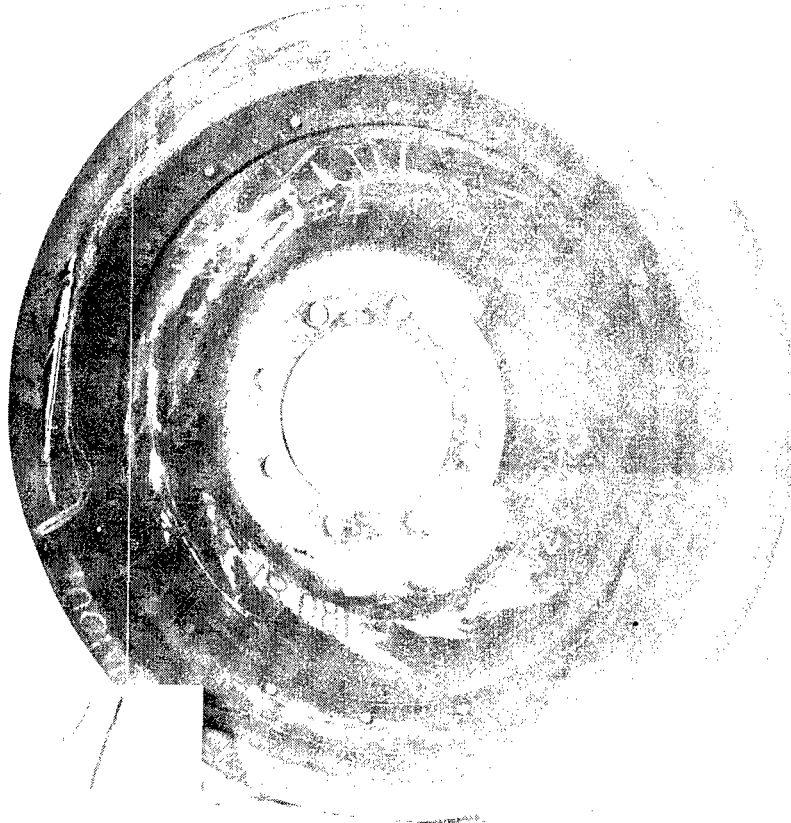
FIGURE 5 - WHEEL NUMBER 4. NOTE PRIMARY  
FAILURE AT 9 O'CLOCK AND  
SECONDARY AT 2 O'CLOCK

Wheel Number Four - The construction was wound cord. The urethane was orange and opaque. Durometer hardness was 81-88. The lower hardness and the large spread in durometer readings was probably due to the cord not being thoroughly impregnated or evenly impregnated with urethane. The wheel was put on the drum tester and run at 10 mph at 2095 pound load. Radial runout was .030 inch. Heavy vibration and bumping was present - sufficient to trip microswitch after twenty minutes. Machine was restarted. After another fourteen minutes the tire blew out. Tread temperature had reached 132°F. The ambient was 97°F. Wheel showed separation at cord wound reinforcement which extended from one side of the wheel to the opposite side and for 20° around the circumference. Another blowout was just starting about 120° from the first one. (See figure 5.)

| WHEEL # | COLOR | CONSTRUCTION | DUROMETER | WEIGHT in lbs | 10 mph @ 2095 lbs | 30 mph<br>2 hrs @ 925 lbs<br>2 hrs @ 1015 lbs<br>2 hrs @ 1110 lbs | 10 mph 2095 lbs | FINAL CONDITION OF TIRE |
|---|---|---|---|---|---|---|---|---|
| 4 | Orange Opaque | Cord | 81-88 | 32.5 | 0.6 hrs | | | Failed (see photo)<br>Excessive vibration.<br>Tread Temp: 137° F. |

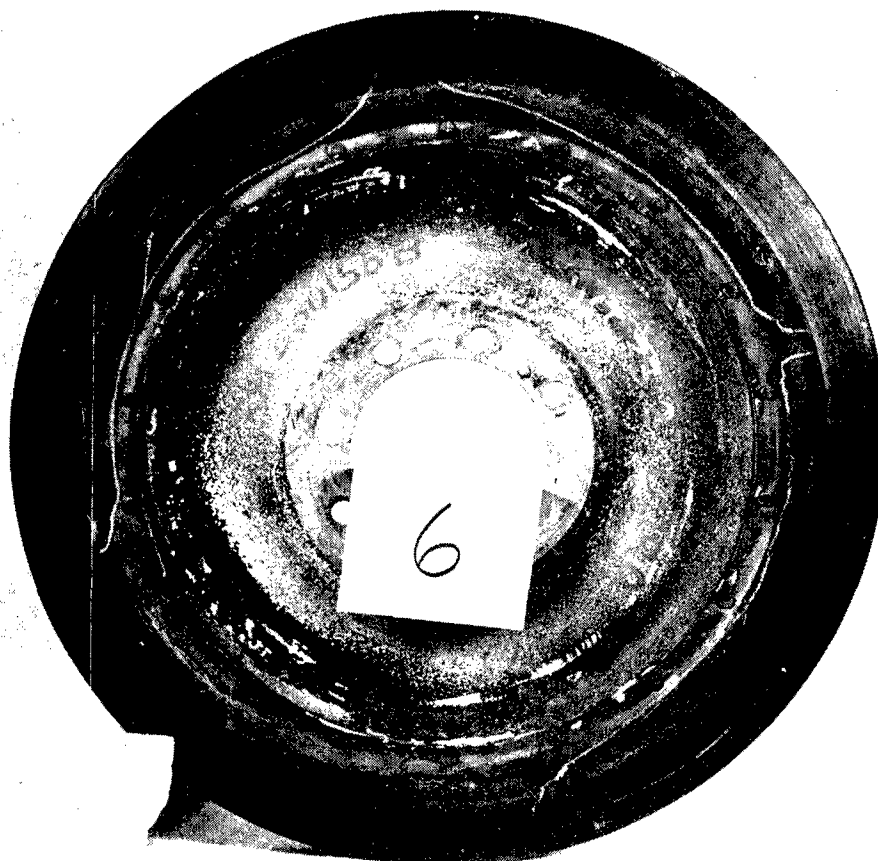
FIGURE 6 - WHEEL NUMBER 6 AFTER ALL TESTING.  
NOTE UNDERCUT AREAS OF TREAD  
CIRCLED WITH CHALK

urethane was black, opaque and the durometer hardness was 76-79. This wheel, as on the previous samples, had undercut portions at the joint between wheel and tire and a putty material present at these places. The supplier explained that he used putty in the temporary molds he cobbled up. The wheel had .035 inch radial runout. The wheel was drum tested for 48 hours at 10 mph and with 2095 pound loading. The condition of the wheel was unchanged after this test. Then it was drum tested at 30 mph at 925 pounds for two hours, at 1015 pounds for two hours, and at 1110 pounds for two hours. Toward the end of the 30 mph test, the undercutting of the tread at the junction with the wheel became slightly more pronounced on both sides of the wheel. Now the wheel was subjected to an additional 48 hour drum test at 10 mph and 2095 pound load. After this test, increased undercutting with radiating cracks from undercut areas and circumferential cracks in tread surface were noted. The ambient temperatures were 90<sup>o</sup> F to 101<sup>o</sup> F. The tread reached a temperature of 122<sup>o</sup> F after the first seven hours of running but then dropped back again to 112<sup>o</sup> F. After the tests, the durometer hardness had increased to 77-81. There was only a slight vibration in spite of the .035 inch runout. An attempt was made to strip the tread from the wheel after the tests but it could not be done. Pieces of the tread were removed by sawing and the circumferential cracks were found to go about 2/3 to 3/4 the depth of the tread above the expanded metal. There was no

separation of the urethane from the expanded metal or the wheel rim. (See Figures 6, 7, and 8.)

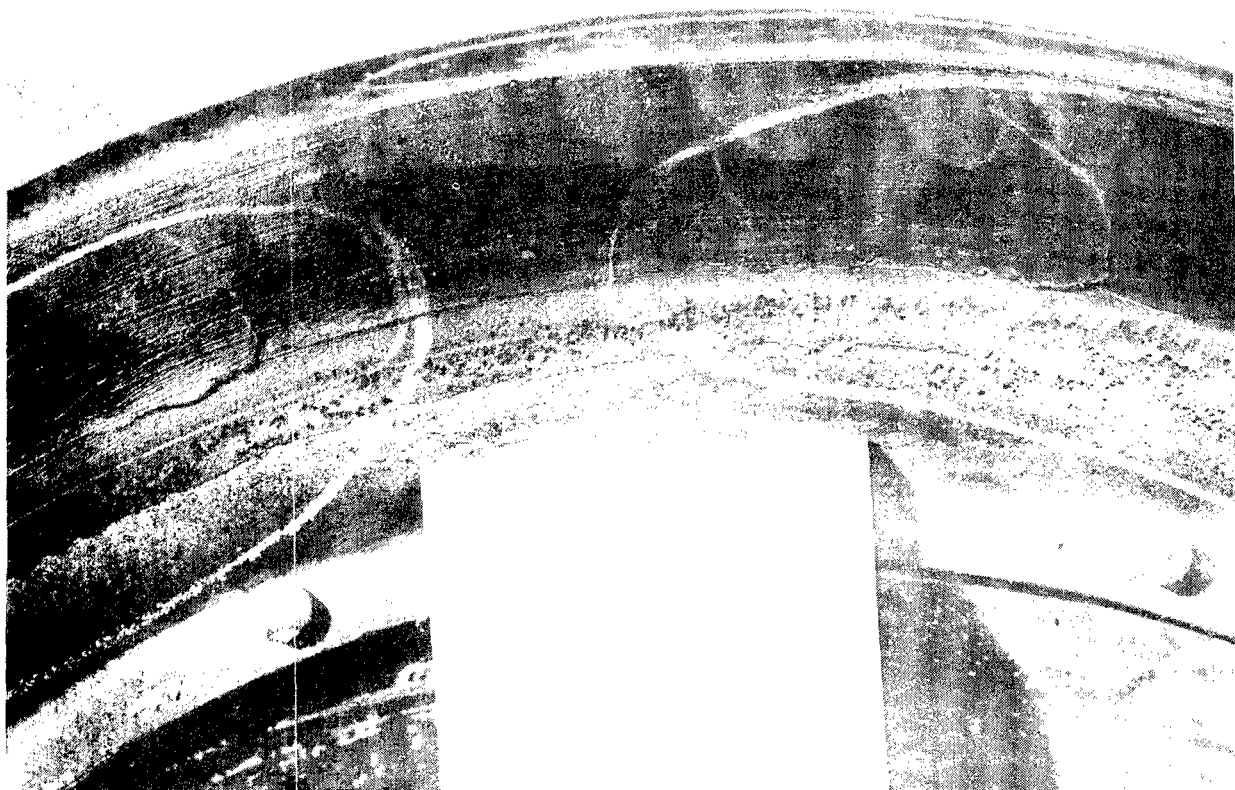
FIGURE 7 - WHEEL NUMBER 6 AFTER TESTS.  
CLOSEUP VIEW OF UNDERCUTTING

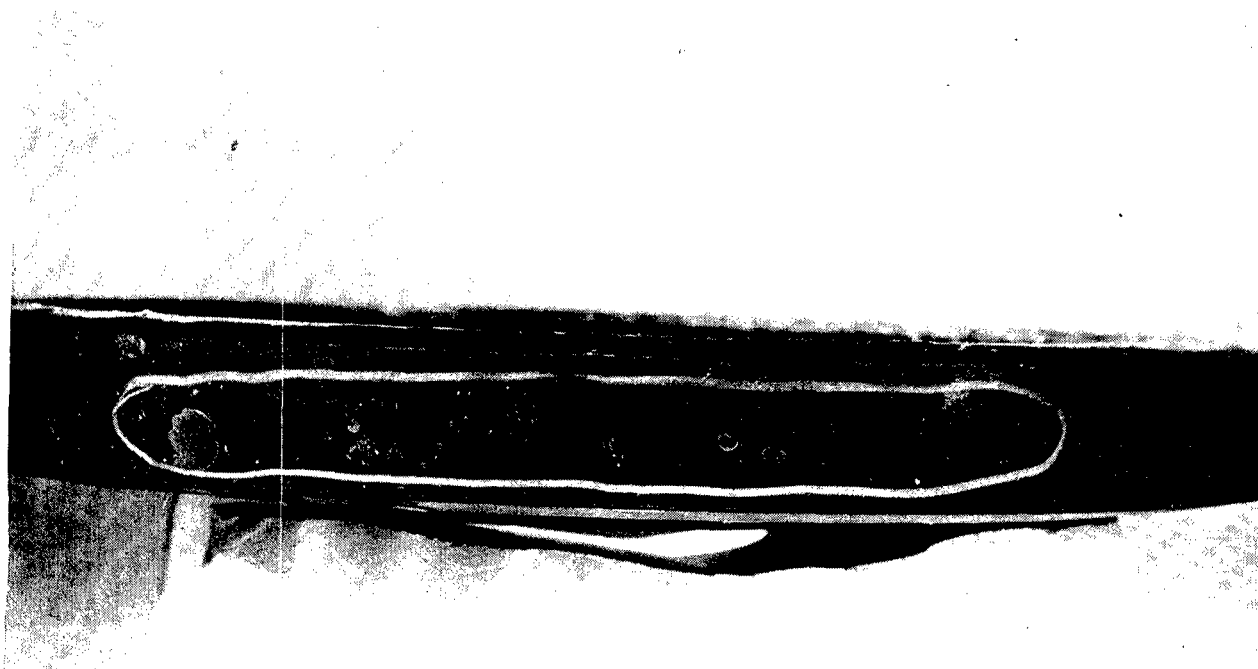
FIGURE 8 - WHEEL NUMBER 6 AFTER TESTS.  
NOTE CRACKS IN TREAD ONLY  
APPEAR WHERE THERE ARE  
FOREIGN INCLUSIONS IN THE  
URETHANE
