PROCEEDINGS OF GAS TURBINE MATERIALS 1972 CONFERENCE
HELD AT THE NAVAL SHIP ENGINEERING CENTER, HYATTSVILLE,
MARYLAND IN OCTOBER 1972

GAS TURBINE MATERIALS CONFERENCE PROCEEDINGS

NAVAL SHIP ENGINEERING CENTER
NAVAL AIR SYSTEMS COMMAND

WASHINGTON, D.C.
OCTOBER 1972

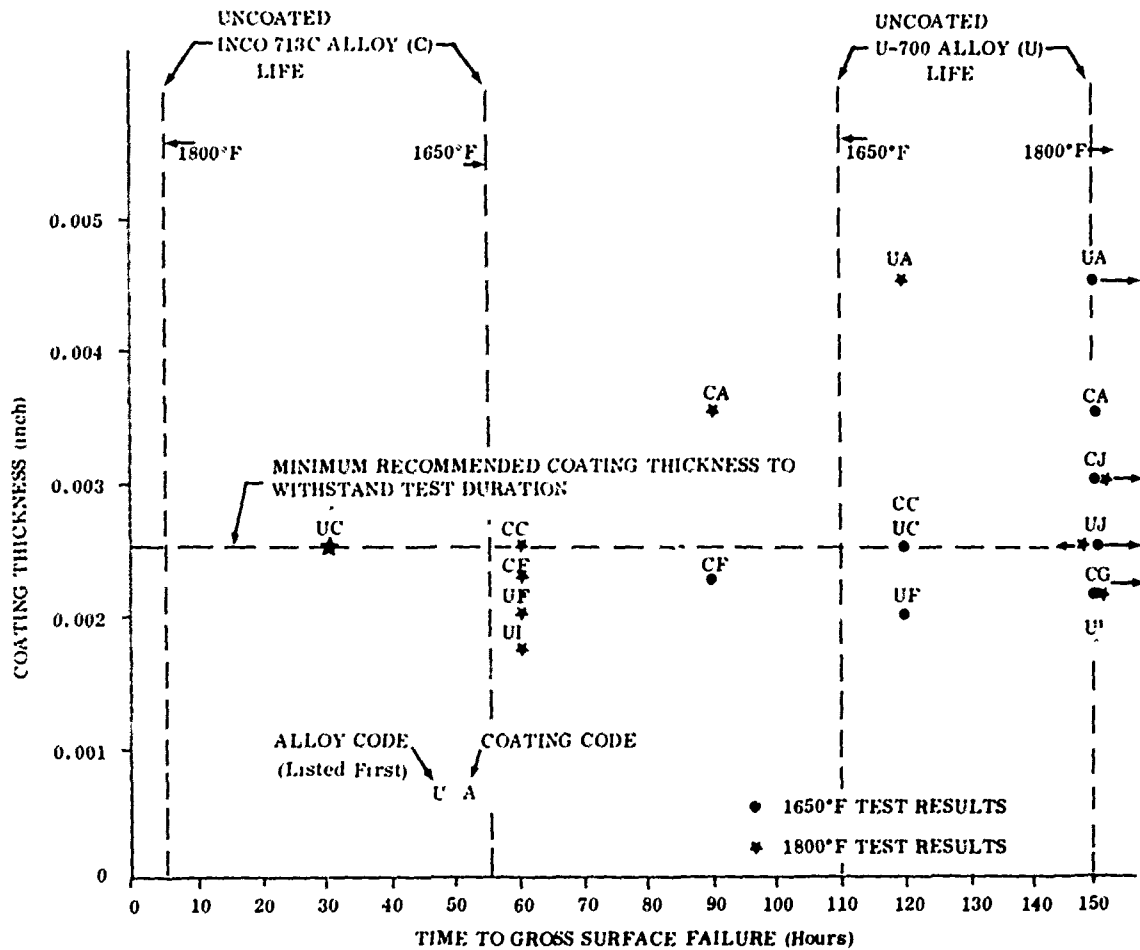
Figure 17. Summary of hot corrosion rig test results on coated medium-chromium content nickel-base superalloys.

Figure 17 presents the hot corrosion rig lives of the various coatings on the medium-chromium, nickel-base alloys (Inco 713C and U-700) plotted against original coating thickness. The data show that coatings can shorten the time to gross failure over the uncoated alloys. This early attack was not observed with any of the very short-lived low-chromium, nickel-base alloys. Coatings C, F, and I decreased the time to significant attack on the U-700 alloy at 1800°F and the A and J coatings showed little or no increase in the time to gross attack on this alloy. The type of attack was similar to that observed on the low-chromium alloys although slightly less severe. The deep localized attack of both low- and medium-chromium alloys in hot corrosion rig testing indicates a strong galvanic influence of the

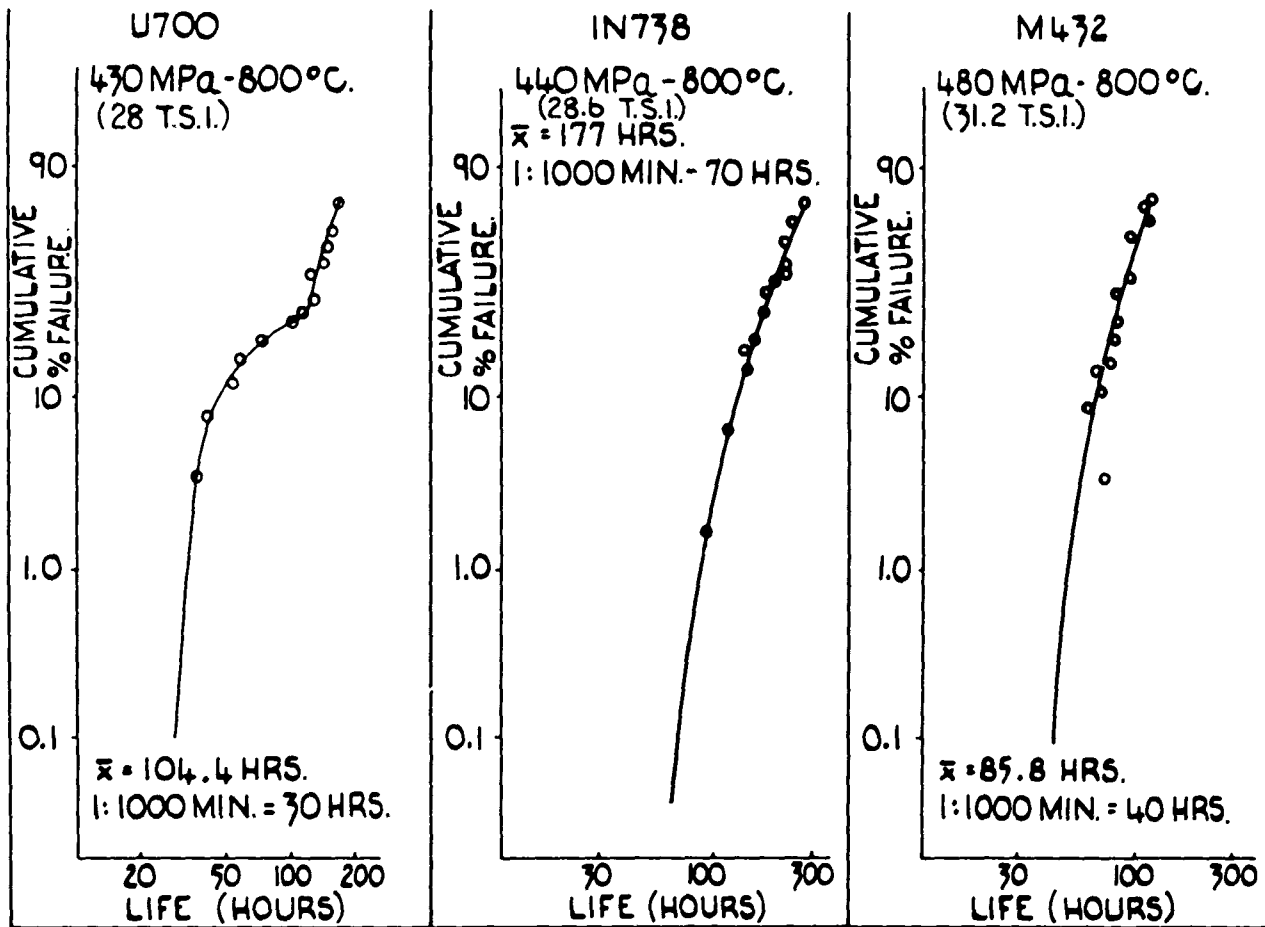
Figure 15. Creep consistency.

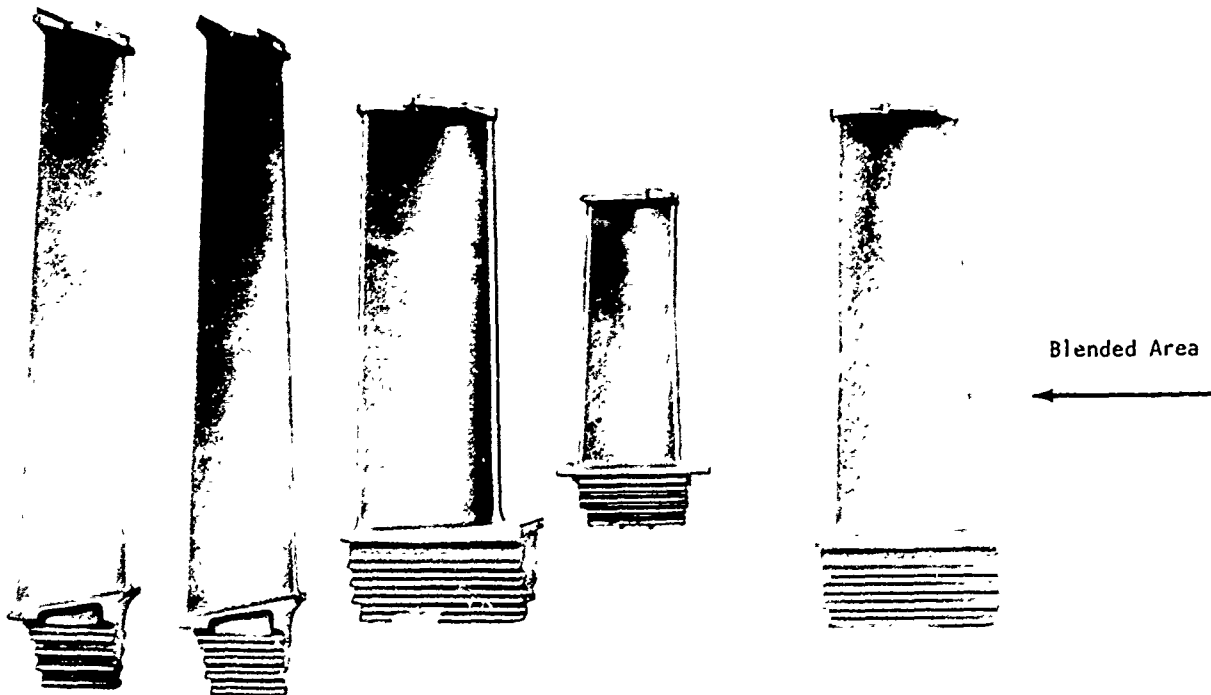
Figure 11. Engine operated blades after complete stripping and recoating with the Al(Cr) slip pack.

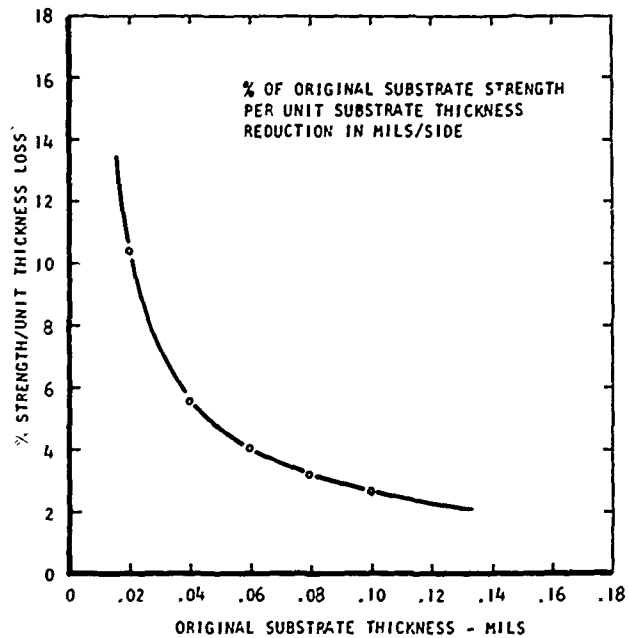
Figure 15. Effect of original substrate thickness on the reduction in load bearing ability per unit thickness loss.
