AMMRC CTR 76-5

## FINISHING TECHNIQUES FOR SILICON NITRIDE BEARINGS

H. R. BAUMGARTNER  
NORTON COMPANY  
WORCESTER, MASSACHUSETTS 01606

FINAL REPORT - CONTRACT DAAG46-74-C-0055

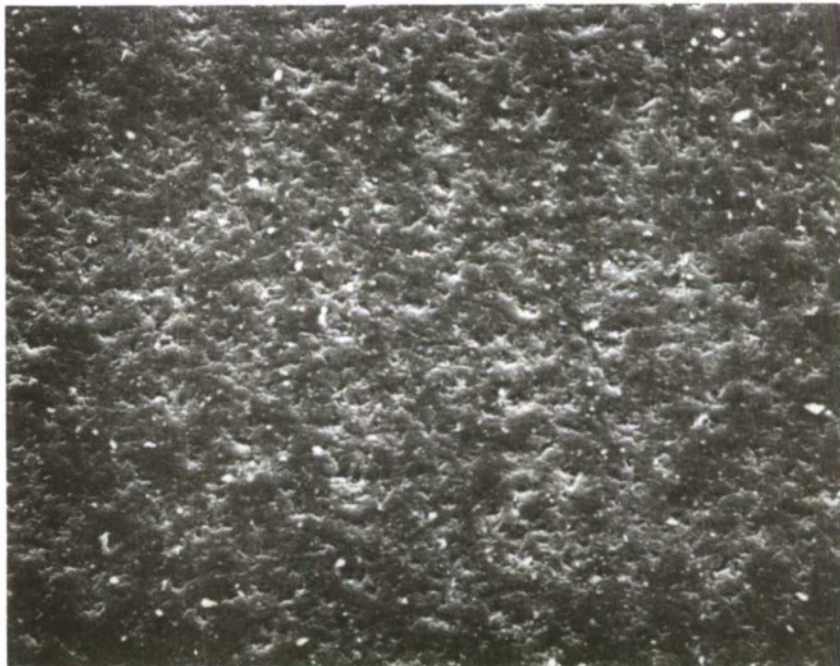
FIGURE 10 - Finish Variation #19 (diamond grit lap)  
on NC-132  $\text{Si}_3\text{N}_4$ , 1000X.

Figure 20 shows that the impacted  $\text{SnO}_2$  polishing compound is removed from the pull-outs within the load track. The appearance of the diamond lapped surface after RCF testing is relatively unchanged, as may be seen by comparing Figure 21 with Figure 10.

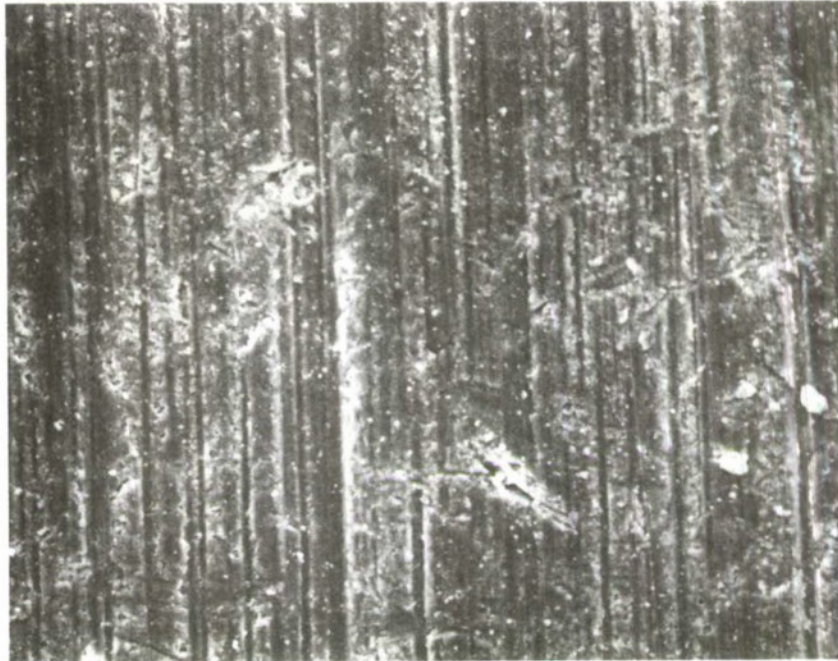
FIGURE 17 - Finish Variation #24 (tumbling in  $B_4C$  grit after 320 grit diamond grind) on strength rod, 500X.

Figure 17 and 18 show two finishes which were applied to strength rods, but not to the RCF specimens. The former is of Finish Variation #24 (tumbling in  $\text{B}_4\text{C}$  grit after grinding). While the tumbling procedure did not remove the grinding scratch topography, impact pits were formed on the surface. Figure 18 shows the strong chemical attack of the hot fluorine etch (Variation #25).

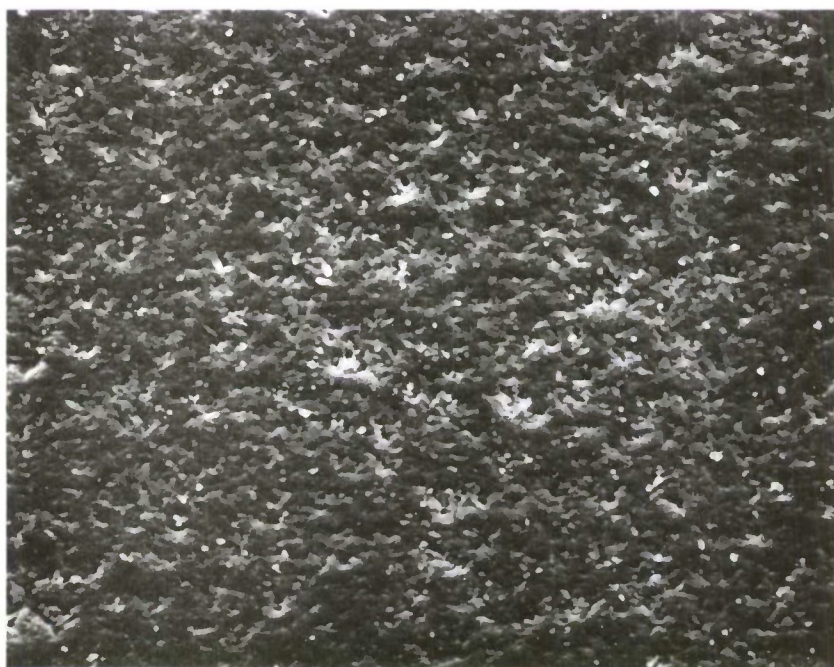
FIGURE 21 - Appearance of diamond grit lapped surface after RCF test, 1000X.

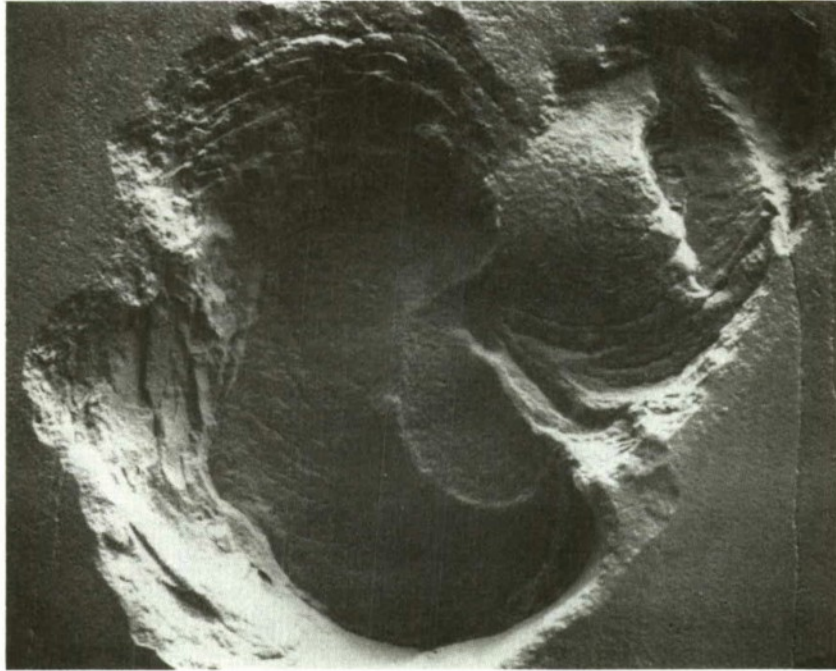
FIGURE 22 - Fatigue spall on RCF Rod #11 after 76.3 million cycles, 100X.

Typical examples of fatigue spalls formed on RCF specimens are shown in Figures 22 through 25. The load track is vertical and the specimen axis is horizontal in all photographs. As found in previous RCF testing on silicon nitride, the majority of spalls originate from a Hertz crack at the edge of the load track. The Hertz cracks border the contact zone around the circumference of the rod, although these cracks may be intermittent and only on one side of the contact zone. These cracks are analogous to cone cracks, which form when plates of brittle material are pressed with a spherical indenter, and arise from the large tensile contact stresses. However, in the RCF case, the cracks are not cones but slope down into the material on either side of the load track. Only infrequently do these cracks curl into the track.

is most clearly seen in the extreme right hand side of Figure 22. The contact stress cracks are true fatigue cracks in that numerous fatigue cycles are required for them to form. Subsequent to the border crack formation, a spall may form as the result of the propagation of a second crack beneath the contact zone. The origin of the second crack appears to be located at the point of slope change of the precedent cone crack analog.

The above spalling mechanism was responsible for most of the spalls. Of all the spalls, only three are believed to have initiated within the load track. There was no difference in spall appearance that could be attributed to material or finish type. Likewise, long lived spalls (Figures 22 and 23) were indistinguishable from short lived ones (Figures 24 and 25).

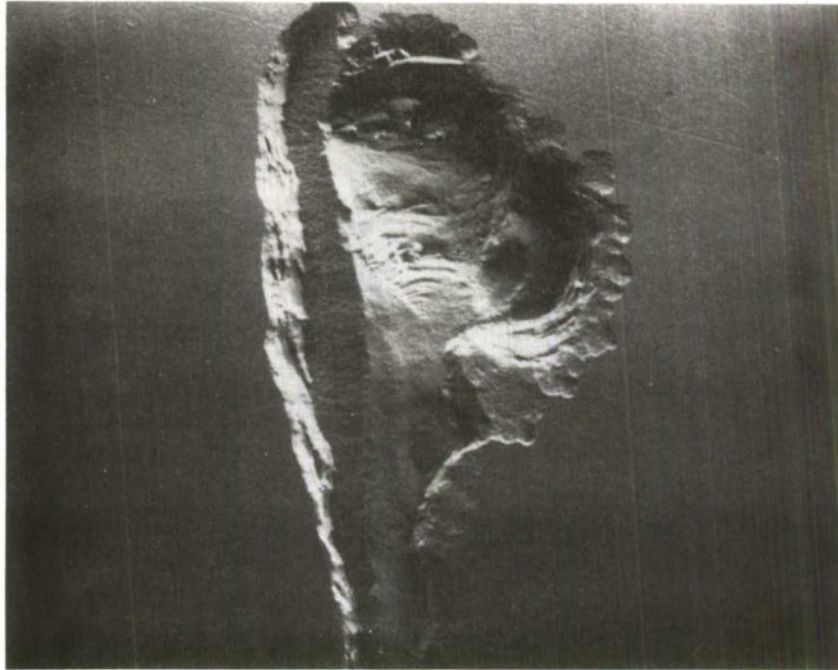
FIGURE 24 - Fatigue spall on RCF Rod #15 after 0.92 million cycles, 50X.

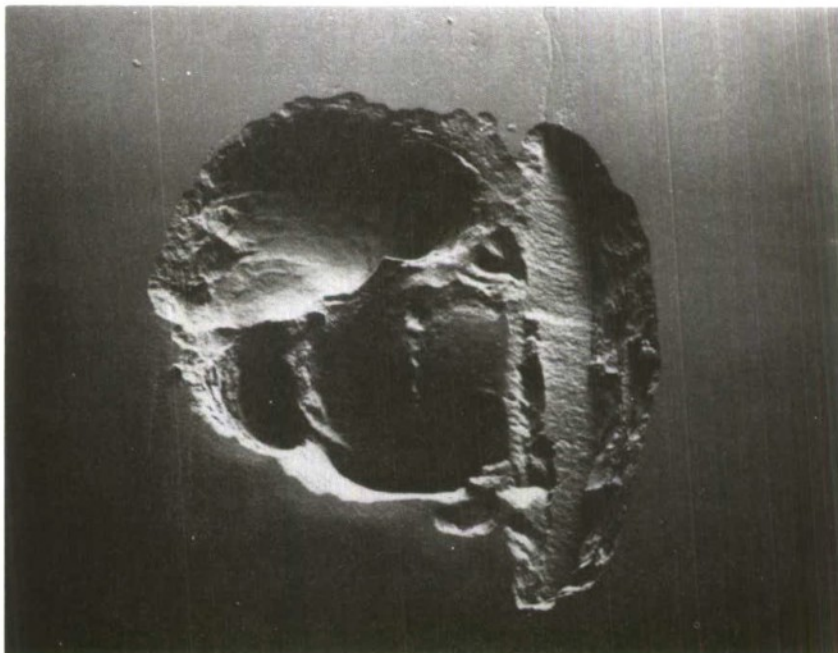
FIGURE 25 - Fatigue spall on RCF Rod #17 after 0.62 million cycles, 50X.
