ARMY AVIATION TEST BOARD FORT RUCKER ALA
MILITARY POTENTIAL TEST OF THE TURBINE-POWERED U-6 AIRPLANE.(U)
SEP 65

SUBJECT: Letter Report of Test, Military Potential Test
of the Turbine-Powered U-6 Airplane

⑩ USATECOM Project No. 4-5-1020-01

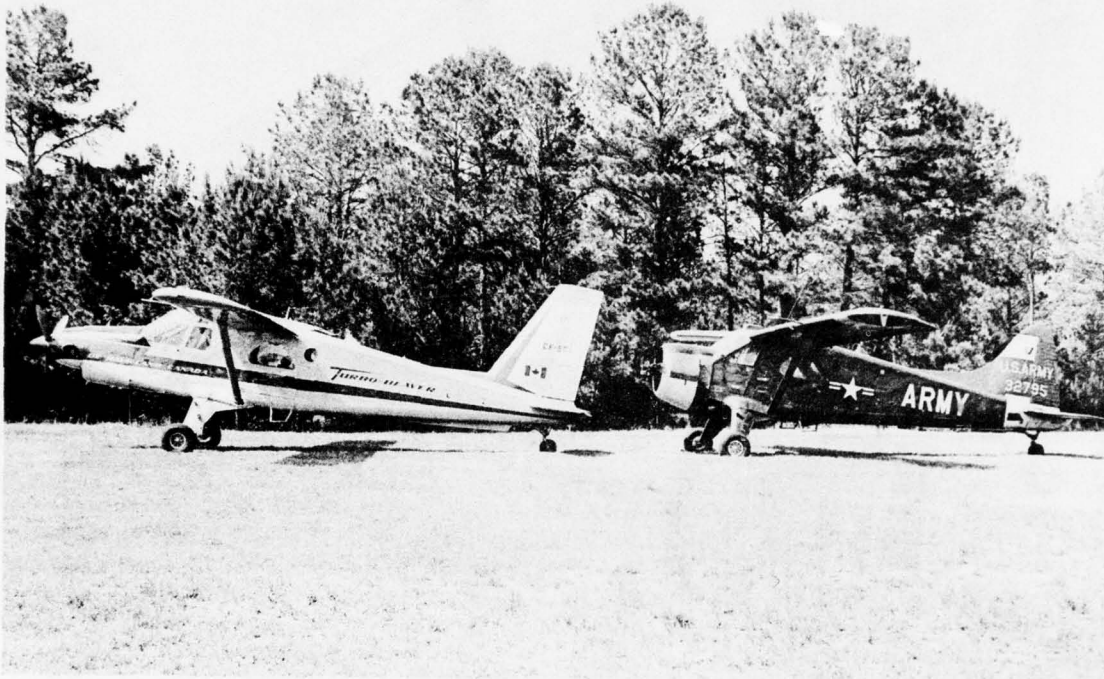
The Turbo-Beaver and the U-6

a. The basic airframe of the U-6 was used in the Turbo-Beaver. The nose cowl was streamlined to fit the gas-turbine engine, and the fuselage was lengthened 30 inches just forward of the leading edge of the wing. These modifications increased the fuselage length by five feet. The rudder assembly was redesigned and increased the height of the airplane by seven inches. The right crew compartment door was changed to a double door 40 inches high and 46 inches wide. The two-bladed propeller was replaced by a three-bladed, reversible-pitch, full-feathering type with the same diameter (8 ft. 6 in.) but a larger pitch range (-14 1/2 degrees to +87 degrees).

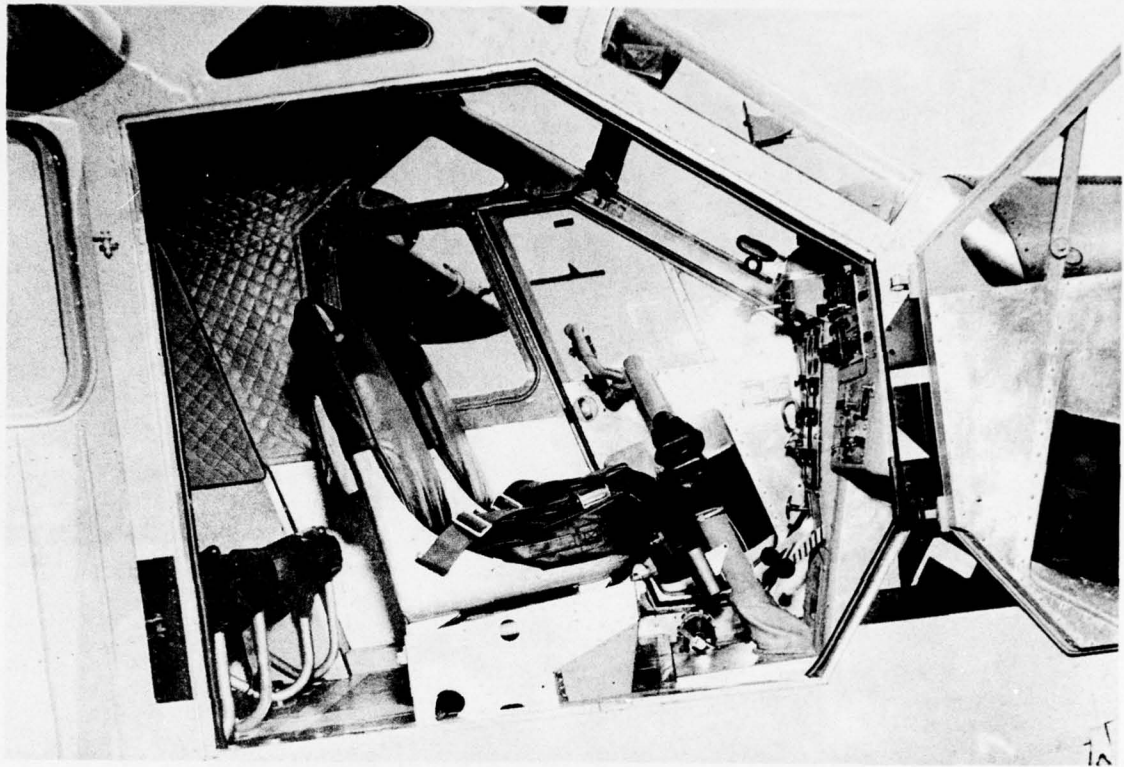
Crew compartment with right double door open.
(Note small window over closed left double doors.)

b. The addition of a small window over the crew compartment door, which was moved 30 inches forward of the wing, and enlarging of the overhead windows greatly increased pilot visibility.

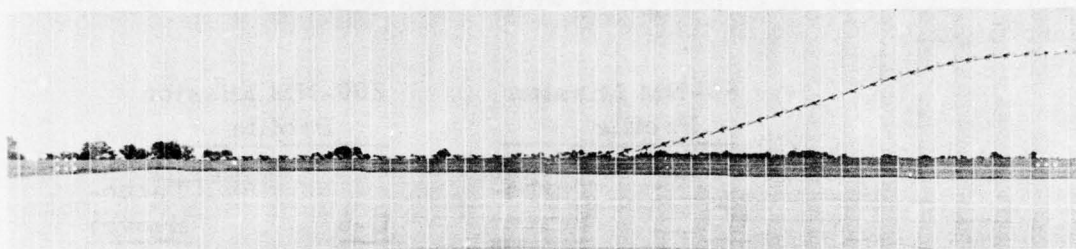
Takeoff of the U-6 (above) and Turbo-Beaver (below)
as recorded by the flight analyzer.

a. The Fairchild analyzer showed that, at both 4500 and 5100 pounds gross weight, the Turbo-Beaver decreased by 26 percent the distance required for takeoff over a 50-foot barrier. By reducing the pitch of the propeller during the approach and reversing the propeller on ground contact, the distance required to land the Turbo-Beaver over a 50-foot barrier was reduced by 26 percent at 4500 pounds gross weight and by 36 percent at 5100 pounds gross weight. However, when the Turbo-Beaver was landed over the 50-foot barrier using currently-prescribed power approach technique without reducing pitch or reversing the propeller, the landing distance required was the same as for the U-6.

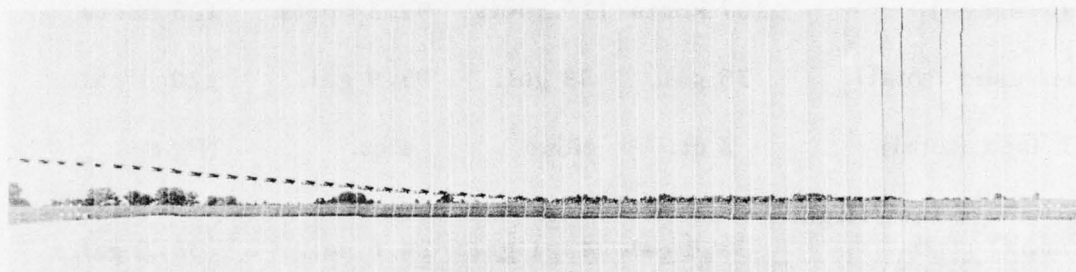
Landing of the U-6 (above) and Turbo-Beaver (below)
as recorded by the flight analyzer.

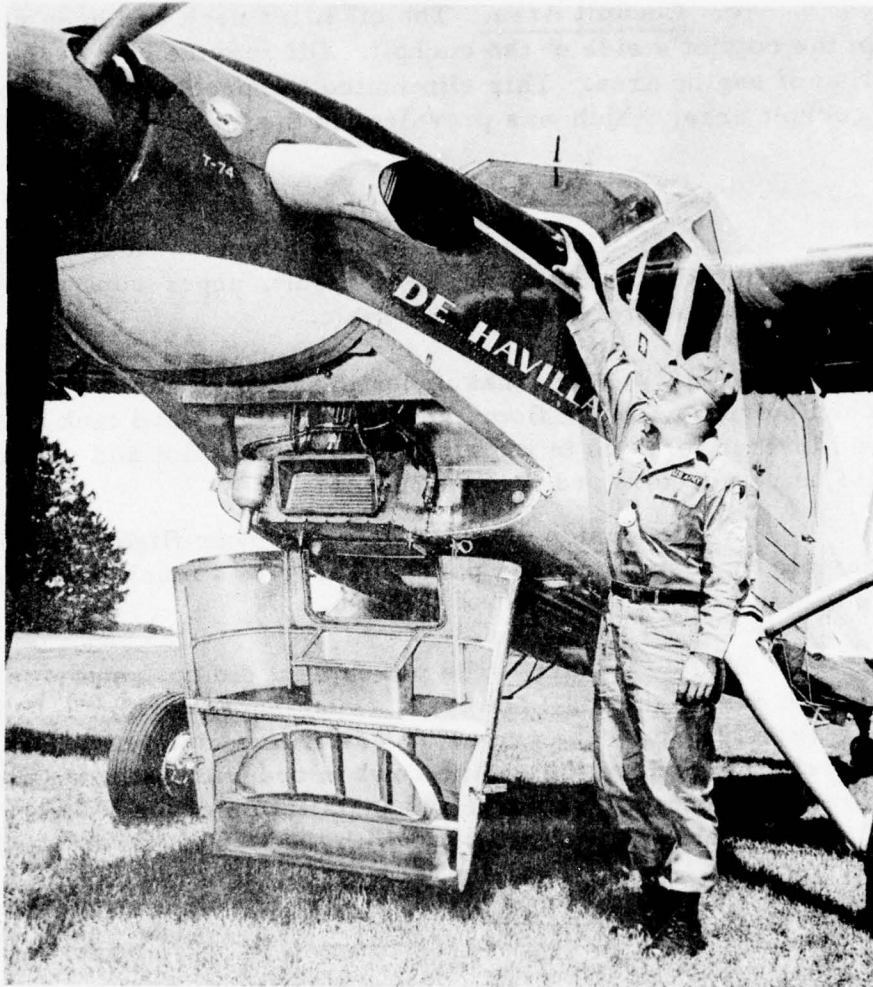
Nose of the Turbo-Beaver with lower engine-access cowling open
