ENGINEERING-ECONOMIC ANALYSIS OF SHORE PROTECTION SYSTEMS:
A BENEFIT/COST MODEL

U.S. Army Corps of Engineers
North Central Division
Chicago, Illinois

Coastal Zone Laboratory
The University of Michigan
Ann Arbor, Michigan

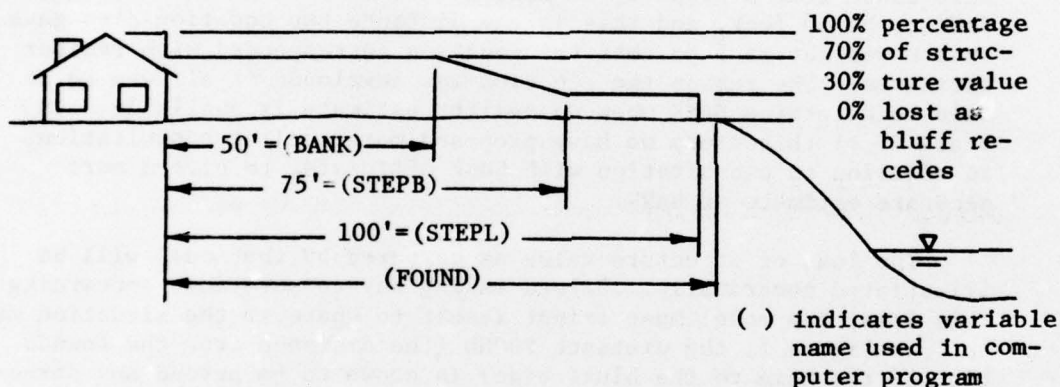
Figure 1. Distribution of structure value over a lakeside lot.

The loss of structure value as computed by the model will be illustrated numerically. Before making any computations concerning this loss, the model must orient itself to whatever the situation may be. In Figure 1, the distance FOUND (the distance from the foundation of the home to the bluff edge) is shown to be beyond any structure value loss. Obviously, this will not always be the case. For example, let us assume that FOUND is initially located in the region of 30 percent structure value loss, between STEPL and STEPB. The estimate of home value input to the program would include the 30 percent loss already suffered. (Home value before erosion progressed to this extent = \$10,000; home value presently = \$7,000.) The model locates FOUND with respect to the critical distances and computes the structure value block as it would have been if the block were as yet undisturbed. The value lost up to the present time is then calculated and stored in variable SVLO--structure value lost old. (SVLO = \$3,000 for this example.) As the bluff continues to recede, a value of SVL (structure value lost) for a given year is computed as follows:

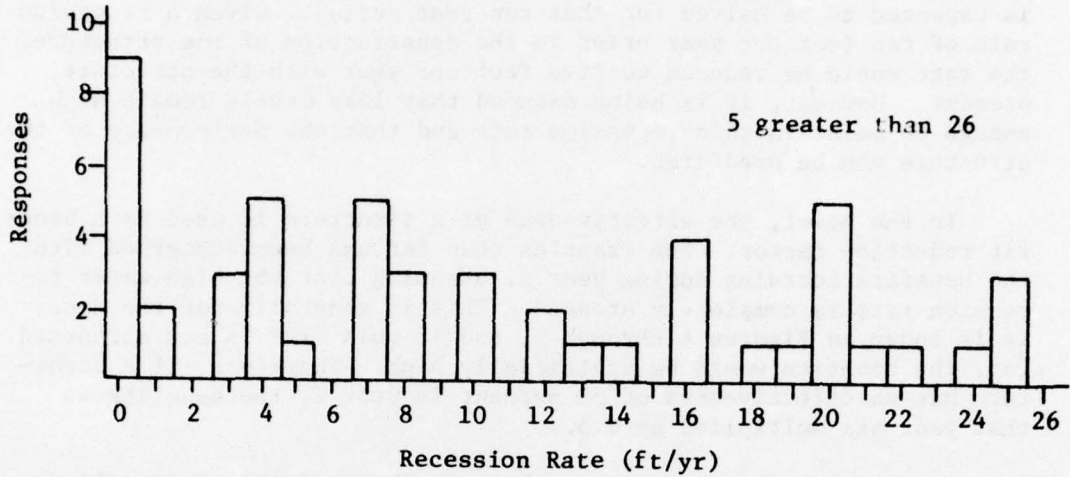
Graph 4. The recession rates for those property owners who took protective action.
