ARMY AVIATION TEST BOARD FORT RUCKER ALA
MILITARY POTENTIAL TEST OF COMMERCIAL OFF-THE-SHELF HELICOPTERS--ETC(U)
NOV 63 W S DAVIS, J F COMER

REPORT OF TEST
USATECOM PROJECT NO. 4-3-1000-02-A ✓
MILITARY POTENTIAL TEST OF COMMERCIAL OFF-THE-SHELF
HELICOPTERS AS BASIC ROTARY-WING INSTRUMENT TRAINERS

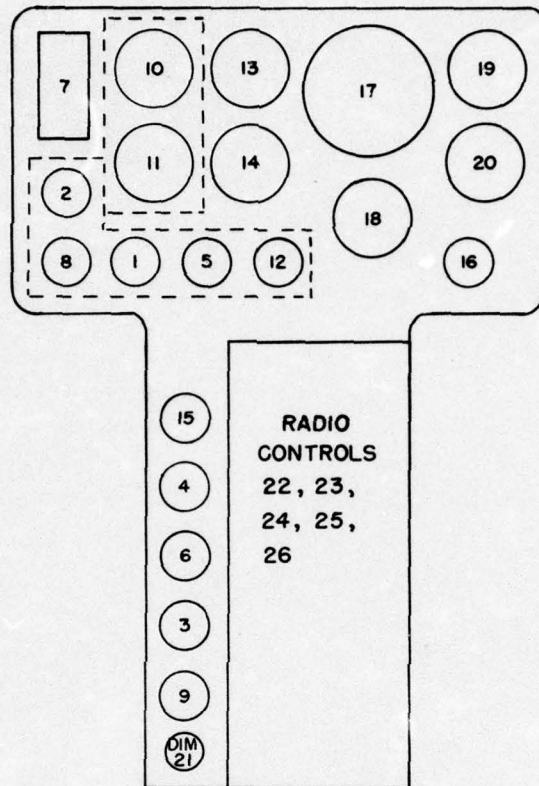
| 1. Cylinder Head Temperature Indicator 2" | 12. Fuel Pressure Indicator 2" |

2.2.1.2 The indicators moved to the lower panel are mainly those for monitoring the electrical system, for which primary monitoring is served by the generator warning light. The engine oil pressure indicator could have been placed on the lower panel since it is primarily monitored by its warning light. Retention with the other engine condition indicators was considered desirable however.
