DESIGN OF SELECTED HELICOPTER COMPONENTS  
FOR EASE OF REPAIR

KAMAN AEROSPACE CORPORATION  
BLOOMFIELD, CONNECTICUT

DECEMBER 1976

**Final Report for Period April 1975 - May 1976**

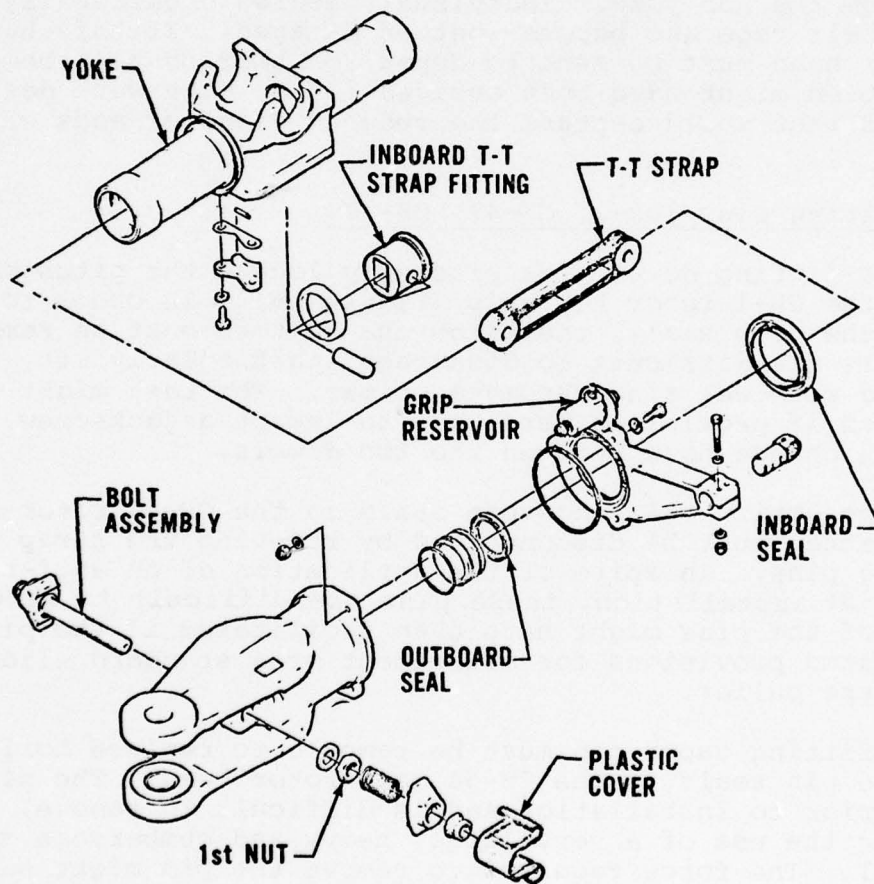
Figure 15. Exploded view, OH-58 main rotor hub.

To replace grip seals in the OH-58 main rotor head, it is necessary to disconnect the outboard end of the T-T strap from the grip (Figure 15). A pair of nuts threaded onto the long

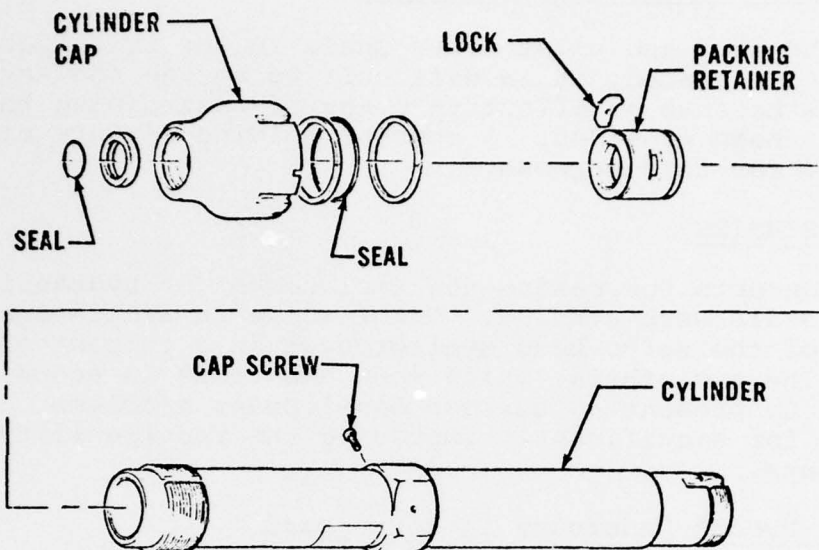
Figure 30. AH-1 hydraulic actuator, partial assembly.

To replace piston seals in the AH-1 hydraulic actuator, an intricately machined metal bushing, called a packing retainer, must be removed and reinstalled mid-way down the bore of the cylinder. The retainer is locked in position via three keys which engage circumferential grooves in the cylinder wall and slots milled into the outside diameter of the retainer (Figure 30). In operation, the keys react shear loads. The slots in
