# Technical Memorandum

AIRCRAFT ENGINE DRIVEN ACCESSORY SHAFT  
COUPLING IMPROVEMENTS USING HIGH-STRENGTH,  
LOW WEAR POLYIMIDE PLASTIC

Systems Engineering Test Directorate

30 December 1976

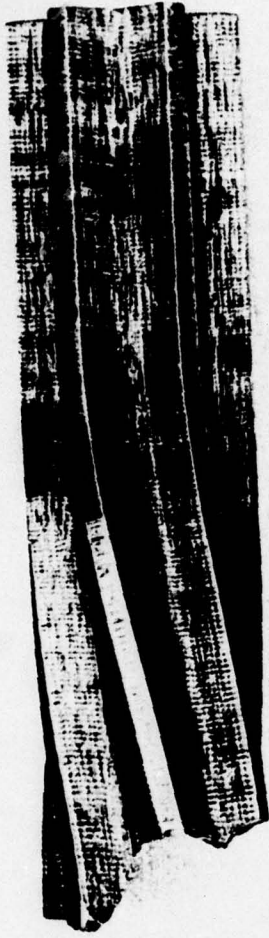
Figure 14  
Results of 125 Foot-Pound (170 N-m) Static Torque  
Test Showing Sheared Steel Inner Shaft

23. The six toothed shaft configuration shown in figure 13 was similarly evaluated in the same H-53 primary hydraulic system pump and subjected to repeated full load applications. The coupling had previously demonstrated a static torque rating of 125 foot-pounds (170 N-m) based on the level at which the steel shaft sheared (see figure 14). It should be noted that in this configuration the weakest element is the steel shaft and that no cracks or other evidence of overload were observed in the plastic component. This coupling endured 3,085 full load application cycles over a 51.4 hour period with minimal plastic element wear and no signs of heating or imminent failure. This success was followed by an additional test of the same components of 300 hours duration with the coupling interface intentionally misaligned 20 minutes (0.33 degree) and with full load application cycles of 1 hour. Following the additional 300 hour test, the coupling was again disassembled to inspect for signs of wear, heating, or imminent failure. A minor amount of wear was evident from a trace of plastic dust which had accumulated in the roots of the internal splines. This wear was so slight as to be immeasurable. The plastic component fit the inner steel shaft as tightly after 350 hours as when originally installed. The six toothed inner shaft bore no evidence of heating as had been experienced in the triangular shaped shaft. The shaft temperature, checked immediately after the test, was 38°C. Hydraulic fluid temperature was limited to 37°C to minimize pump degradation during the coupling endurance test. Microscopic examination of the plastic elements revealed no cracks which, if present, would indicate impending failure. Similarly, no cracks or wear were observed in the steel inner shaft or outer steel splines. This set of test conditions was duplicated during a second 350 hour test of the same steel shaft with two new plastic inserts. During this second test, the driving component was an actual H-53 gearbox shaft which was severely worn and had been rejected by the Naval Air Rework Facility. The results of the second 350 hour test were identical to the first test, indicating that this design can successfully be applied to severely worn as well as new gearbox splines.
