**INVESTIGATION OF RECREATIONAL BOAT
STEERING AND CONTROL SYSTEMS**

**John R. Taylor
USCG Research and Development Center
Avery Point
Groton, CT 06340**

April 1976

Final Report

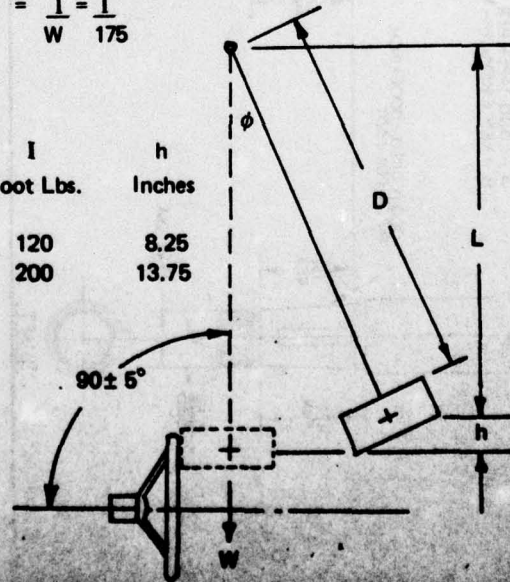
FIGURE 6 - STEERING WHEEL IMPACT TEST FIXTURE

- D = 90 ± 6 (inches)
- W = 175 (pounds)
- L = D cos φ (feet)
- h = D - D cos φ (feet)
- I = Impact Value (foot pounds)
- I = W (h) = W (D - D cos φ)
- $h = \frac{I}{W} = \frac{I}{175}$

I	h
Foot Lbs.	Inches
120	8.25
200	13.75
