Overlay of Large, Placed Quarrystone and Boulders to Increase Riprap Stability

Bruce L. McCartney and John P. Ahrens

TECHNICAL PAPER NO. 76-19
DECEMBER 1976

U.S. ARMY, CORPS OF ENGINEERS
COASTAL ENGINEERING
RESEARCH CENTER

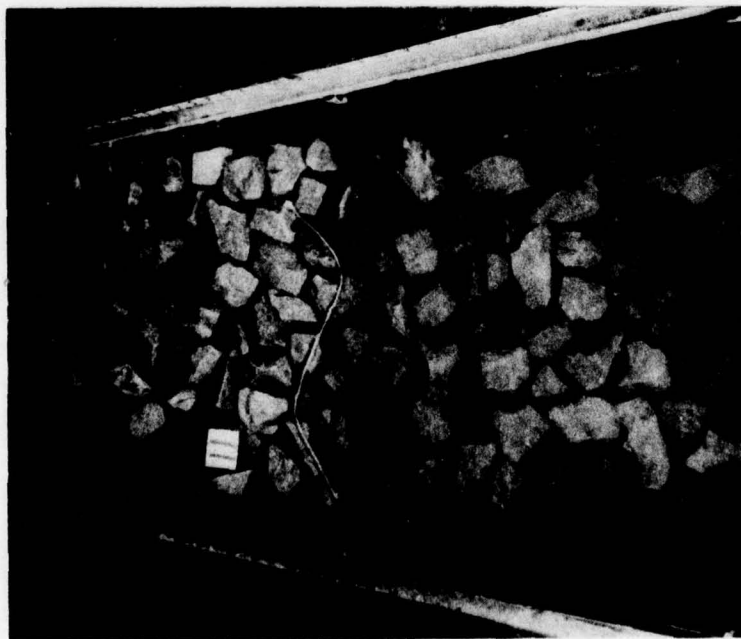
Figure 2. Small wave tank test of 100-percent stone overlay (angular quarrrystone).

Initial condition,
rope denotes stillwater level;
tank 1.5 ft wide;
1.5- to 2-in quartzite

Slope following wave attack of
 $H_s = 0.375$ ft
(minor damage condition);
1.5- to 2-in quartzite

Small tank tests photos of quarystone and boulders having 100-percent overlay and the boulders having 67-percent overlay are shown in Figures 2, 3, and 4.

tests appeared to be more blocky than the quarystone overlay in the small-scale tests (compare Figs. 2 and 6). However, the scale effects shown in Table 2 are consistent with the findings of Thomsen, Wohlt, and Harrison (1972) who found sizable scale effects on riprap stability in small-scale model tests.

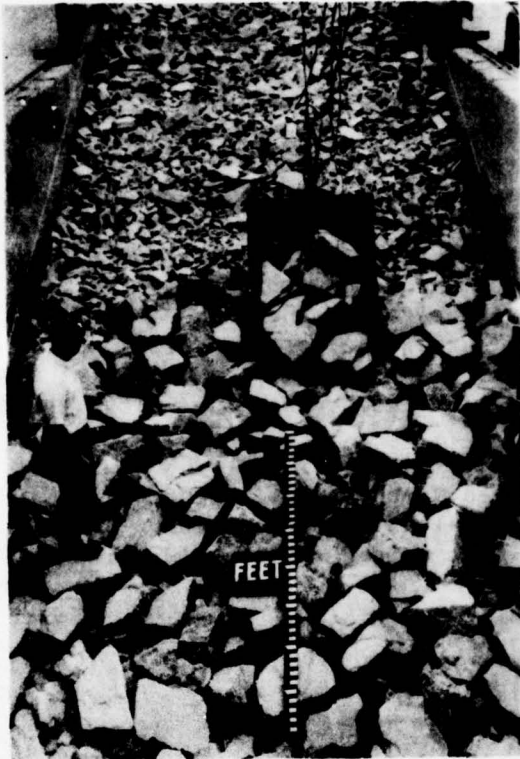
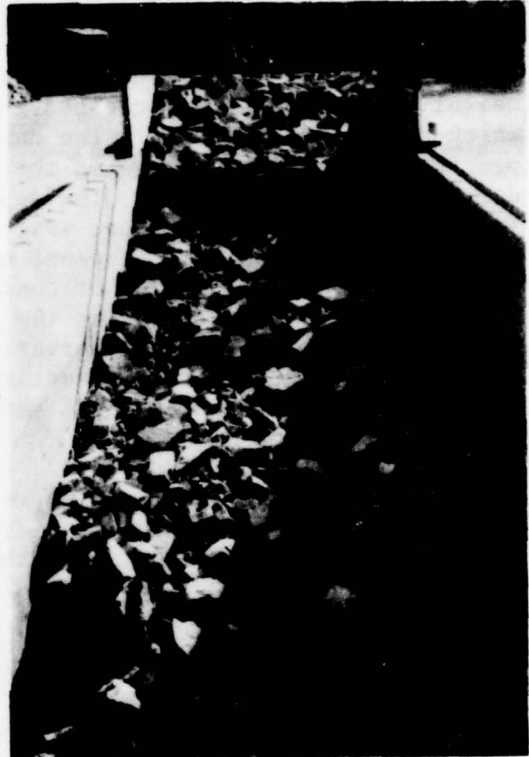
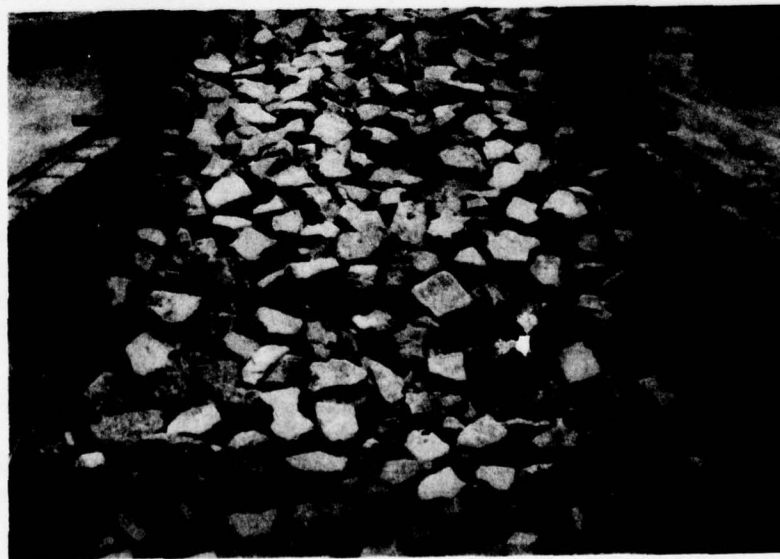
Figure 6. Prototype tests of 100-percent stone overlay (quarystone) coverage.

Slope construction

Slope failure, $H_g = 3.85$

Initial condition

The large wave tank testing at prototype scale was done to determine what corrections were needed for the small-scale test results to make the small tank test representative of prototype conditions; i.e., determine scale effects. Large tank test photos of the 100-percent quarrrystone overlay ($W_{50} = 100$ pounds) are shown in Figure 6.

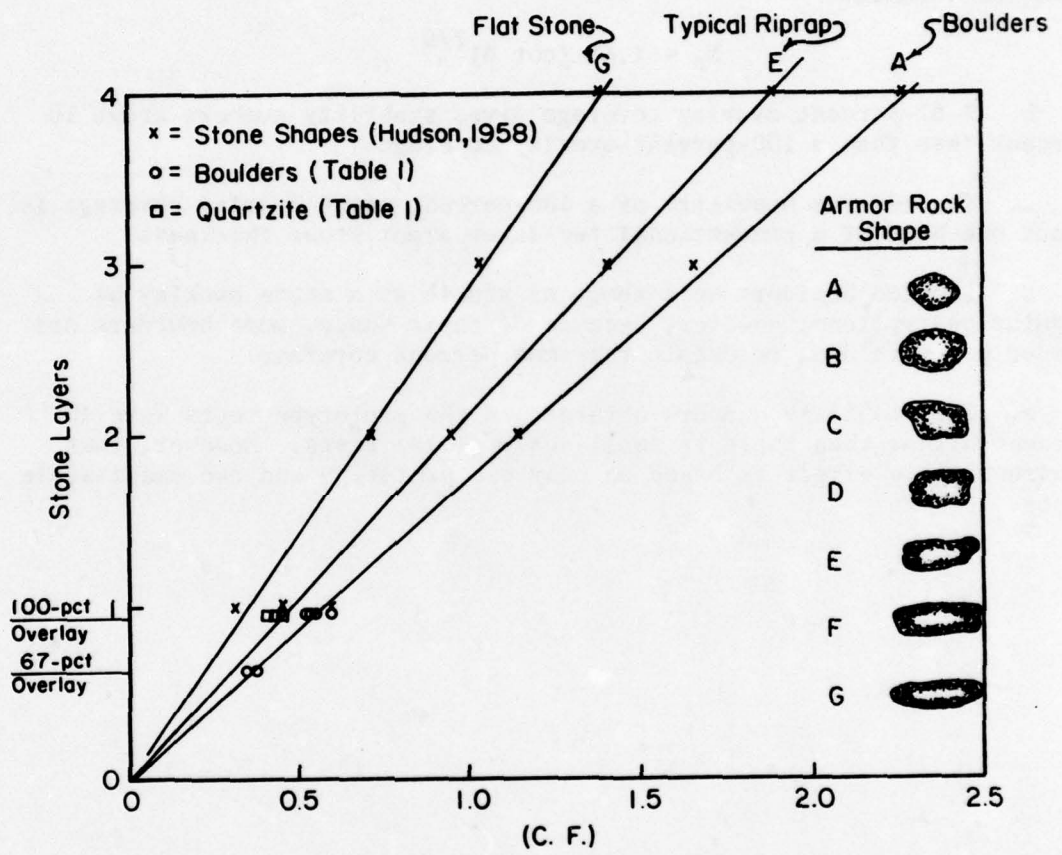
Figure 7. Stone coverage fraction for overlay coverage and armor shape.

The number of stones per unit area necessary to have the 100-percent stone overlay condition (all stones touching) is different for boulders and quartzite quarystone because of stone shape. The coverage fraction (Table 1) shows 100-percent coverage of boulders having a coverage fraction between 0.53 to 0.59; the 100-percent coverage for quarystone (including prototype and small-scale tests) has a coverage fraction between 0.41 and 0.43. This means that to obtain 100-percent coverage about 30 percent more of the rounded boulders would be required per unit area than the blocky quarystone.

Conventional two layers of overlay have about the same zero-damage wave height stability as the 100-percent overlay. Therefore, a conventional two-layer overlay $W_{50} = 730$ pounds. From Figure 7:
