# FUNDAMENTAL INVESTIGATION OF FATIGUE CRACK GROWTH RETARDATION IN ALUMINUM ALLOYS

Northrop Corporation  
Aircraft Division  
3901 West Broadway  
Hawthorne, California 90250

SEPTEMBER 1976

TECHNICAL REPORT AFML-TR-76-156

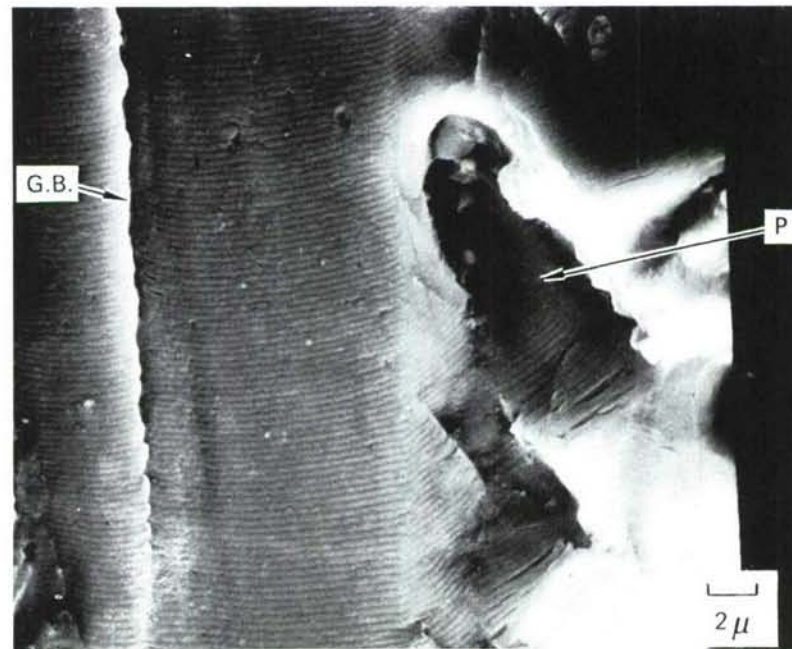
FIGURE 20. FRACTOGRAPHS FROM THE FAILED FCP SPECIMENS SHOWING INTERACTIONS OF GRAIN BOUNDARY (G.B.) AND SECOND PHASE PARTICLES (P) WITH CRACK-FRONT
