TECHNICAL REPORT H-77-4

# LAKE DARDANELLE, ARKANSAS RIVER

Hydraulic Model Investigation

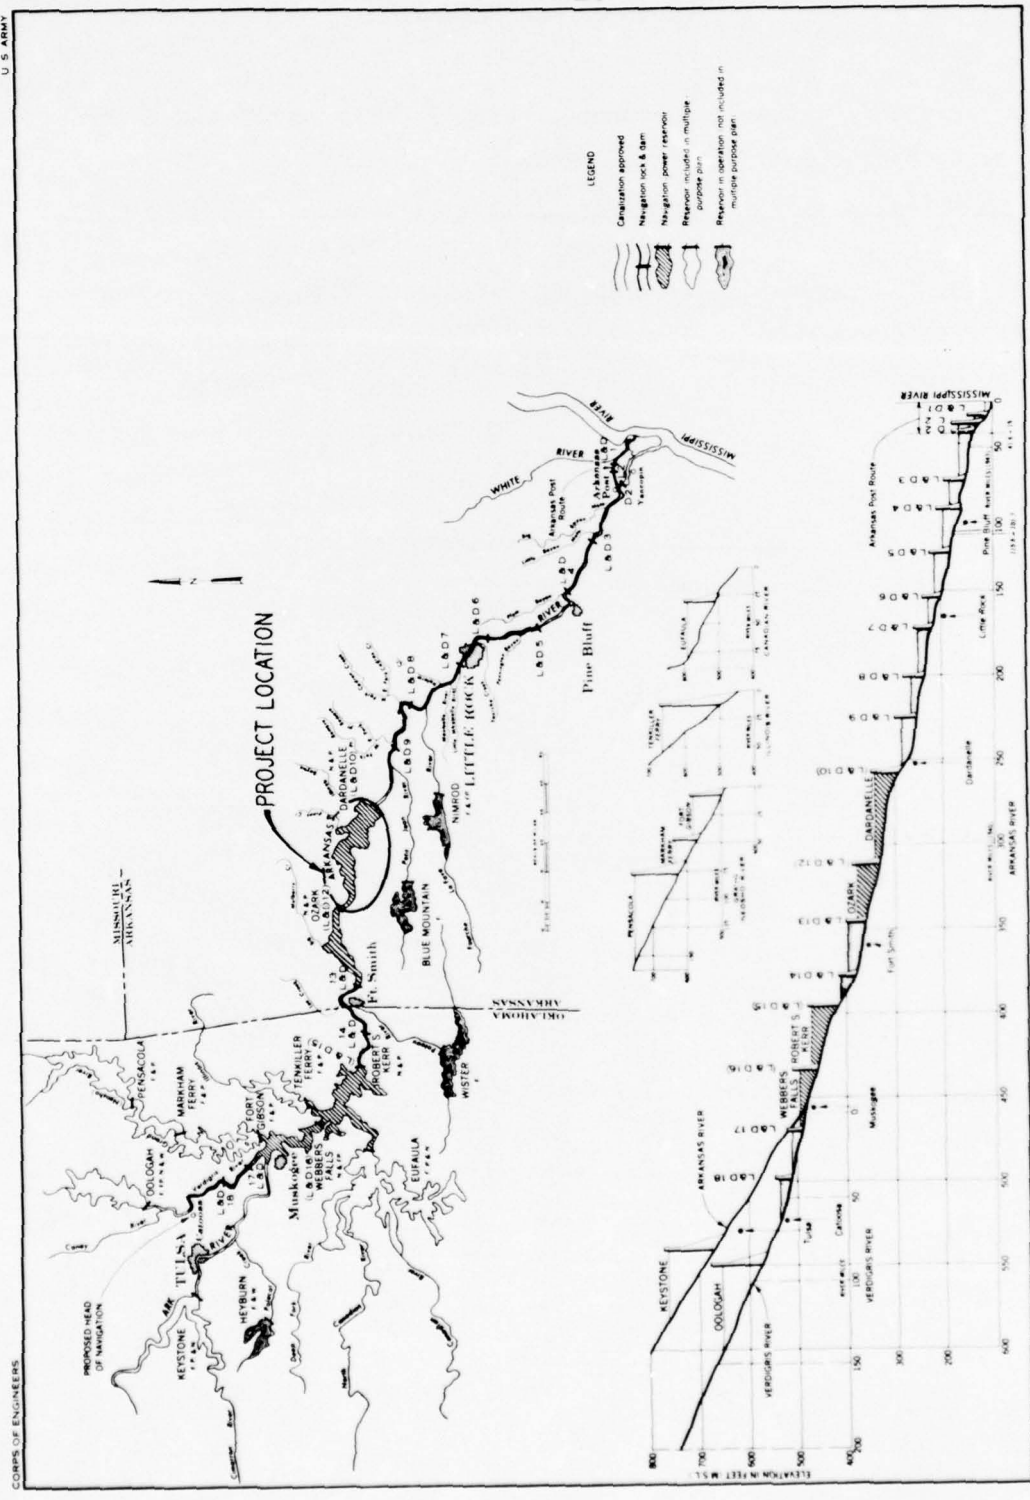
Figure 1. Vicinity map

2. The system (Figure 1) consists of: (a) seven large upstream reservoirs that provide flood control storage, trap sediment, and supply water for power, navigation, and other uses; (b) four high-lift locks and dams that provide depth for navigation, provide head for power, and trap some sediment; and (c) thirteen low-lift locks and dams that provide minimum 9-ft\* depths for the remainder of the 448-mile navigation channel from the Mississippi River to Catoosa, Oklahoma (near Tulsa). The total lift for the system is 420 ft.
