Report No. FAA-RD-77-19

AN INVESTIGATION OF THE LIGHTNING ELIMINATION
AND STRIKE REDUCTION PROPERTIES
OF DISSIPATION ARRAYS

Final Report

U.S. DEPARTMENT OF TRANSPORTATION
FEDERAL AVIATION ADMINISTRATION
Systems Research & Development Service
Washington, D.C. 20590

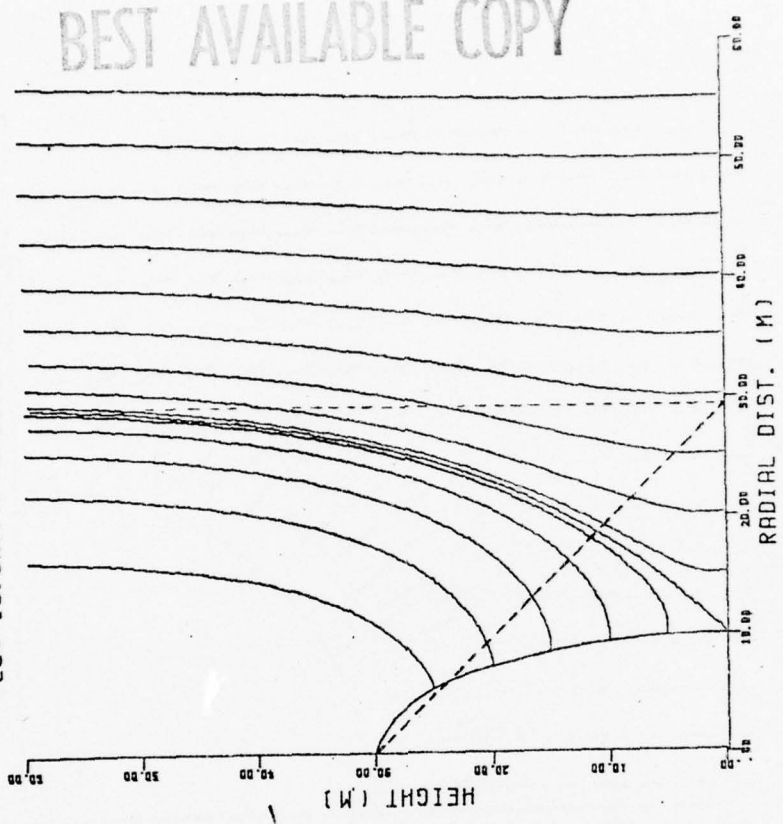
Figure 4. Electric Field Lines and Collection Area

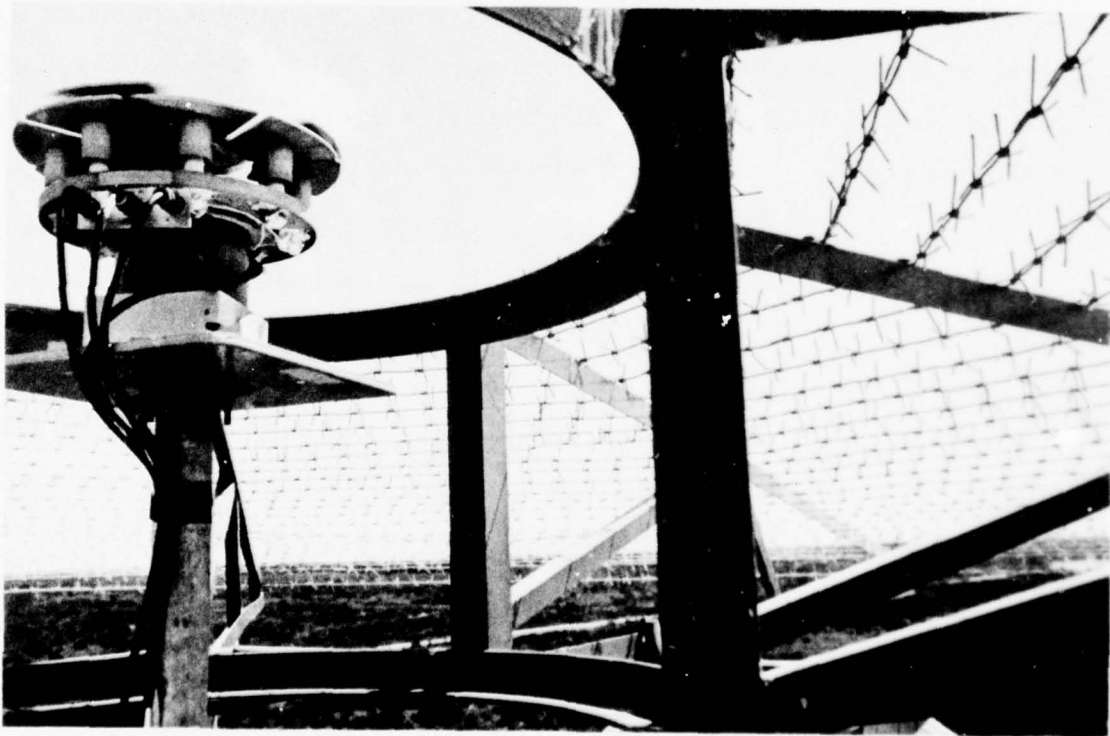
Figure 15 . Close up of umbrella array at MILA

A closer view of the collimation tower complete with umbrella array is shown in Figure 28a, a close up of the array in Figure 15.

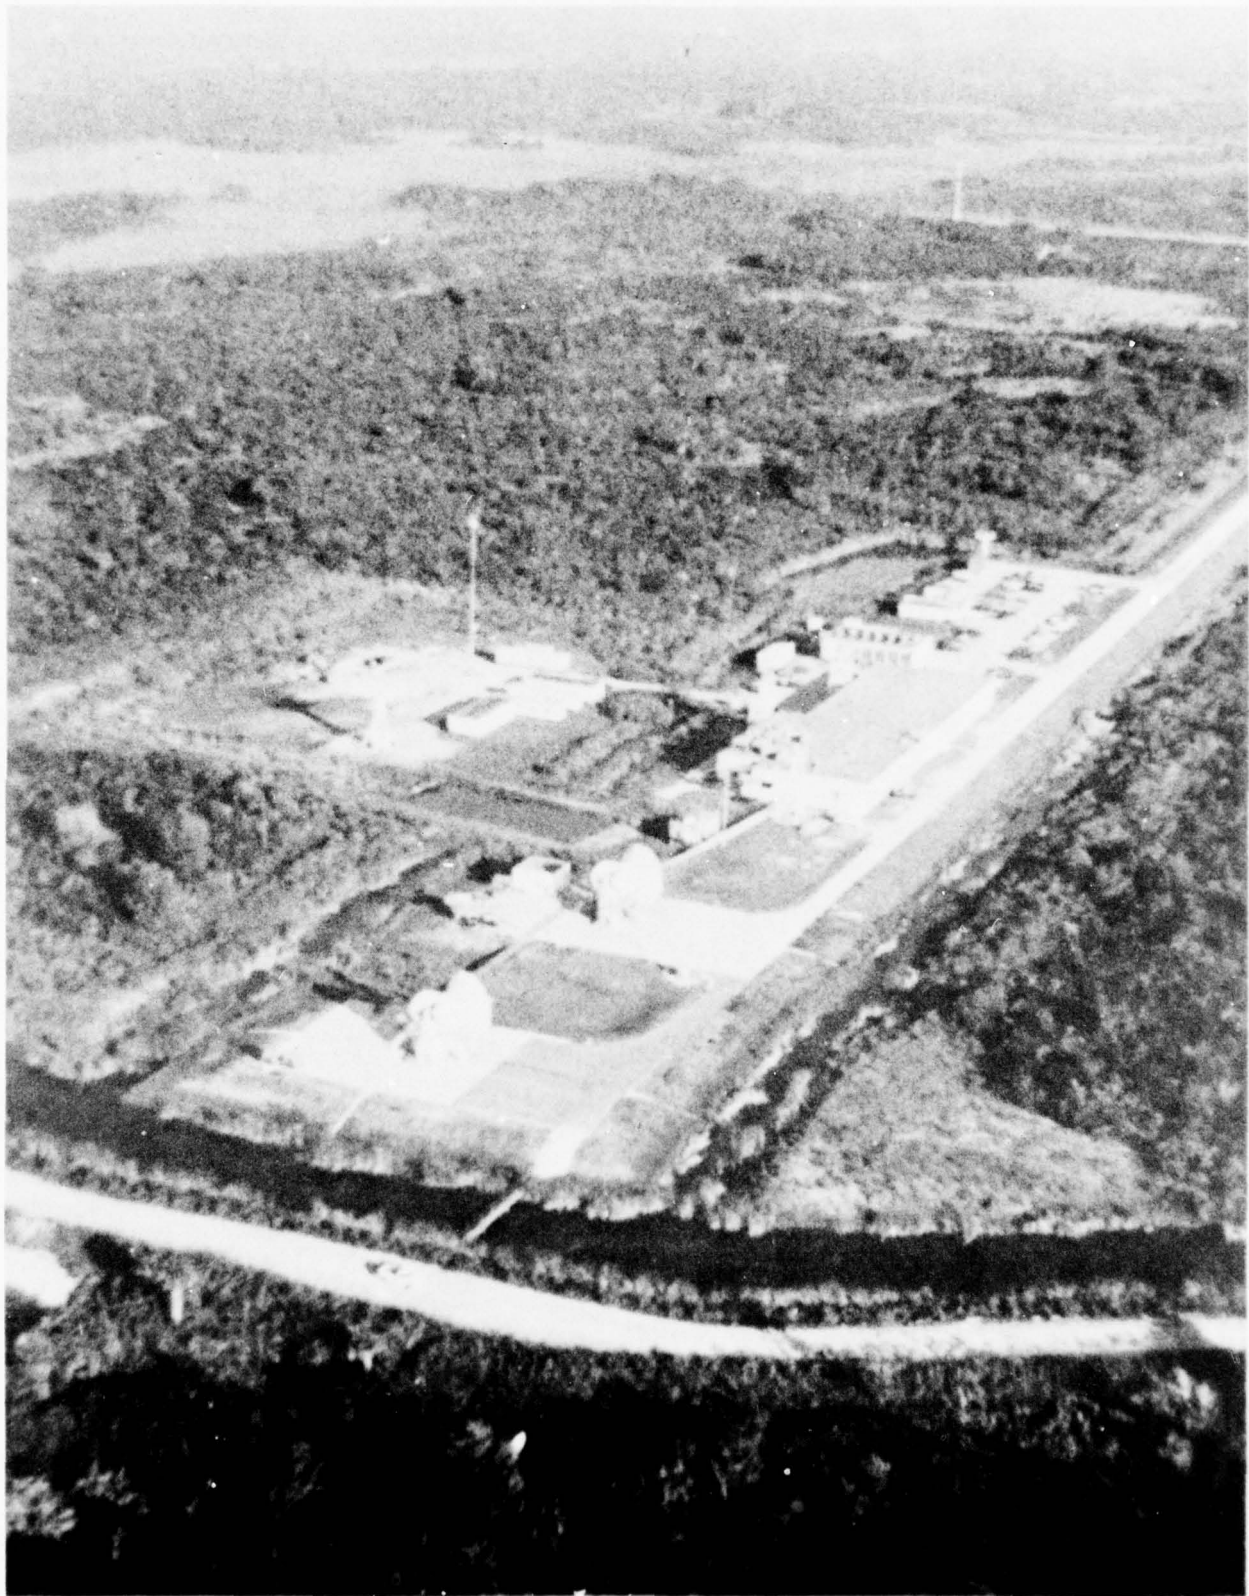
An aerial photograph of the site is shown in Figure 27. The facility housed a selection of dissipation arrays which were installed during 1974 to provide a lightning prevention system for the complete facility even though there was no evidence that lightning had ever struck it. The dissipation arrays included a 24 sq. ft panel array located between two 30 foot parabolic dish antennas, a perimeter array around the roof line of the main building, a truncated conic array on a 100 ft collimation tower and a large umbrella array over 20 feet in diameter which was located on the 100 foot collimation tower some $\frac{1}{2}$ mile north of the main facility. This distant collimation tower is shown in the upper right hand section of Figure 27 and most of the investigations were conducted there.

Figure 27. Aerial view of the NASA/MILA tracking site

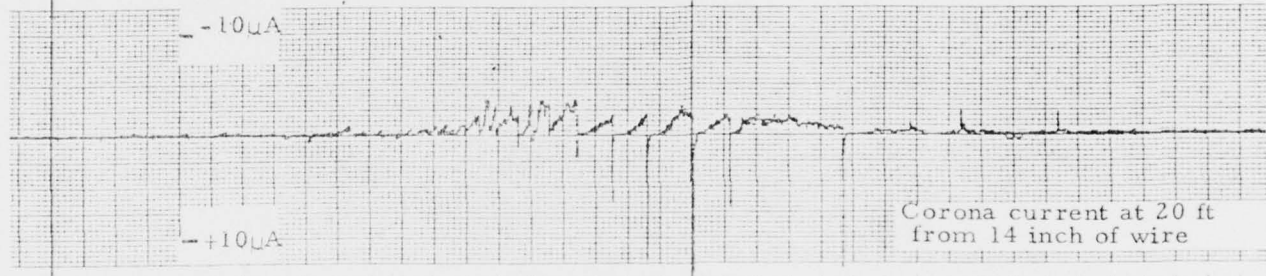
Fig. 33 60

The 14 inch piece of dissipation wire also on one occasion gave corona currents similar to the single point. Again, this was under high field and high wind conditions as displayed in Figure 33. Throughout the summer thunderstorm season there was no occasion when the single point gave off less corona than a multiple point at the same height. In general the 14" and 96" dissipation wires gave off similar amounts of corona at levels approximately $\frac{1}{3}$ less than the single point.

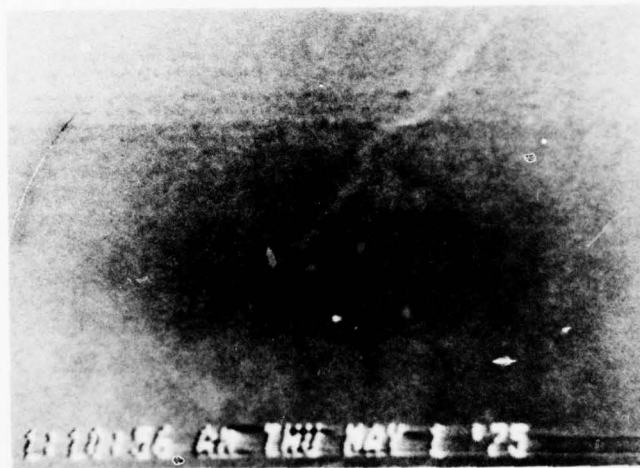
Figure 42a.

Lightning strikes to the tower were photographed during the time period when the dissipation array was mounted on top. Coincidentally, no more video records of strikes to the tower were obtained, after the array had been replaced by a lightning rod. Figures 42a and b show two strikes to the tower as observed from the forestry tower on 1 May and 8 June 1975. The bright dot in the center of the picture is a fault on the silicon diode tube. Heavy rain was falling at these times, but later in the record the strike point was identified as the tower top. Further photographs of lightning to the 1200 foot tower array taken from the trailer are shown in Figures 43 a-c. These occurred in May 1975 within a few seconds of one another and there is no doubt that the strike was to the array at the top of the tower. Two minutes later the tape recorder was damaged by a large surge in the remote control line, which ran from the base of the tower, probably indicating another strike. Figure 43c shows much blooming but indicates an upward going leader as a horizontal branch to the west is shown, whereas two frames later when the camera blooming stops it is evident that the main strike is vertical.

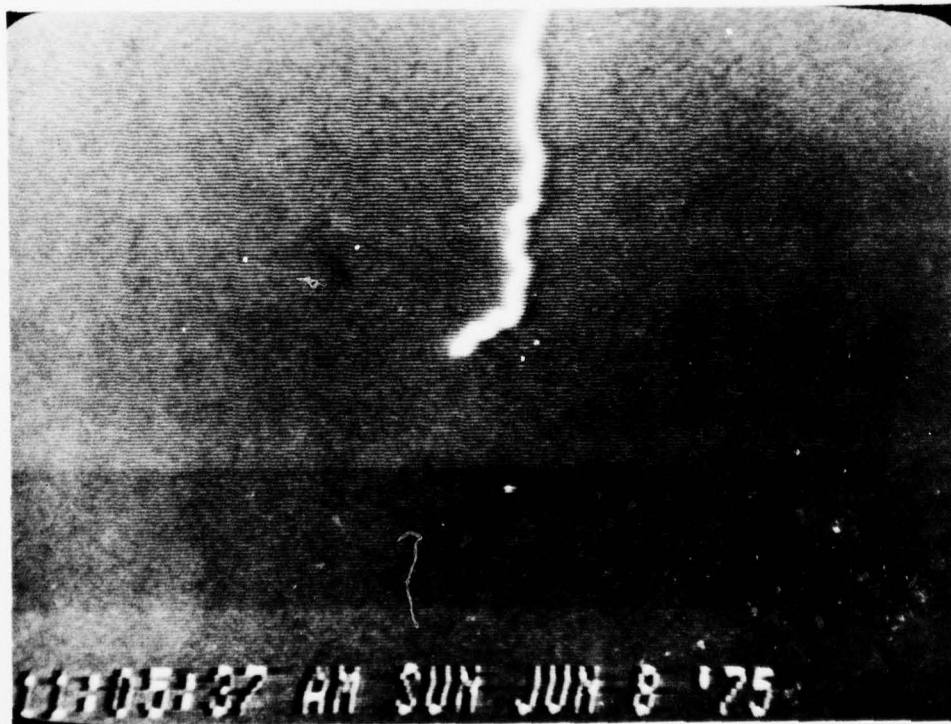
Figure 42b.

Lightning striking an array on top of the 1200 ft tower as viewed from the forestry tower
