**AXBT PROBE/ELECTRONICS**

**FINAL REPORT  
FEASIBILITY STUDY  
AN/SSQ-36 PIP**

**PREPARED FOR  
OFFICE OF NAVAL RESEARCH  
17 MAY 1977  
UNDER CONTRACT  
N00014-76-C-0230**

1. REPORT NUMBER	2. GOVT ACCESSION NO.	3. RECIPIENT'S CATALOG NUMBER
	(9)	
4. TITLE (and Subtitle) FEASIBILITY STUDY: AXBT/EA AIRBORNE EXPENDABLE BATHYTHERMOGRAPH/ ELECTRONICS ASSEMBLY		5. TYPE OF REPORT & PERIOD COVERED FINAL <del>REPORT</del> <sup>REPORT</sup>
AUTHOR(s) C. N. Tirrell, G. Washburn, J. Balboni, P. Demeo		6. PERFORMING ORG. REPORT NUMBER R-817
PERFORMING ORGANIZATION NAME AND ADDRESS Ocean Systems Division The Sippican Corporation Marion, MA 02738		7. CONTRACT OR GRANT NUMBER(s) N00014-76-C-0230

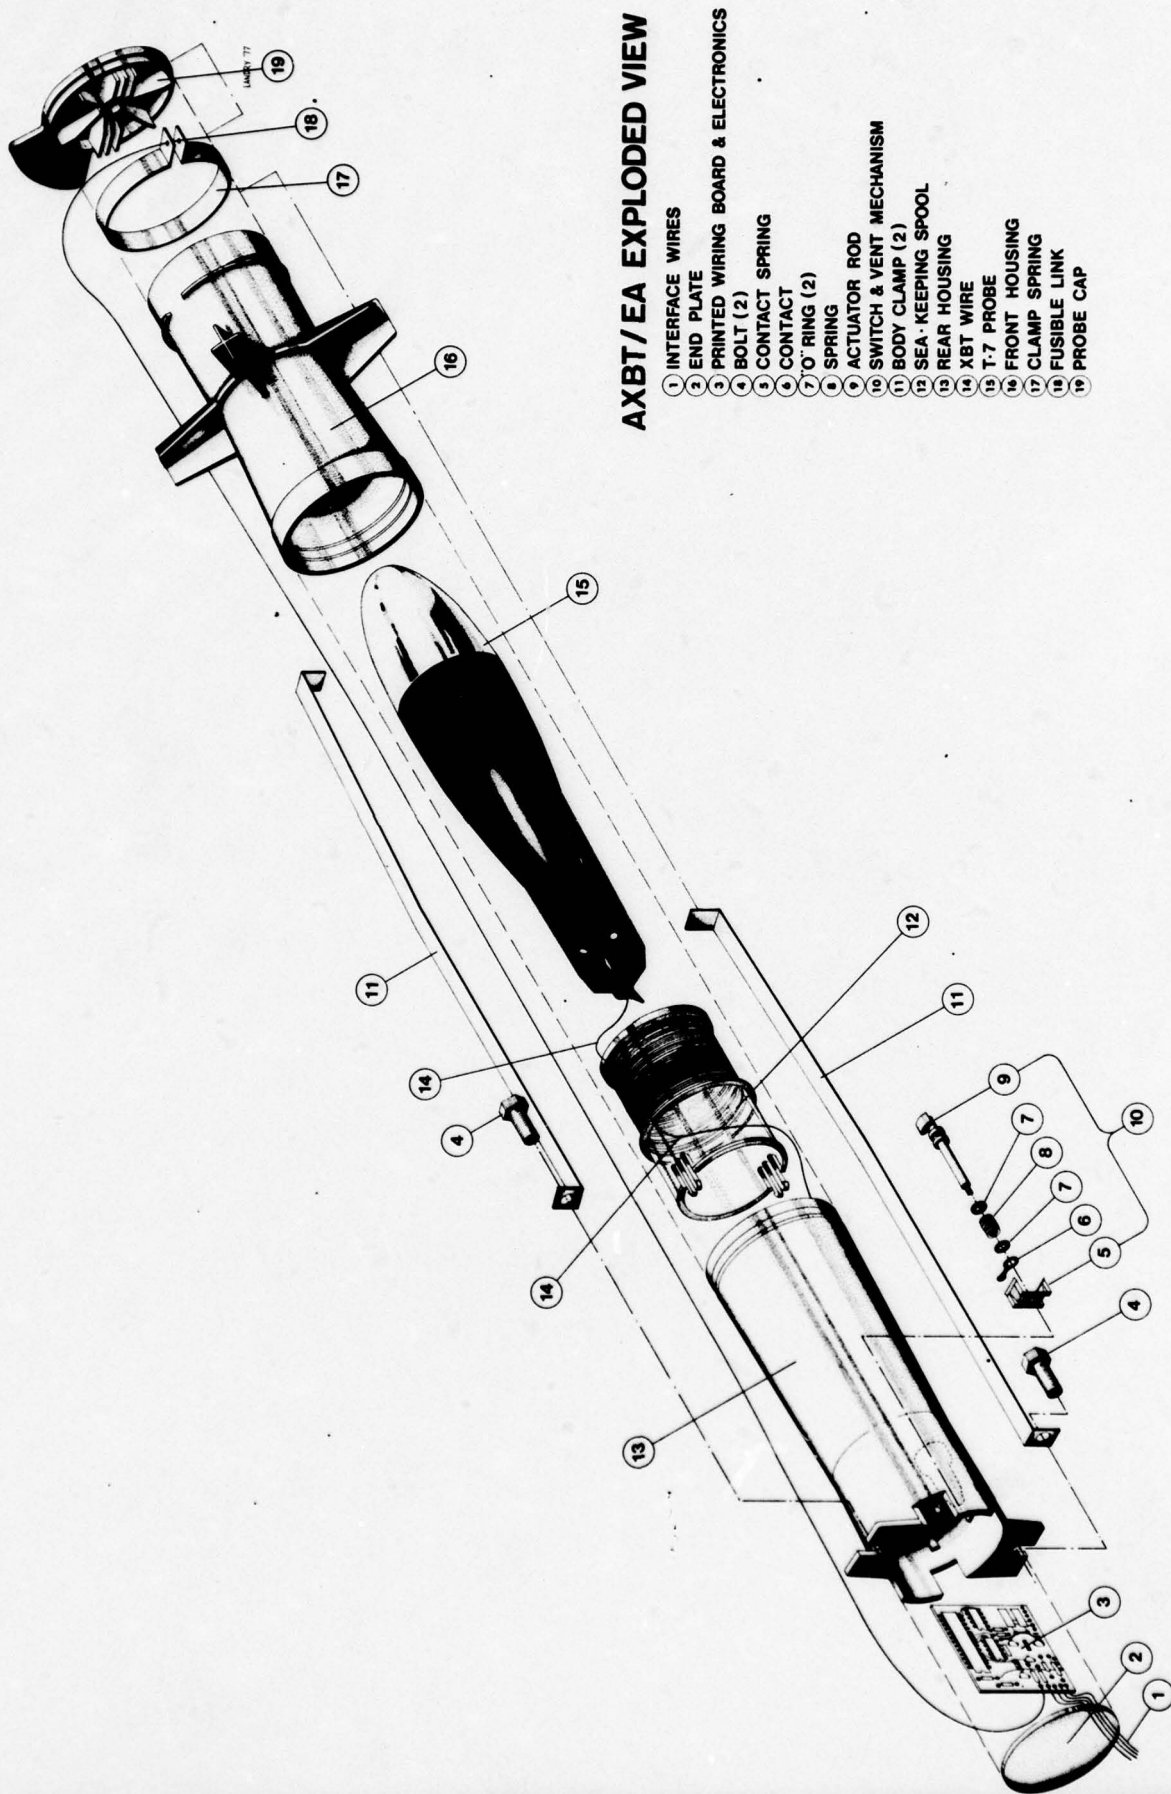
Figure 6-1

The probe cap is a plastic molding with a vent hole for pressure equalization which keeps the probe in the housing prior to probe release.

The end plate is a plastic molding which seals the electronics chamber in which is a printed wiring board with all electronics.

The sea-keeping spool is a plastic molding which holds the T-7 probe firmly at the afterbody and contains approximately 200 feet of magnet wire. Testing was conducted in sea state 3, which confirmed the need for this spool to prevent damage to the magnet wire due to the action of wind and waves on the buoy.

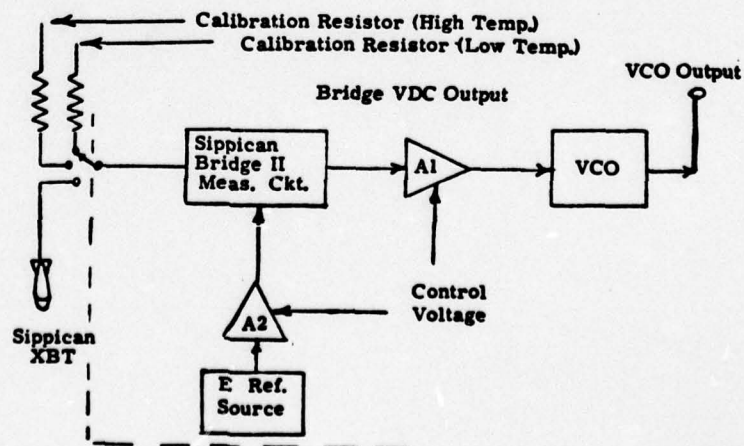
The Sippican Bridge II D. C. Thermistor Measuring Bridge is utilized in the normal manner where its output is zero VDC at the low temperature end of its range and typically 10 VDC at the high temperature end of its range. It is supplied with a nominal reference voltage ( $E_{Ref}$ ) of 3.2 VDC from a reference source and amplifier A-2. The first order errors in the bridge circuit for the relationship of thermistor probe resistance/bridge output voltage are mainly operation amplifier DC characteristics, aging, component tolerance, reference voltage, and their related temperature coefficients. At the low temperature end of its range, the reference voltage term is cancelled out and removed as a first order source of error.

The output voltage of the bridge is inverted and scaled in operational amplifier A-1 to establish the voltage-to-frequency gain factor of the system for the given nominal value of  $E_{Ref}$  supplied to the bridge. Provision is made in amplifiers A-1 and A-2 for controlling their output voltage which in effect varies the offset voltage in A-1 and  $E_{Ref}$  supplied to the bridge in A-2. It should be pointed out that by varying  $E_{Ref}$ , the effective gain of the system is varied. If a resistance equal to the thermistor probe at the low temperature end of the bridge range is terminated at the bridge input, the VCO nominal frequency can be adjusted by the offset voltage control of A-1. If a resistance equal to the thermistor probe at the high temperature end of the bridge range is terminated at the bridge input, the VCO nominal frequency can be adjusted by the  $E_{Ref}$  voltage control of A-2. Therefore, by adjusting these two control voltages, a means of calibrating the VCO frequency for a specified bridge input resistance has been established which includes the bridge circuit errors and VCO gain sensitivity errors.

Figure 4-1 Thermistor Bridge &amp; VCO

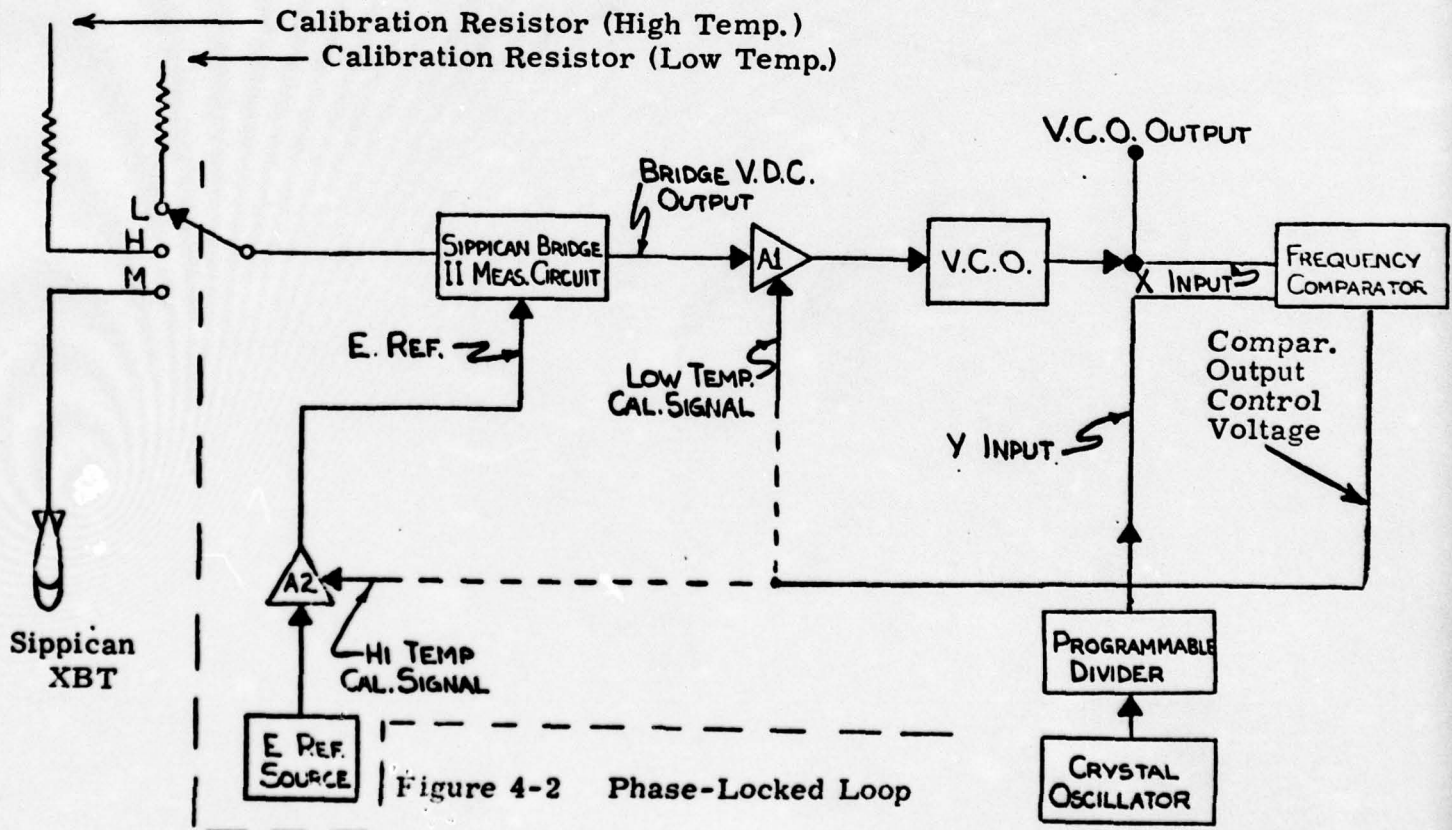
Phase-Locked Loop (Fig. 4-2)

The VCO, in addition to providing the system output, drives the X input of a frequency comparator circuit using a four-quadrant analog multiplier. The Y input of the frequency comparator is connected to a programmable divider which is driven from a quartz crystal oscillator. This permits comparison of the X input from the VCO to one of two frequencies originating from the crystal oscillator. The output of the frequency comparator is integrated, amplified, and buffered and represents an analog control voltage which is proportional to the frequency-phase relationship of the X-Y voltages at the input. By selectively feeding this control voltage back to the control inputs of A-1 or A-2, a phase-locked loop is established consisting of the bridge input resistance, bridge circuit,  $E_{Ref}$ , amplifiers A-1, A-2, and the VCO. As stated previously, if the input of the bridge is terminated with a calibration resistor equal to the low temperature end of its range, the input to A-1 will be zero VDC  $\pm$  an error voltage resulting from bridge components. If we likewise drive the Y input of the frequency comparator at a frequency equal to the desired VCO output frequency and connect the comparator output control voltage to the A-1 control input, then the resulting phase-locked loop will cause the control voltage applied to A-1 to shift in a way that will lock the VCO at the same frequency applied to the Y input of the comparator. If we likewise drive the Y input of the

comparator at a frequency equal to the desired VCO output frequency at the high temperature end of the bridge range, terminate the input with a high temperature calibration resistor, and connect the comparator output control voltage to the A-2 control input, then the resulting phase-locked loop will cause the control voltage summed at A-2 to shift in a way that will lock the VCO at the same frequency applied to the Y input of the comparator. The gain and time constant of the phase-locked loop is designed so that the capture frequency range is always greater than the maximum accumulative error of the VCO nominal frequency at the low and high temperature calibration points.

Figure 4-2 Phase-Locked Loop

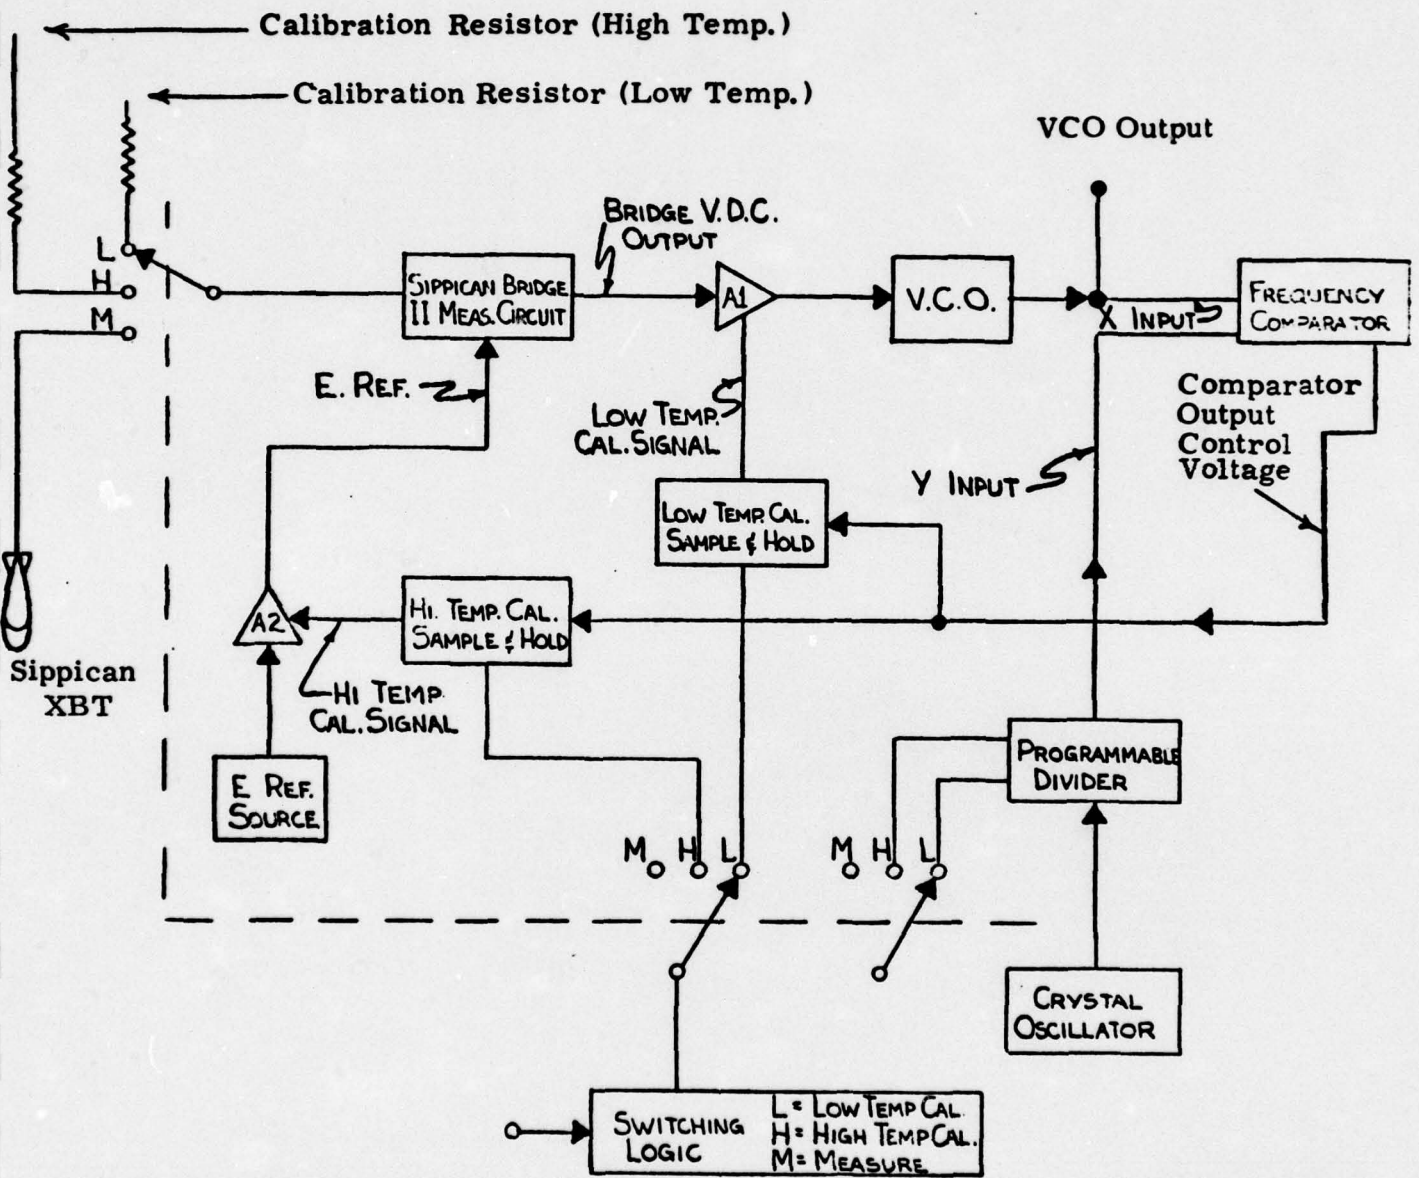
It is desirable when possible to choose the low and high temperature calibration frequencies so that the crystal oscillator frequency can be a common multiple. This permits the use of a single crystal oscillator. A programmable divider follows the crystal oscillator to select the correct calibration frequency. By using appropriate logic for switching the bridge input, control voltage sample and hold circuits, and the programmable divider, a sequence of low and high temperature calibration, one or more

times, followed by bridge input termination to the thermistor probe is established.

Figure 4-3 Temperature to Frequency Measuring System

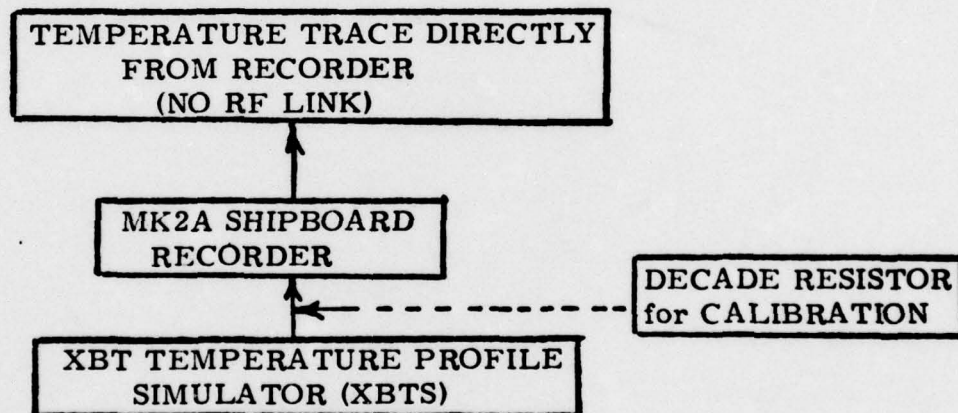
Figure 5-7

Using the test setup shown in Figure 5-7, a decade resistor box was connected to the MK2A recorder. The strip chart recorder was calibrated at  $-1^{\circ}\text{C}$  and  $35^{\circ}\text{C}$  in accordance with the thermistor R-T table. The recorder was then connected to the XBTS and a temperature profile was made (Figure 5-8).

Sippican MK2-A SHIPBOARD RECORDER TEST SET-UP

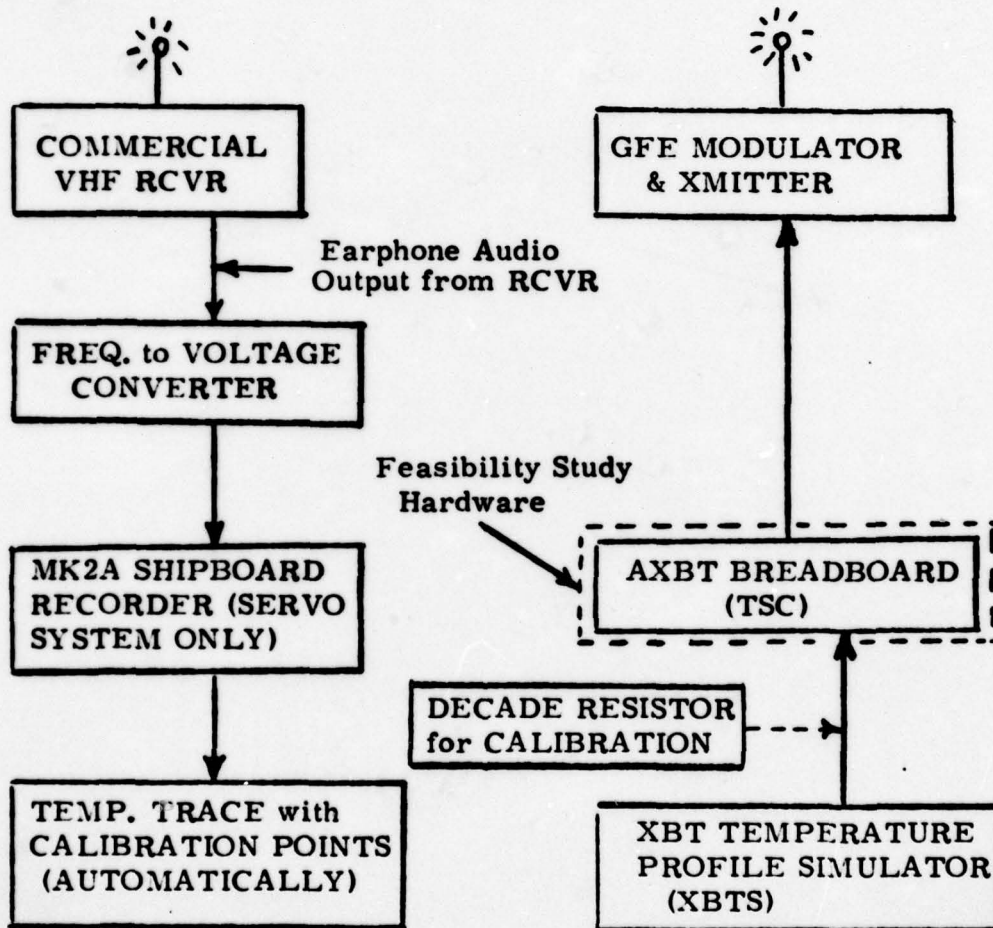
Using the test set-up shown in Figure 5-9, a decade resistor box was connected to the AXBT breadboard. The strip chart recorder at the end of the RF loop was calibrated at  $-1^{\circ}\text{C}$  and  $35^{\circ}\text{C}$  in accordance with the thermistor R-T table. The AXBT breadboard was connected to the XBTS and a temperature profile was made (Figure 5-10). Comparison was then made between Figures 5-8 and 5-10 for identical temperature profiles.

SIPPICAN AXBT, P-3C MOCKUP TEST SET-UP  
Figure 5-9

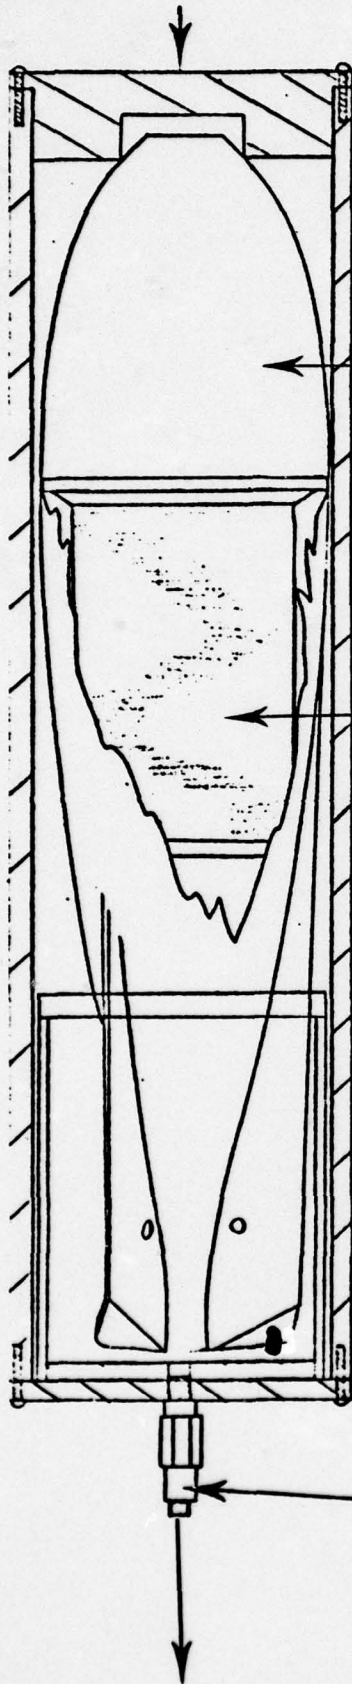
Figure 7-7

The T-7 probe without wire was then replaced with a complete T-7 probe from inventory (see Fig. 7-7). Full dead-blow hammer impacts (corresponding to Fig. 7-2) were applied and shock pulses recorded (see Figs. 7-8, 7-9, 7-10 and 7-11). All of these pulses showed a decaying sinusoidal acceleration at  $\approx 7.5$  KHz superimposed on the shock pulse. This sinusoidal acceleration was attributed to a resonance of the probe spool at the mounting flange.

ACCELEROMETER

ACCELEROMETER OUTPUT  
TO OSCILLOSCOPE
