AVSCOM REPORT NO. TR76-23

**A COMPARISON OF VARIOUS NON-DESTRUCTIVE  
INSPECTION PROCESSES USING HOT ISOSTATICALLY  
PRESSED POWDER TURBINE PARTS**

Donald E. Nulk  
General Electric Company  
Aircraft Engine Group  
Lynn, Massachusetts 01910

Final Report

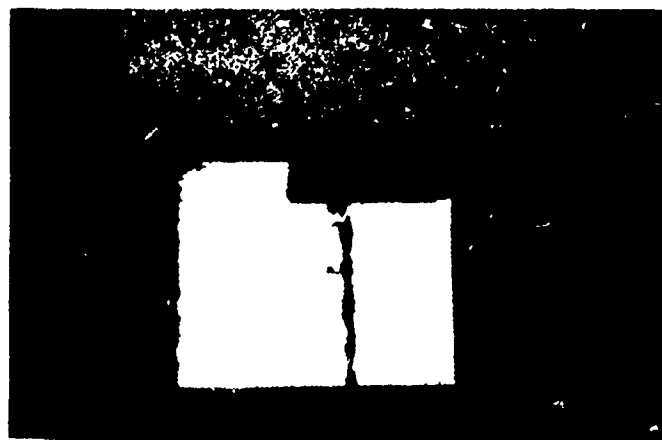
Figure 64: Image Of A Known Simulated Crack 1/4' Deep In A 1 1/2'' Thick Test Sample Using The Same Set-Up As For Figure 63.
