**STUDY OF EROSION MECHANISMS
OF ENGINEERING CERAMICS**

Fifth Interim Technical Report
(January 1, 1976 to March 31, 1977)

by
M. E. Gulden

Solar, an International
Harvester Group

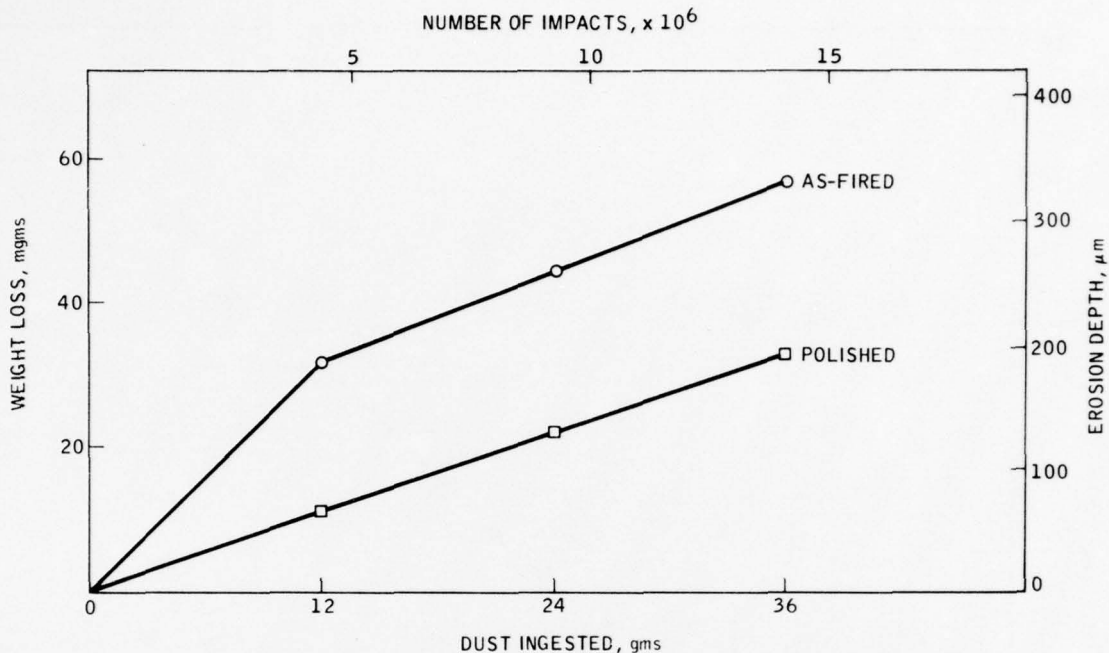
Figure 8. Effect of Surface Layer on Erosion of Reaction Bonded Si_3N_4 . As-fired Condition Contains Surface Oxide Layer. Polished Condition has Layer Removed. (273μ Quartz, 155 mps).

It was found that the oxide surface layer erodes more rapidly than the bulk material. A characteristic example of this behavior is shown in Figure 8. Beyond the surface layer, the erosion rates for as-fired and polished material are the same as would be expected. Although not shown in Figure 9, the depth of material showing the increased erosion rate is $\sim 100\mu$. Visually, the grey surface layer is $\sim 50\mu$ thick. Apparently, the extent of surface compositional and structural differences extends deeper into the material than appears visually.

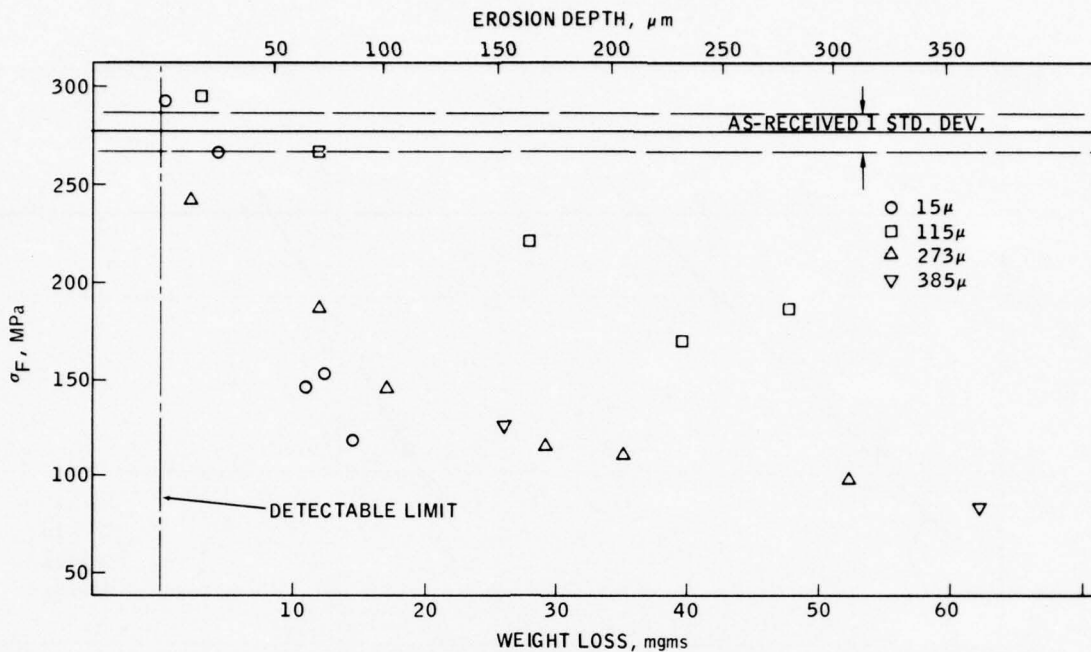
Figure 11. Effect of Erosion on Strength of Reaction Bonded Si_3N_4

The strength of reaction bonded Si_3N_4 after erosion was determined for specimens in the as-fired surface conditions. The results are shown in Figure 11. Several specimens were also tested in the as-received condition to establish baseline strength. If the specimens had been polished, a higher average strength would be expected, but previous work at Solar has shown a much greater scatter in strength values for polished compared with as-fired specimens (Ref. 6). For values up to $\sim 100\mu$ erosion depth, surface layer effects exist. Beyond 100μ , the results reflect parent material behavior.

Specimens were eroded with the particle sizes shown in Figure 11 traveling at various velocities. There is an obvious decrease in strength with erosion. An estimate of the critical flaw size, based on a fracture toughness value of $2.2 \text{ MPa m}^{1/2}$ gives $\sim 17\mu$ for the as-received material, and $\sim 230\mu$ for the weakest eroded specimen, which is an increase of over 1 order of magnitude in critical flaw size.

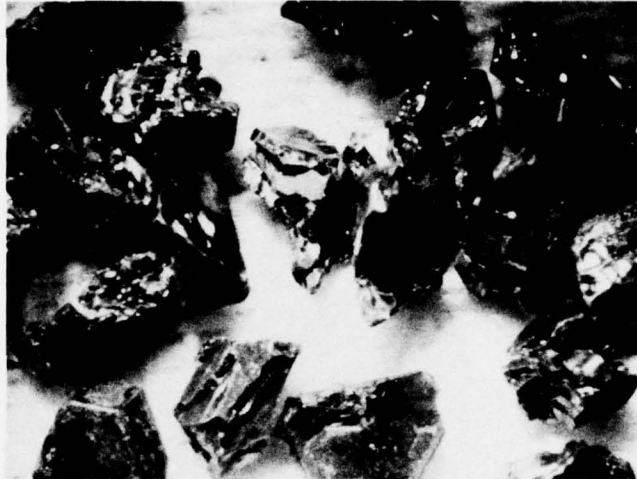
Figure 15. SiC Particles Used for Eroding MgF₂
Magnification: 14X
