STANFORD RESEARCH INSTITUTE  
Menlo Park, California 94025 · U.S.A.

(4) Topical Report,

(6) FRACTURE TOUGHNESS OF CVD ZnS

SRI Project 4928

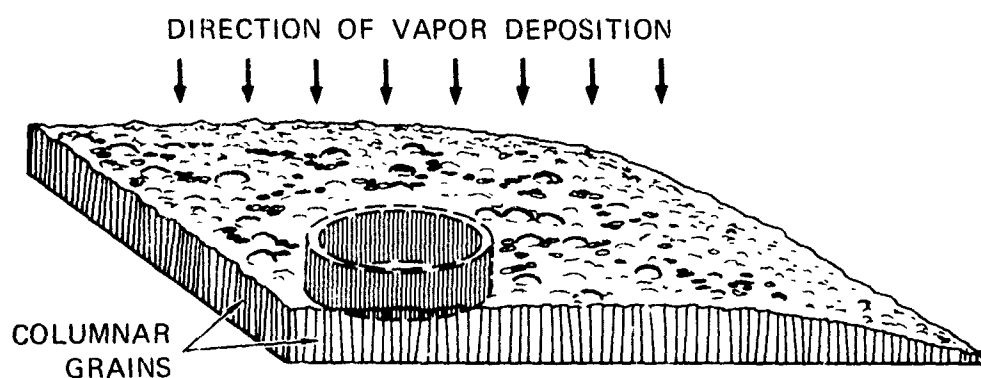
(a) As-Received Plate of ZnS Showing Orientation of Ring Specimen with Respect to Direction of Vapor Deposition.

Chemical vapor deposited zinc sulfide (CVD ZnS) produced by Raytheon Corporation under contract to the Air Force Materials Laboratory (AFML) was supplied in as-deposited plate form through the kind cooperation of Mr. Lawrence Kopell (AFML) and Dr. James Pappis (Raytheon). The microstructure consisted of columnar grains oriented roughly parallel to the direction of vapor deposition (normal to the plane of the plate, Figure 1). The grains had average cross sectional diameters of 7  $\mu$ m and aspect ratios of about 8. Six specimen rings, 25.4 mm inside diameter by 30.5 mm outside diameter by 6.35 mm high, were machined from the plate with the height dimension parallel to the growth direction (see Figure 1). The estimated finish on all surfaces was 800  $\mu$ m. A flat-bottomed notch was introduced from the outside surface along a diameter to a nominal depth of 1.27 mm using a 0.25-mm-thick diamond wheel at 1000 surface meters per minute. To ensure accurate notch orientation and to reduce notch damage, we designed a special holding jig, and accomplished the notching in a number of 0.05 mm passes. Root radii were estimated to be 0.15 mm.

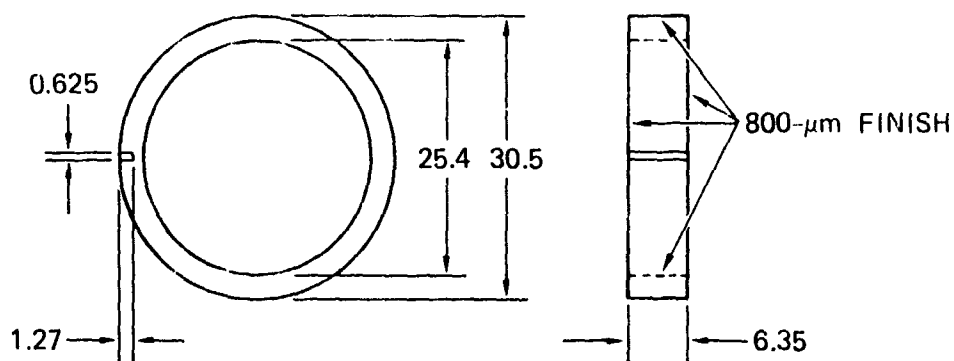
MA-4928-1

(b) Engineering Drawing giving Ring Specimen Specifications  
(All dimensions in mm)

FIGURE 1 ZINC SULFIDE RING SPECIMEN

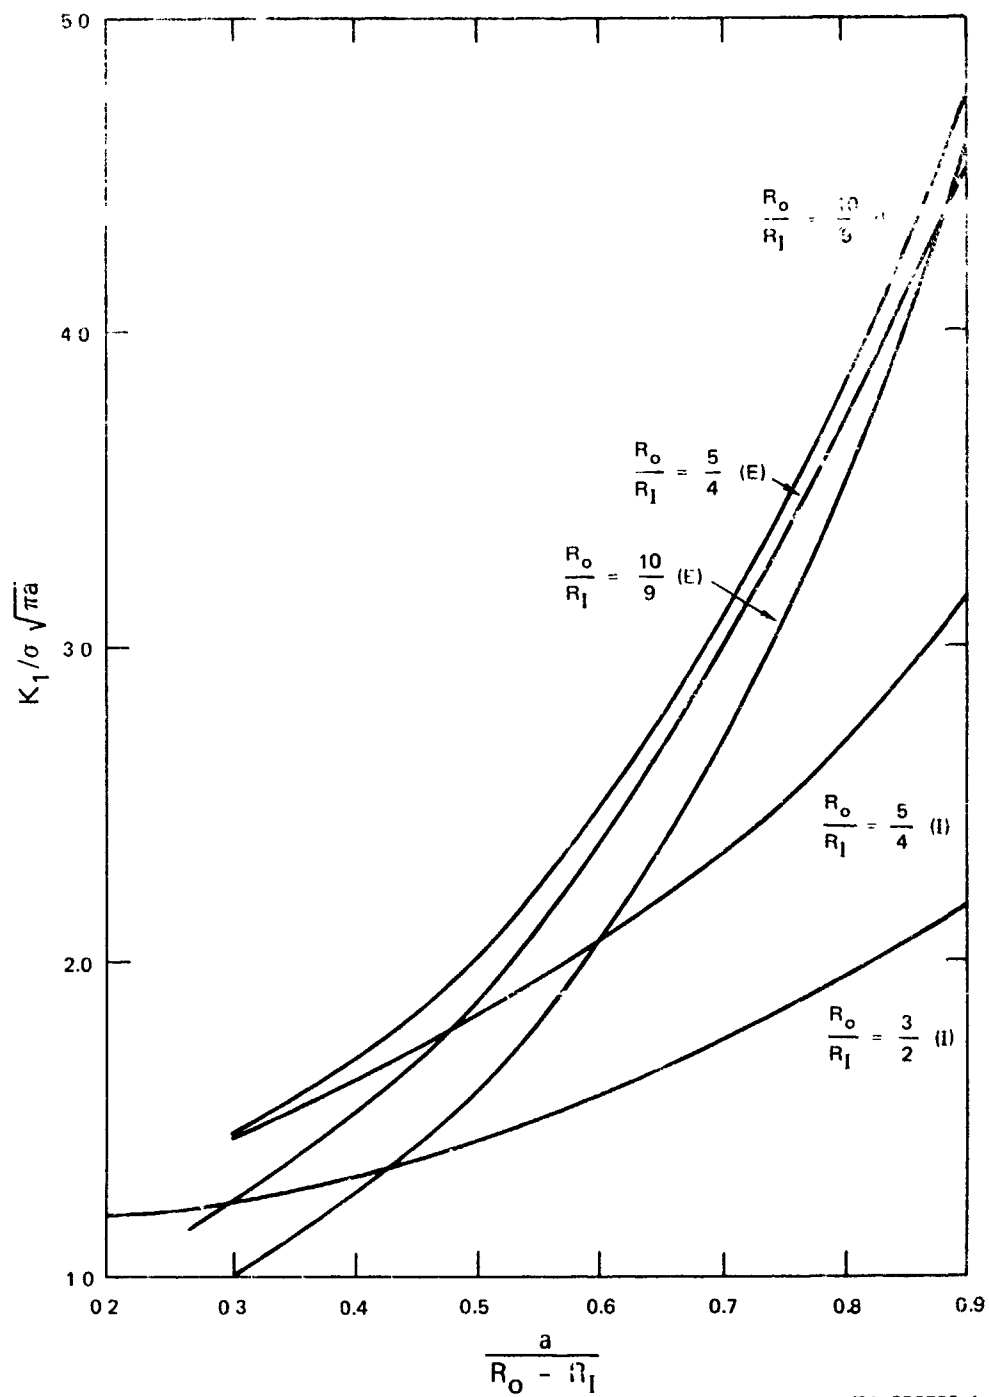
FIGURE 2 K-CALIBRATION CURVES FOR INTERNALLY (I) AND EXTERNALLY (E) NOTCHED RINGS OF VARIOUS RADIUS RATIOS,  $(R_o/R_I)$ .

where  $K_{Ic}$  is the plane strain fracture toughness,  $\sigma_c$  is the critical hoop stress at notch instability,\*  $a$  is the notch length, and  $A$  is a geometrical constant. The values of  $A$  for notches in rings of several geometries are given in Figure 2.

| Specimen No. | External Diam. $\phi$ $m \times 10^{-3}$ | Internal Diam. $\phi$ $m \times 10^{-3}$ | Wall Thickness $R_o - R_i$ $m \times 10^{-3}$ | Notch Size, $a$ $m \times 10^{-3}$ | Burst Pressure $P_c$ MPa | External Surface Stress $\sigma_c$ MPa | Normalized Crack Length | | Calibration Factor (from Fig. 2) | Fracture Toughness $K_{Ic}$ MPa $m^{1/2}$ | Comments |
