Report No. CG-D-121-76  
Task No. 764241.2/15

A PRELIMINARY TEST OF A GOVERNMENT-OWNED  
LOCAL AREA OIL ON WATER SURVEILLANCE SYSTEM

June 1976

Final Report

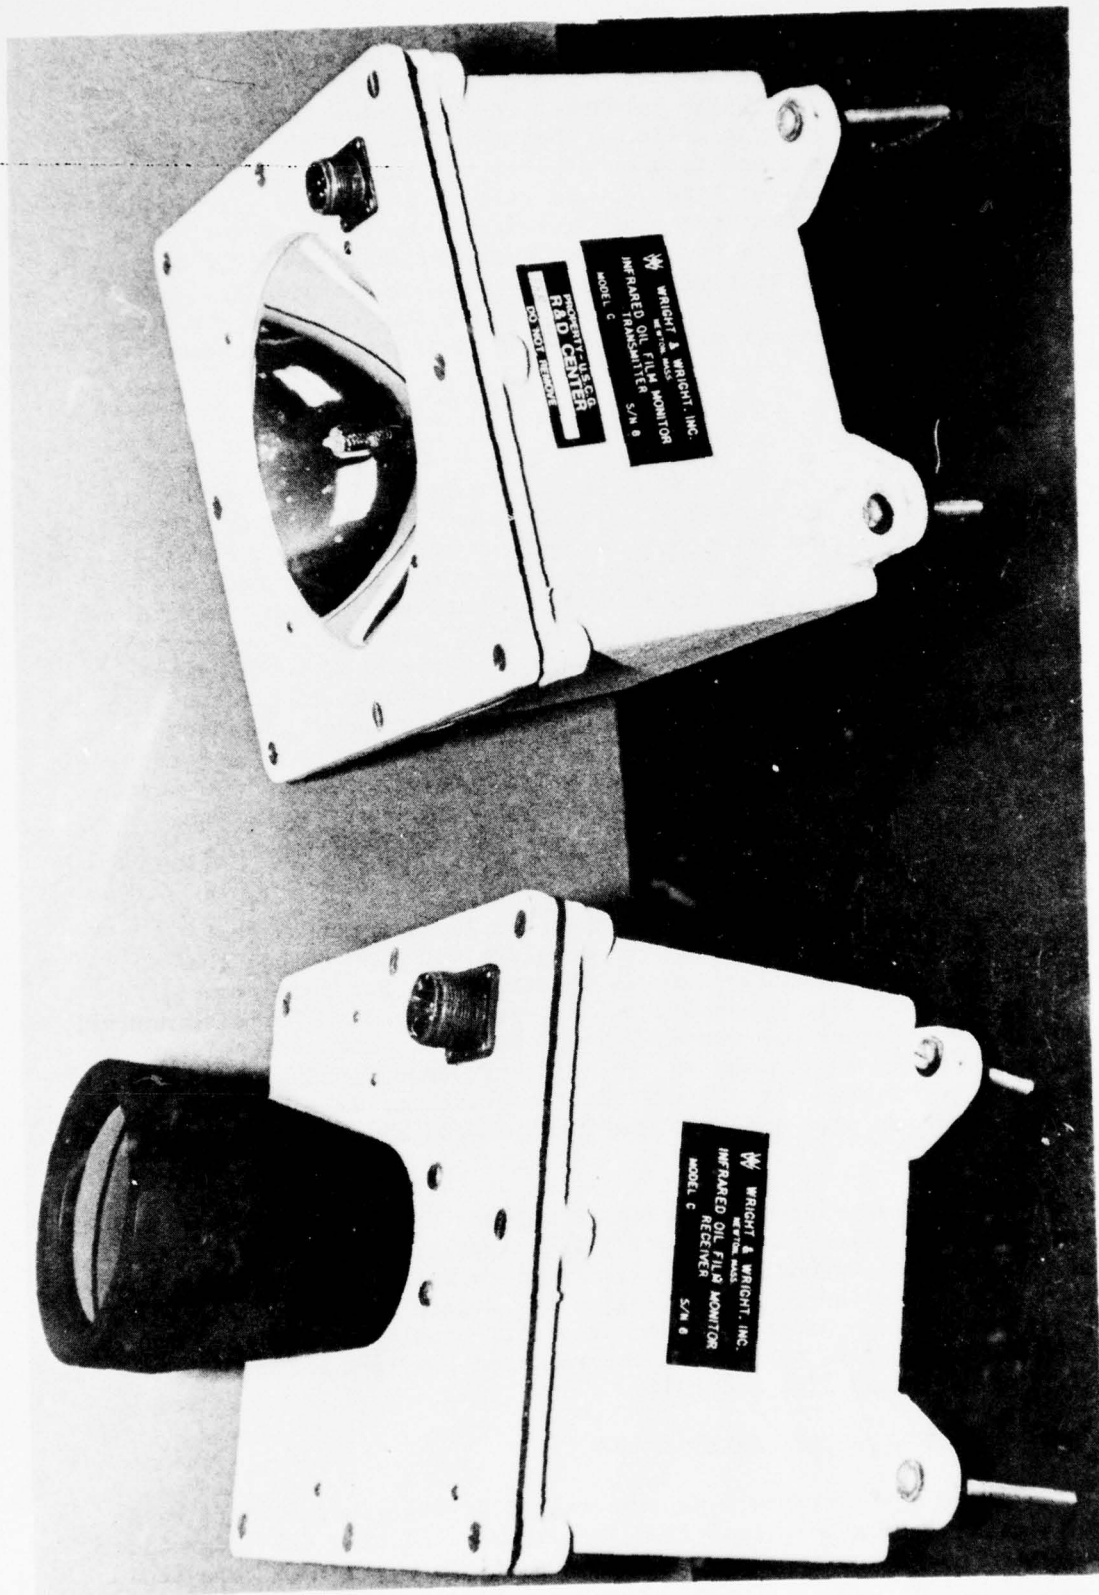
FIGURE 2. OIL FILM MONITOR MANUFACTURED BY WRIGHT AND WRIGHT, INC.

The Wright and Wright sensor, called an Oil Film Monitor, also is an infrared reflectance device. It used a 500-watt tungsten halogen lamp and a parabolic reflector to direct the radiation to the water's surface. The receiver unit collects the reflected radiation with an arsenic trisulfide lens and focuses it into the receiver unit where it passes through two optical interference filters in a rapidly rotating filter wheel to an ambient temperature indium arsenide detector. The filters allow radiation in the 2.4 to 2.6 micron and 3.0 to 3.2 micron wavelength bands to alternately reach the signal detector. The ratio of the 2.5 micron to 3.1 micron signals is then electronically processed. Its value should be approximately 1.8 volts for water and increase to over 2.2 volts for oil.

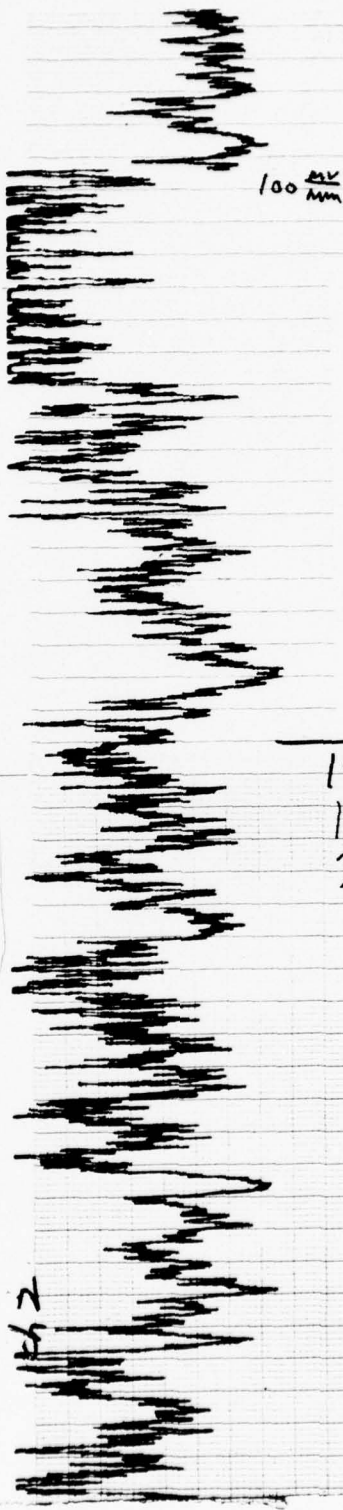
FIGURE 17 - Rambie sensor strip chart recording showing response to invisible oil. Sample #30 Channel 3 is ratio value.

FIGURE 17, Ramble Sensor #1  
23 February 1976 - Sample #30  
Chart speed .5 cm/min  
Response to invisible oil film
