INVESTIGATION OF FIRST PLY FAILURE IN GRAPHITE/EPOXY
LAMINATES SUBJECTED TO BIAXIAL STATIC
AND FATIGUE LOADINGS

FINAL TECHNICAL REPORT

APRIL 1977

TECHNICAL REPORT AFML-TR-77-62
Final Report for Period 15 February 1975 through 15 March 1977

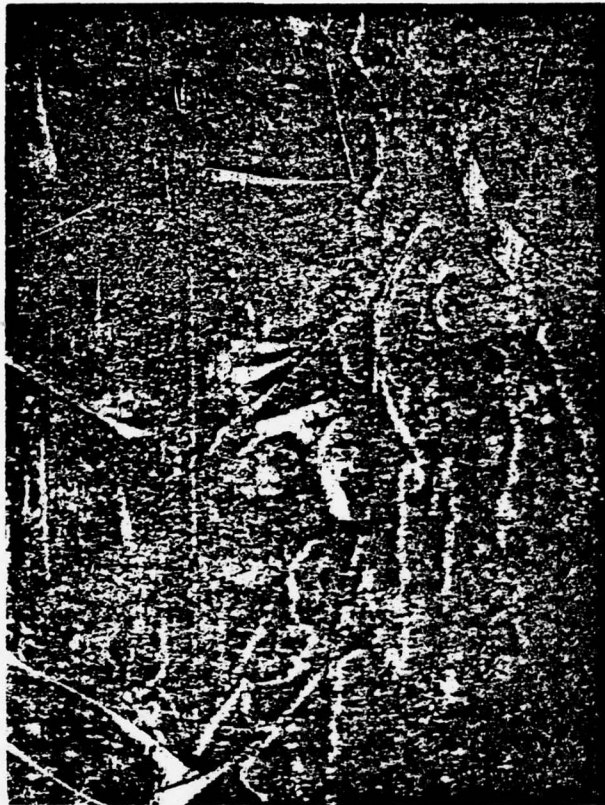
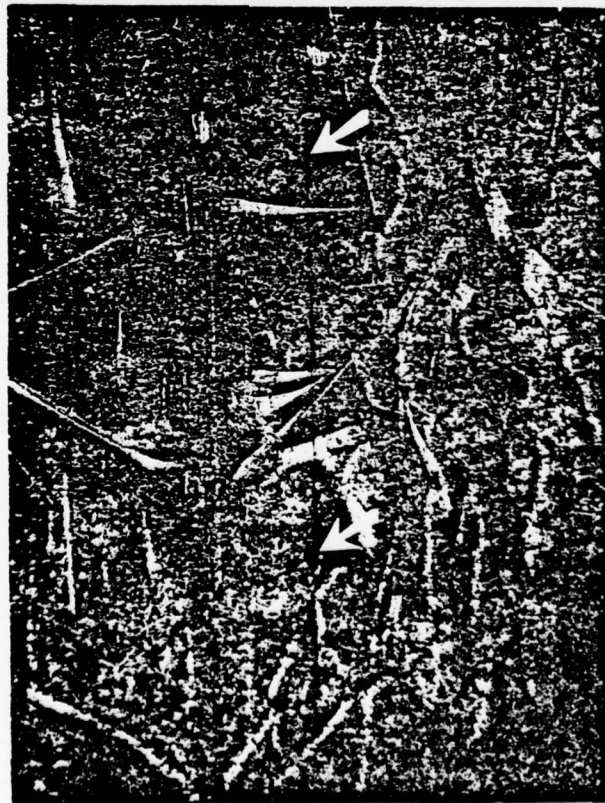
Figure 9. FPF Detected by Replication Techniques in a $[0/90]_s$ Tube

tape had rehardened, it was peeled from the tube and labeled for later observation. After the baseline observations, the specimen was loaded to successively higher predetermined values, but the load reduced and held constant during the replication process, as previously described. In order to examine the replica records under a microscope, they were first coated with a thin vapor deposited layer of aluminum. Replicas for each specimen were examined with a stereo-optical microscope, beginning with the last replica just before fracture, and working backwards in the replication sequence until cracks present in the last replica disappeared altogether. In this way an upper bound on the load corresponding to FPF could be established. Photomicrographs were taken of all replicas in which emergent or developed cracks were found. Figures 8 and 9 show cracks detected with replication microscopy of a $[\pm 45]_s$ and a $[0/90]_s$ tube, respectively.

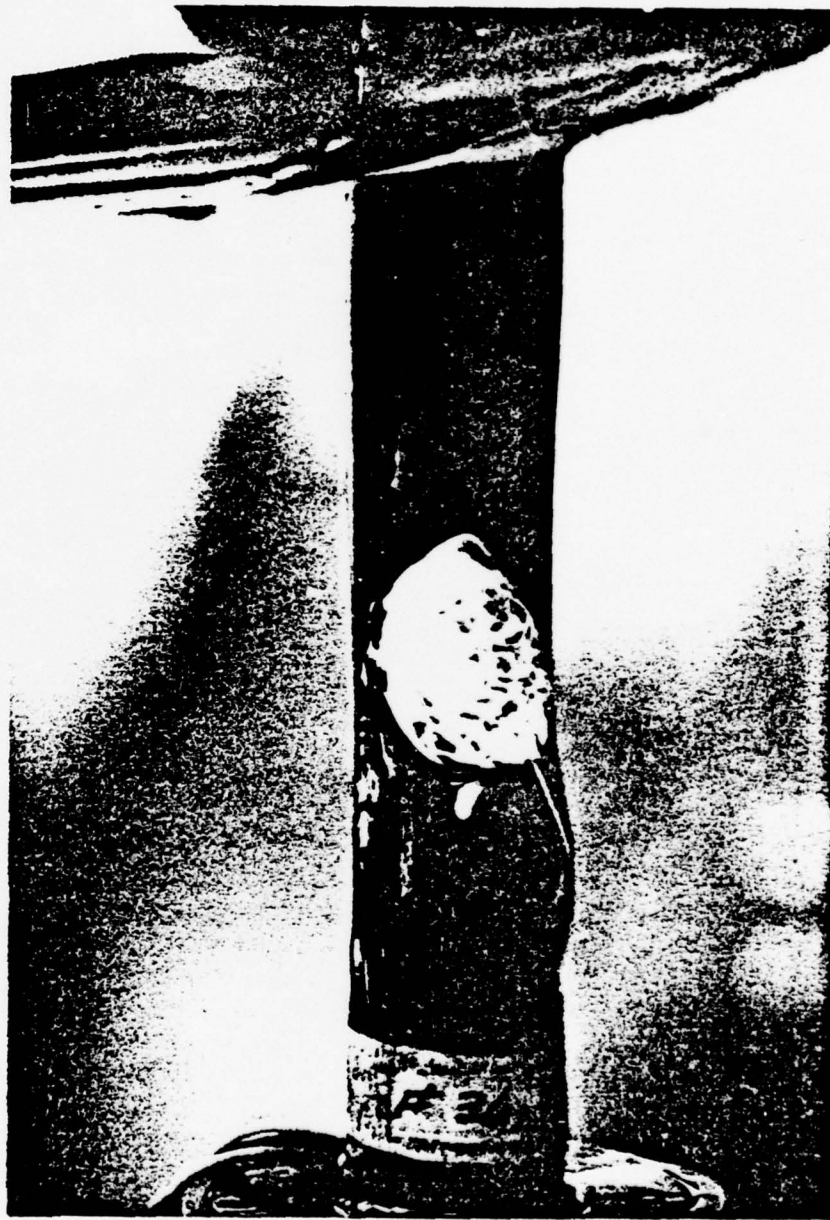
Figure 13. Tube Number 36 After
Failing in Torsion

The final two tubes, numbers 36 and 40, were tested with uniaxial torsion. Failure apparently was caused by torsional buckling (see Figure 13). Upon removal of load these specimens both reverted back to their original shapes, and retained most of their original stiffness. This behavior was surprising, since earlier theoretical and experimental work with $[0]_4$ tubes showed them to have torsional failure strengths well below torsional buckling strengths. (1)
