# Research and Development Technical Report

## TACTICAL MINIATURE CRYSTAL OSCILLATOR

THE BENDIX CORPORATION  
COMMUNICATIONS DIVISION  
East Joppa Road  
Baltimore, Maryland 21204

Semiannual Report 15 October 1975 - 15 June 1976

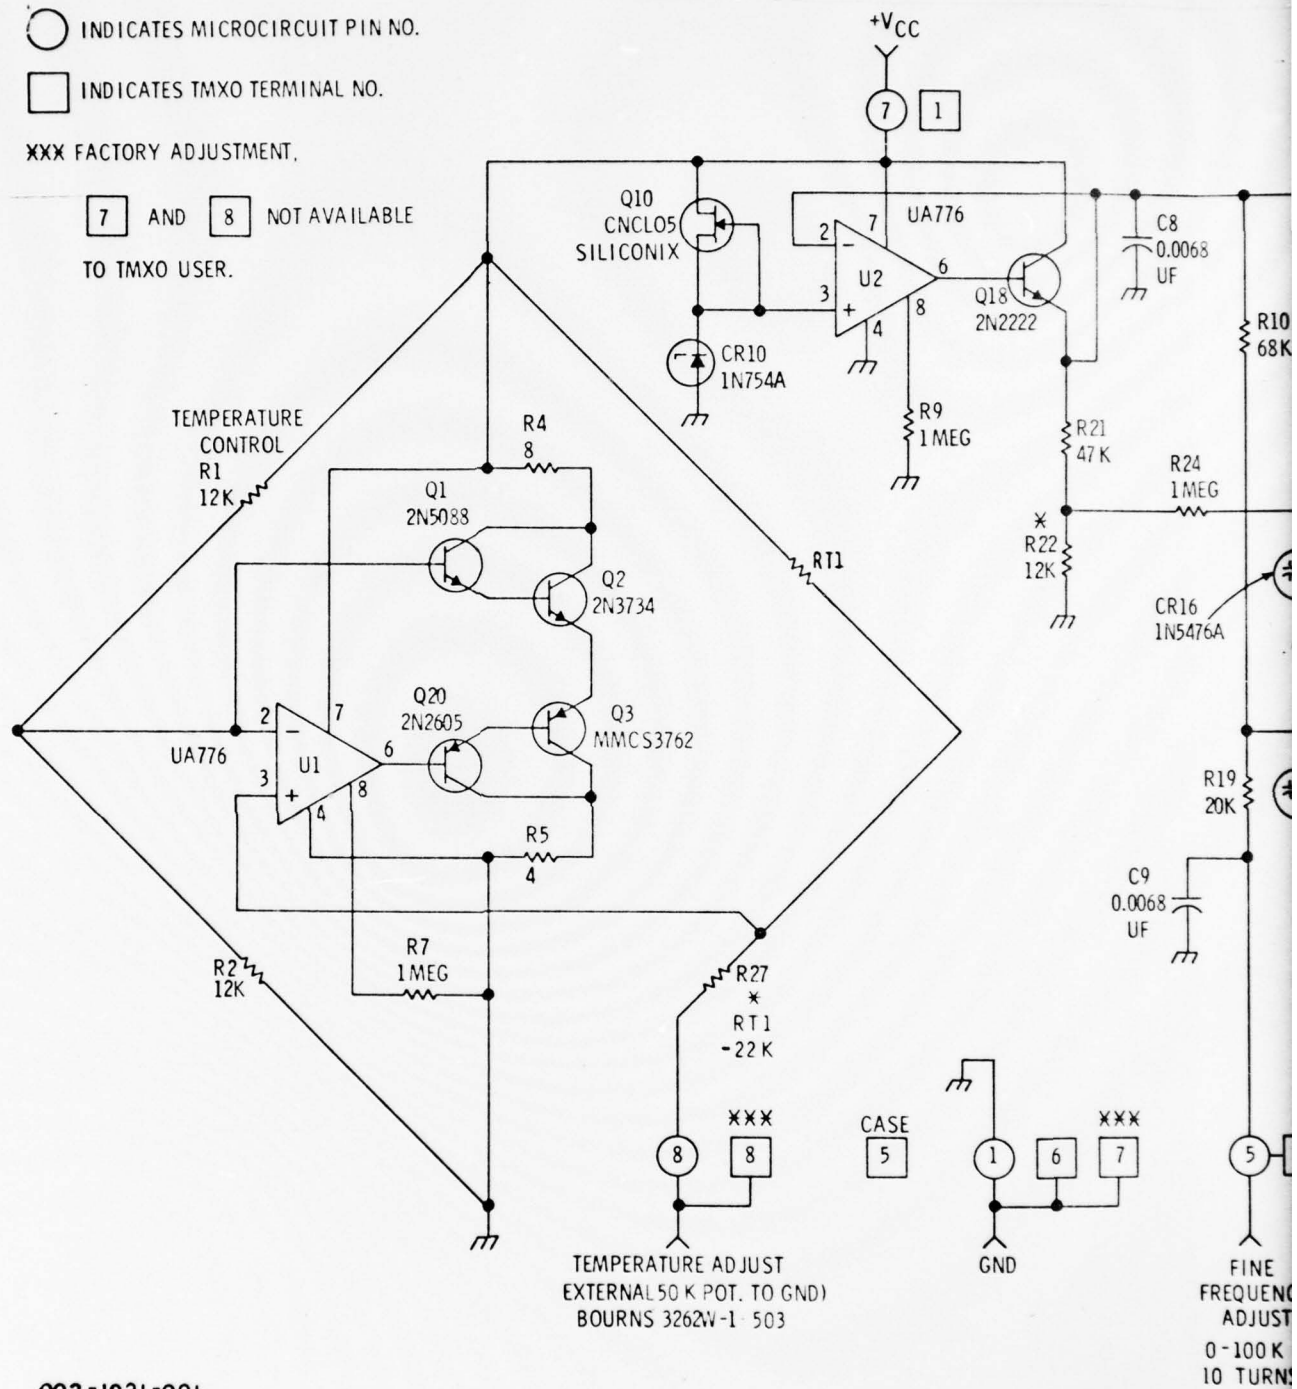
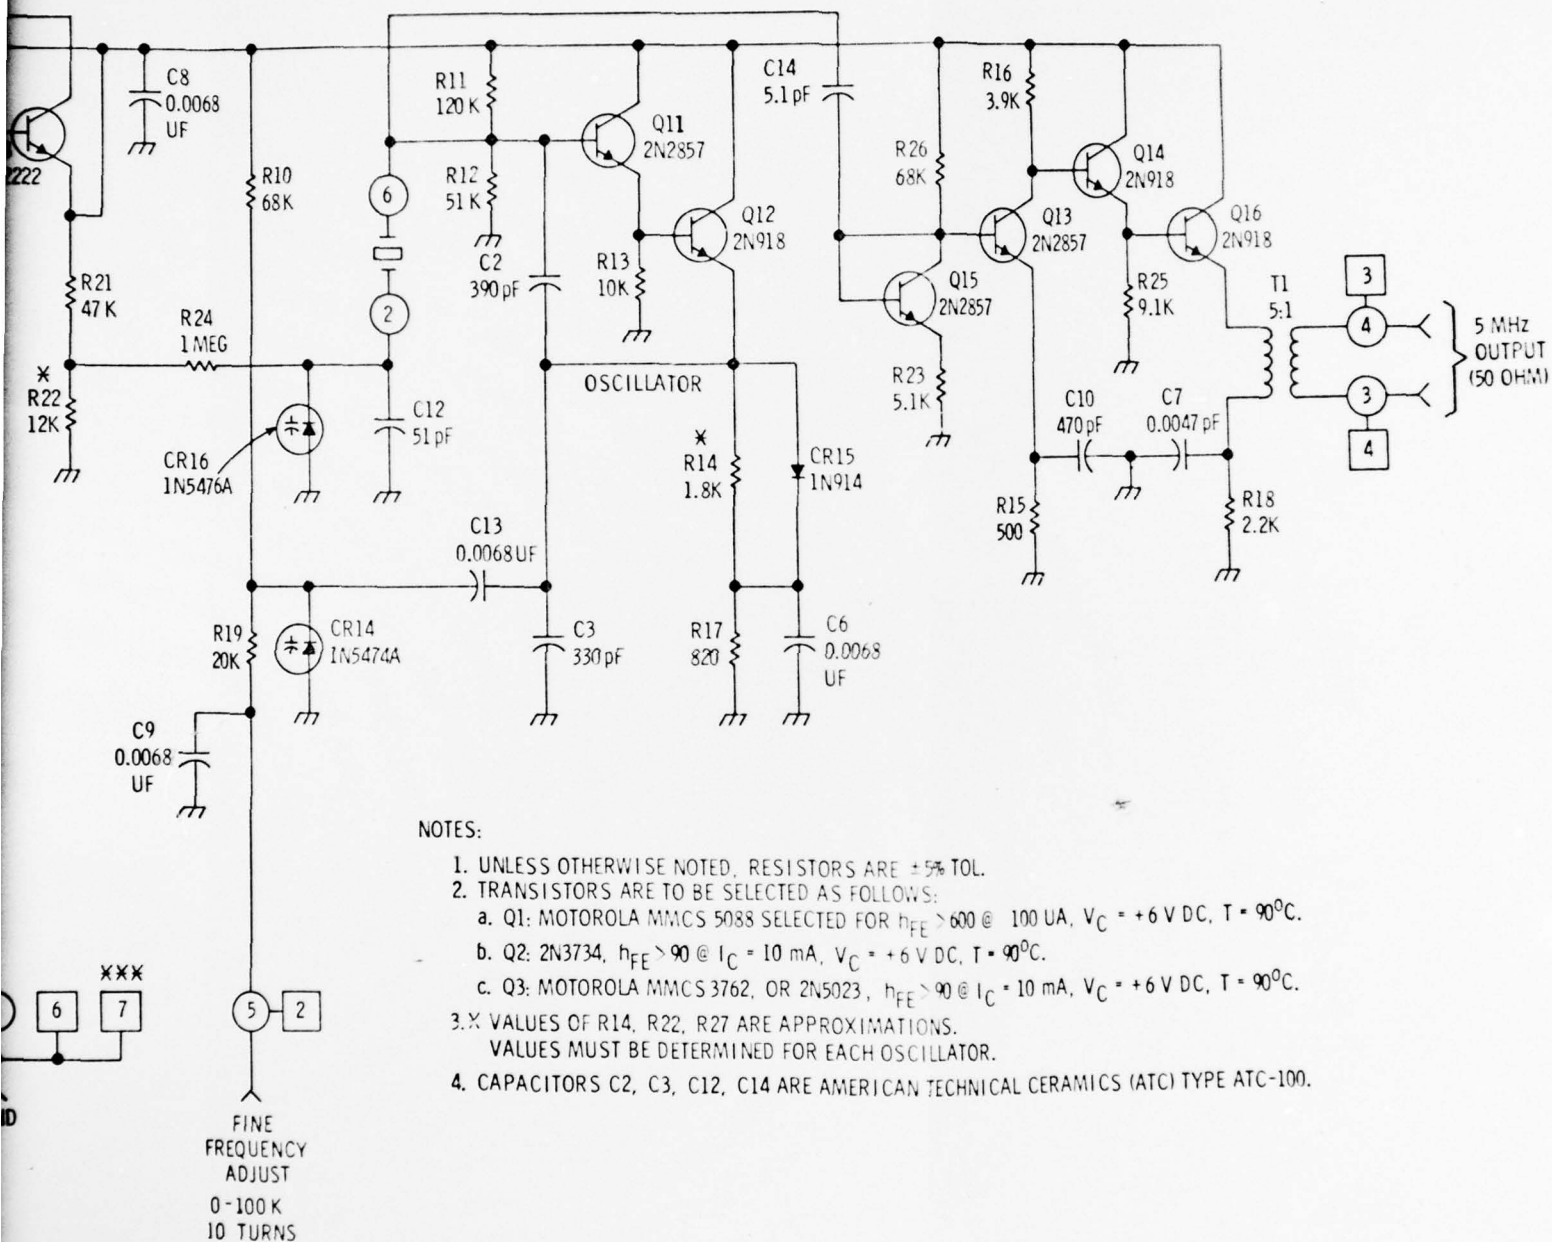
Figure 1. Electrical Schematic of TMXO

The electrical schematic, used in the deliverable models, is shown in Figure 1. It is the same as presented in the previous report with the exception of the values of R27 and the external temperature setting potentiometer. The value of R27 has been changed from an unspecified select by test value, to (RT1 at 90°C) - 22 k $\Omega$ . The potentiometer has been changed from 20 k $\Omega$  to 50 k $\Omega$ .

These changes were necessary to allow for the resistance tolerance of the thermistor at 90°C, and for the +5°C variation in the upper turn temperature of the crystal. The value of the thermistor at 90°C is 54 k $\Omega$ , +10%. The minimum thermistor value due to its tolerance is 49.6 k $\Omega$  at 90°C. If the upper turn temperature of the crystal is a 95°C, the minimum thermistor value will be 42 k $\Omega$ . The maximum thermistor value will be a +10% tolerance thermistor, when the upper turn temperature is +85°C. This value is 73 k $\Omega$ . Therefore, allowing for a +10% thermistor tolerance, and a +5°C upper turn temperature tolerance, the thermistor range will be from 42 k $\Omega$  to 73 k $\Omega$ . The minimum potentiometer value is 73 k $\Omega$  - 42 k $\Omega$  = 31 k $\Omega$ . Using a 50 k $\Omega$  potentiometer, the near optimum value of R27 = RT - 22 k $\Omega$ , measuring RT at 90°C. Refer to Table 1.

Q10 of the present circuit is a CNCL05, a FET current limiting device, manufactured by Siliconix. This chip is no longer available and a replacement must be found. This is not a serious problem as several similar devices are available.

To eliminate the noise on the input current pulse, the heater circuit will be redesigned for steady state operation. To improve the frequency/voltage stability, the coarse varactor will be replaced with a tapped capacitor. Better isolation will be incorporated to enhance the frequency/load characteristics. The circuit will be modified so that it will operate with a 10 MHz fundamental and a 10 mHz third overtone, as well as with the 5.115 MHz fundamental. A replacement for Q10 will be found to replace the part which is no longer made.

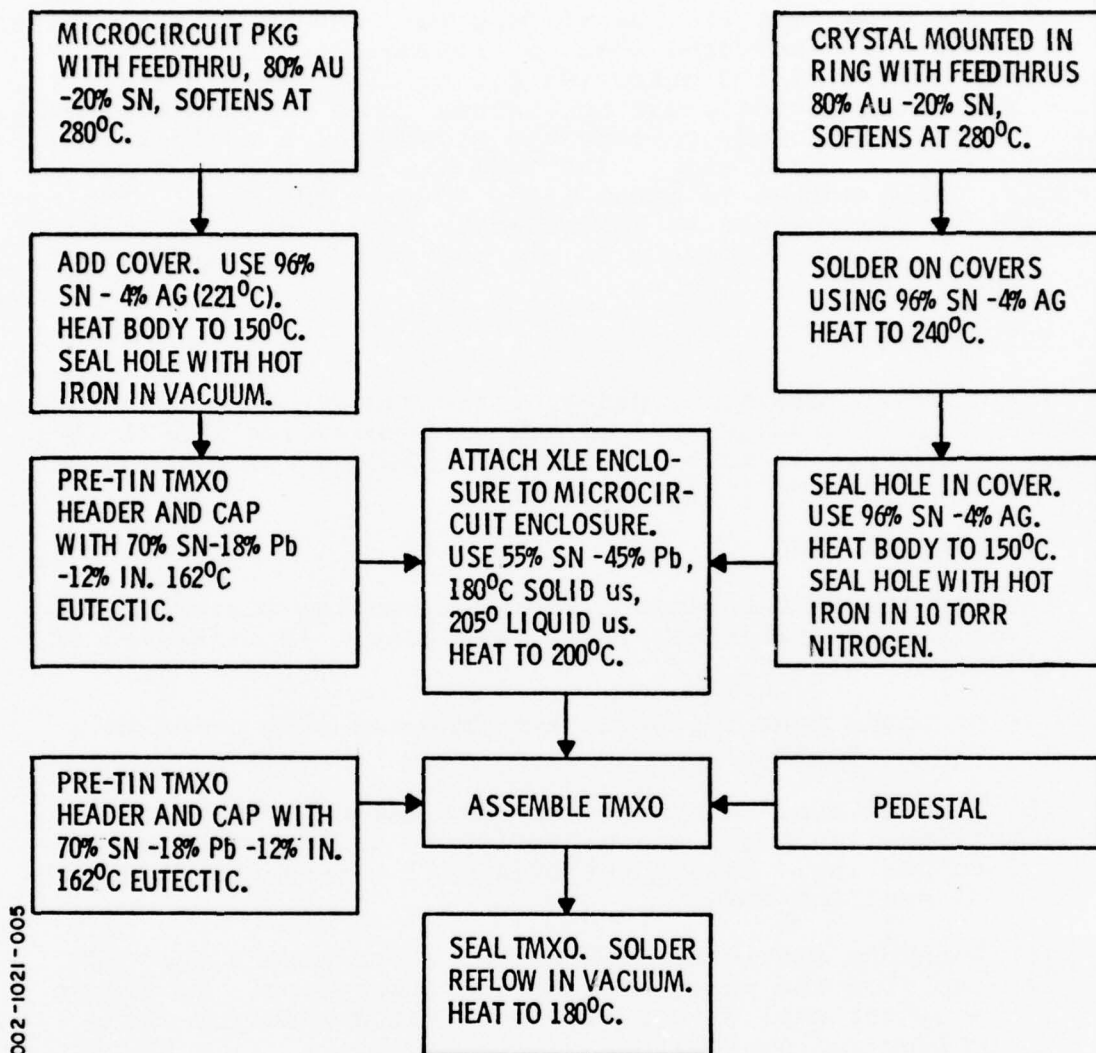
Figure 5. Solder Flow Chart

The improper selection of solders can lead to catastrophies. Such a catastrophe occurred when we originally chose the 60% tin - 40% lead solder (181°C eutectic) for joining the crystal enclosure to the microcircuit enclosure. When sealing the TMXO, this 181° solder flowed, coating the microcircuit enclosure and shorting out the oscillator. The TMXO was sealed with a 162°C eutectic, being heated to about 180°C to make the seal. The 181°C solder was changed as described in paragraph 4 of this section. The correct solders to use are indicated in Figure 5, Solder Flow Chart.

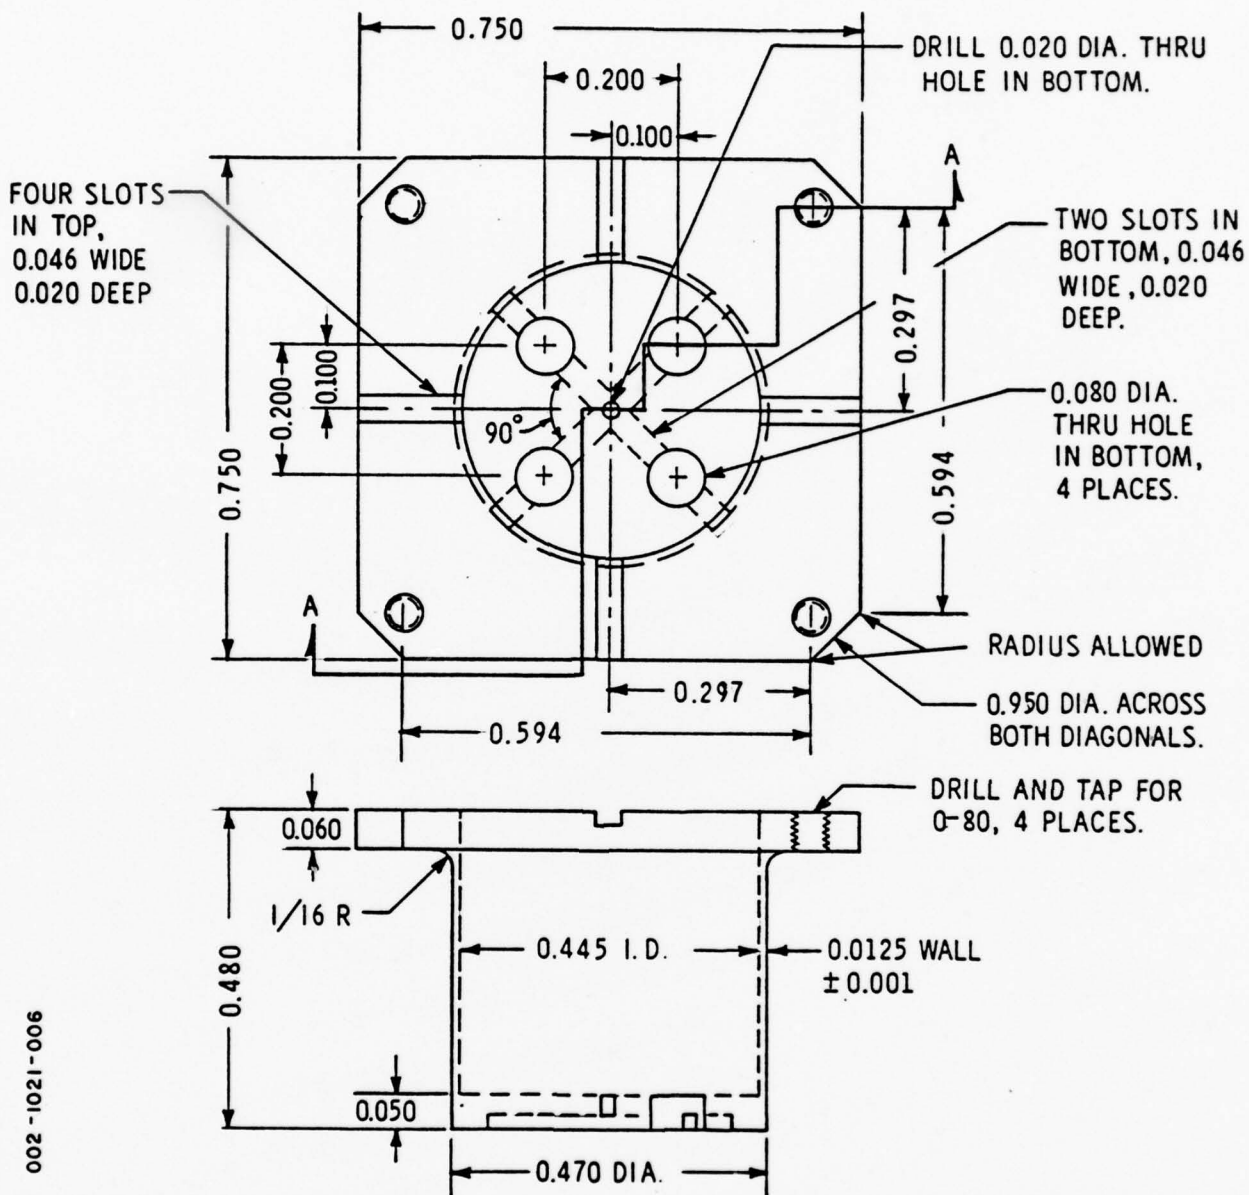
Figure 6. Pedestal for TMXO

Experiments with a stainless steel pedestal in a stainless steel TMXO package have shown that the outgassing is below the getter's pumping speed (greater than  $4.4 \times 10^{-10}$  Torr l/s). The pedestal and cap was outgassed for 96 hours at 400°C. The header was outgassed at 200°C for 96 hours. Just prior to sealing, the assembly was outgassed 40 hours at 150°C.

A similar experiment with a VESPEL pedestal resulted in a pressure rise in the TMXO package. A small leak in the TMXO package as well as insufficient outgassing of the pedestal was probably the cause. The pedestal had previously been outgassed as follows.
