CONTRACT REPORT D-77-3

## RECENT AND PLANNED MARSH ESTABLISHMENT WORK THROUGHOUT THE CONTIGUOUS UNITED STATES A SURVEY AND BASIC GUIDELINES

E. W. Garbisch, Jr.  
Environmental Concern, Inc.  
P. O. Box P  
St. Michaels, Md. 21663

April 1977  
Final Report

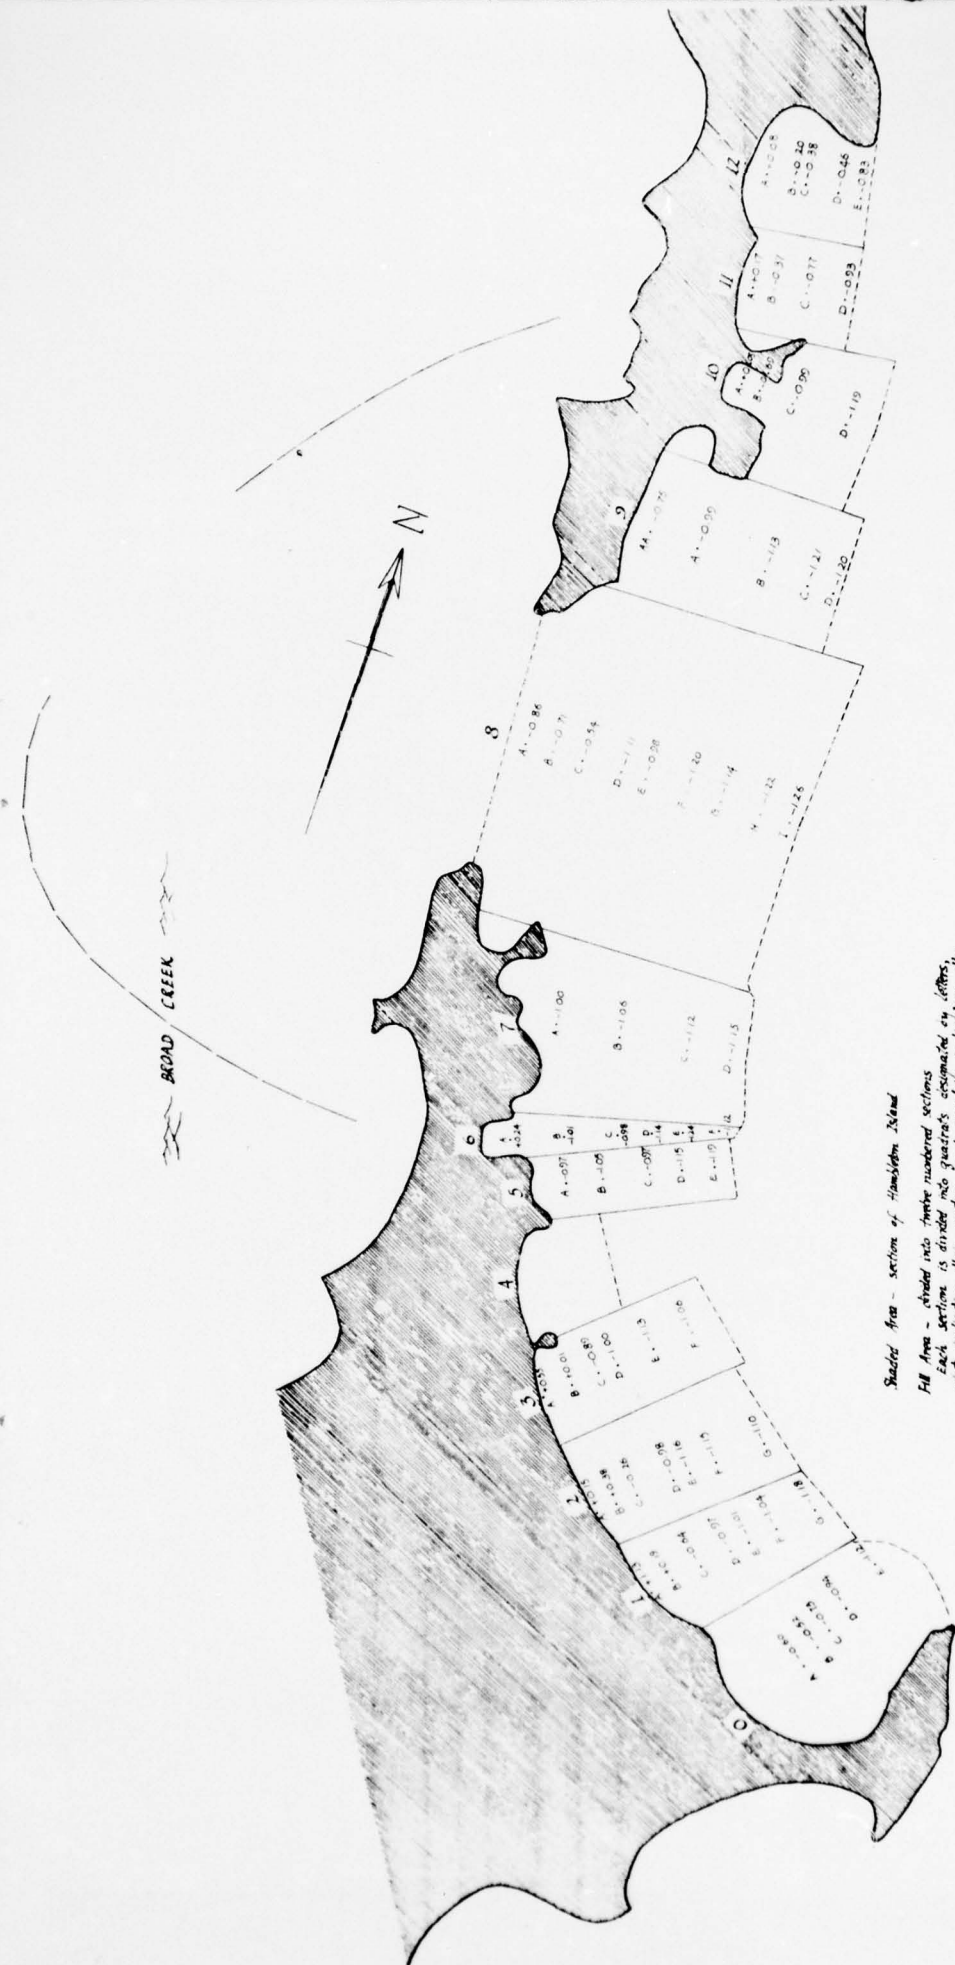
Shaded area - section of Himslohm Island  
 Full Area - divided into twelve numbered sections  
 Each section is divided into quadrants designated by letters,  
 and numbers indicating their centers, and numbers indicating the  
 elevations at their centers relative to M.S.M. Short broken  
 lines represent stream bed limits of 1:2.1 incorporation. Long  
 broken lines represent plastic breakwaters.

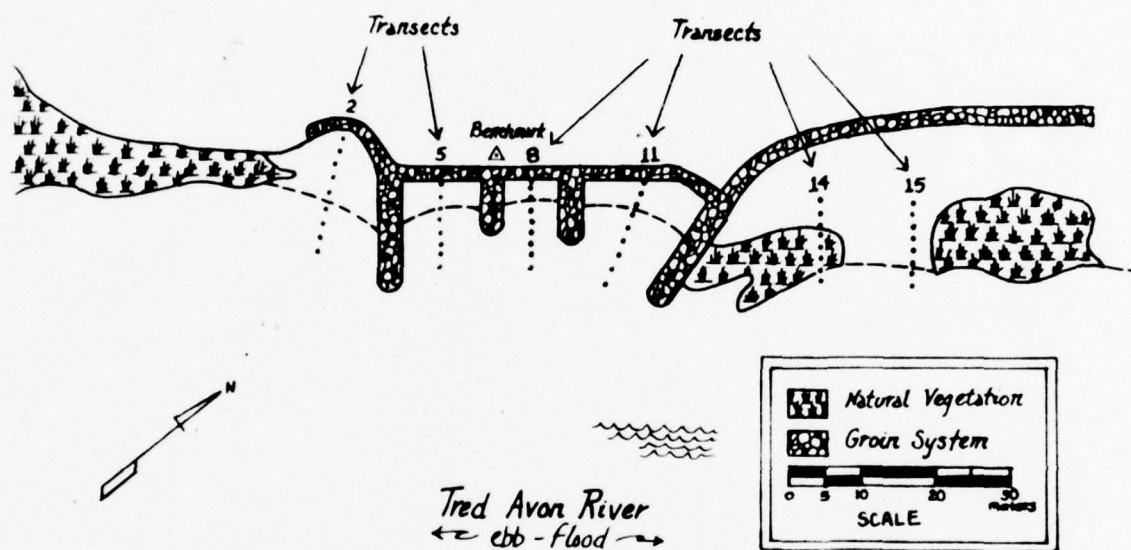
Drawing of site 2 showing the elevation monitoring transects passing through the six planting areas.
