REPORT NO. NADC-76316-30

FATIGUE EVALUATION OF AUTO TIG WELD JOINTS FOR HEAT EXCHANGER APPLICATIONS

J. J. Bethke
Air Vehicle Technology Department
NAVAL AIR DEVELOPMENT CENTER
Warminster, Pennsylvania 18974

31 JANUARY 1977

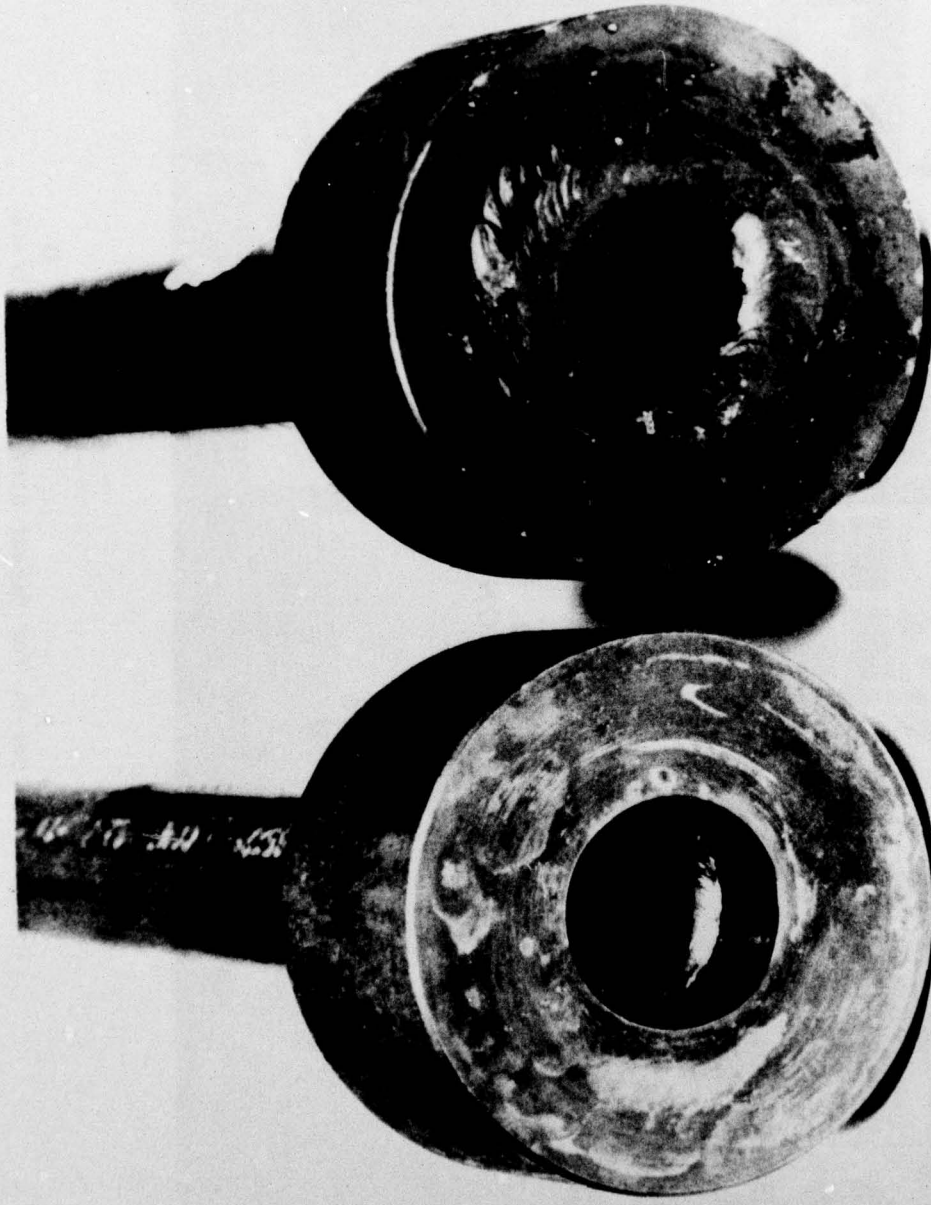
Figure 4. End View of Test Specimens Showing Welds

The manual welded and auto-TIG machine welded test specimens, shown in Figures 1 - 4, consist of a 2-1/4 Cr- 1 Mo heat resistant steel tube welded to a 1-1/4 Cr - 1 Mo end wall section. The two specimen types are identical except for the weld design and technique used in the attachment of the tube to the end wall. Nominal dimensions are the same for both specimen types with respect to tube length, outside and inside diameters, end wall base section thickness and hole diameter. Prior to welding, the tubes are inserted into the oversized hole in the end wall section and mandrel expanded to form a snug fit.
