SECOND QUARTERLY REPORT ON
MANUFACTURING METHODS AND ENGINEERING
FOR TFT ADDRESSED DISPLAY

August 7, 1976 to November 7, 1976

CONTRACT DAAB07-76-C-0027

WESTINGHOUSE INDUSTRIAL AND GOVERNMENT TUBE DIVISION
Westinghouse Circle
Horseheads, New York 14845

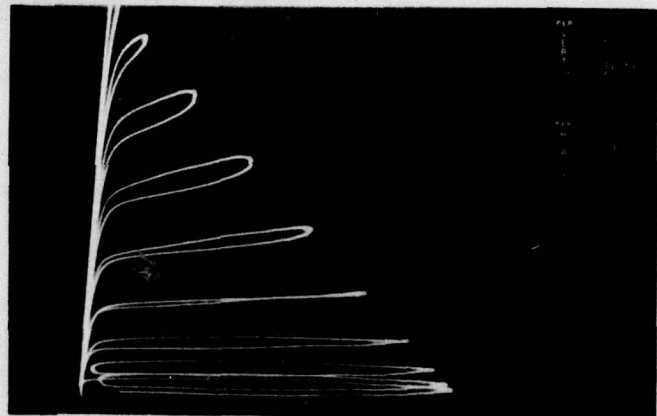
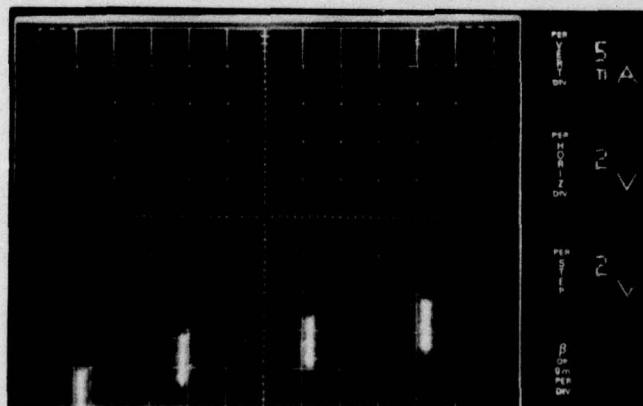
4. MEASURED TRANSISTOR CHARACTERISTICS TAKEN FROM TYPICAL
 DISPLAY CIRCUITS

• A tentative unit cell electrical specification, derived from the research phase of the program was tested as part of the foregoing laboratory dedicated operation. A preliminary electrical specification is given in Table (1); from this analysis a tentative material recipe was generated that resulted in the achievement of these electrical specifications. Table (2) details that material recipe. Fig (4) shows actual measured device characteristics, taken from thin film transistors made on the laboratory unit, that meet these specifications.

Typical Display TFT

Power Device at High Voltages

Leakage in Logic TFT
 $V_{GS} = -10V$

patterns caused by the fractured substrate. Transistor characteristics appear quite reasonable for most of the transistors tested. Switch source-drain leakage measurements were well below 1 na with -20 volt gate bias; power devices were observed to break down at approximately 400 to 450 volts.

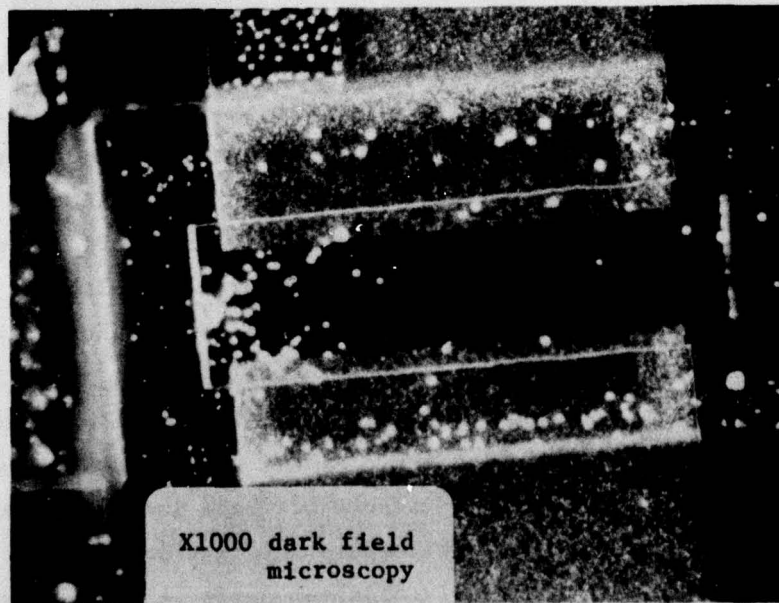
5. INCLUSIONS IN INSULATOR AREAS

The "inclusions" referred to here are quasi-spherical particles, ranging up to two or three microns in size, which occur primarily in the transistor gate area, but also in areas with insulator films only. Fig (5) illustrates these inclusions. A very strong statistical correlation exists between the incidence of these inclusions and the incidence of short circuits. Preliminary information tends to suggest that these inclusions are actually aluminum oxide (Al_2O_3), which is used as the insulator material. This preliminary "information" is derived from the following:

1. Inclusions with this geometry can be found in areas of the substrate that are masked off from every evaporant source except aluminum oxide.

2. Initial analyses by secondary electron emission analysis from a scanning electron microscope always indicate the presence of insulator material only, in areas with inclusions where only insulator material is known to be present.

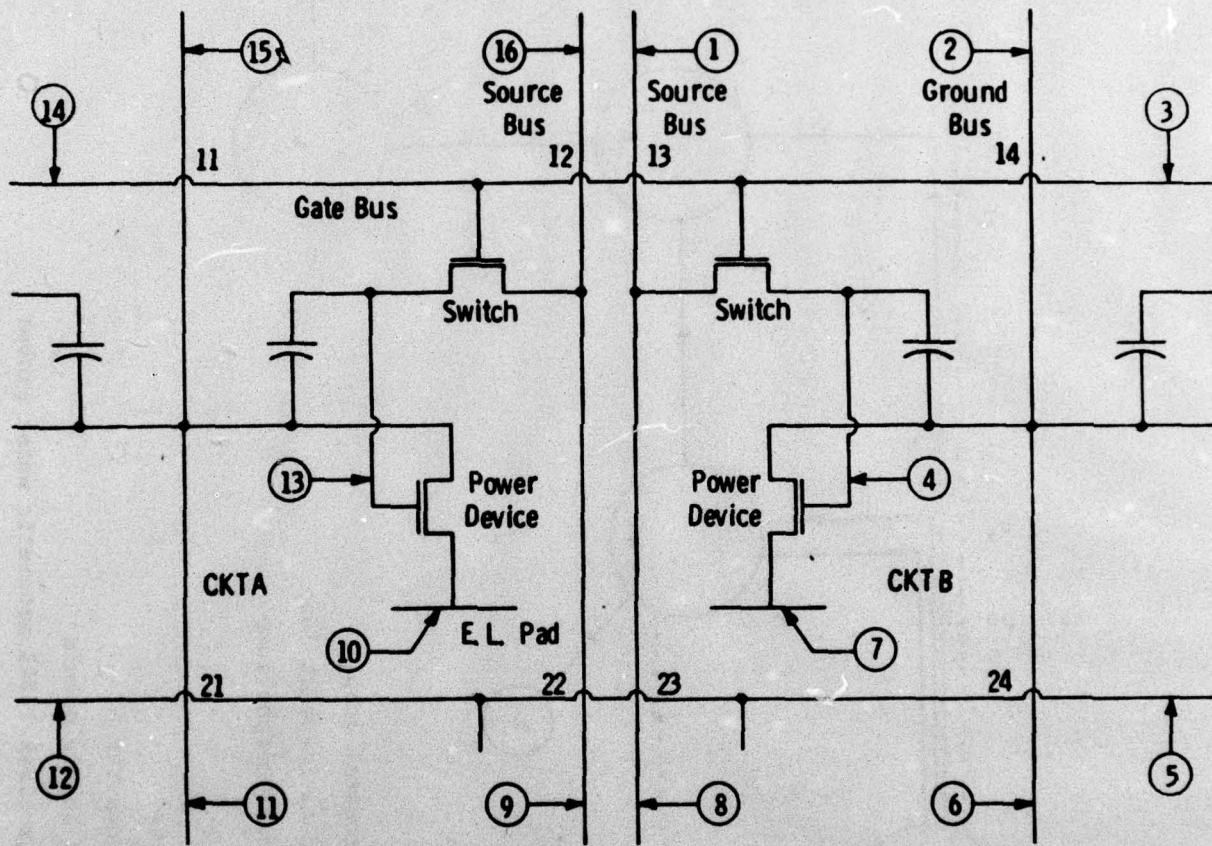
14. PROBE POSITIONS ON DISPLAY CELL PAIR

It is also anticipated that the same system could be used to actually repair TF circuits. Fig (14) shows the selected probe positions on a display cell-pair. By selectively grounding the probes in adjacent regions and applying a capacitor generated voltage across a short it is possible to clear it.
