**DEPARTMENT OF DEFENCE**  
**DEFENCE SCIENCE AND TECHNOLOGY ORGANISATION**  
**MATERIALS RESEARCH LABORATORIES**

**MRL-R-681**

GAS WASHING OF FRACTURE SURFACES  
BY EXPLOSIVE DETONATION PRODUCTS

MARCH, 1977

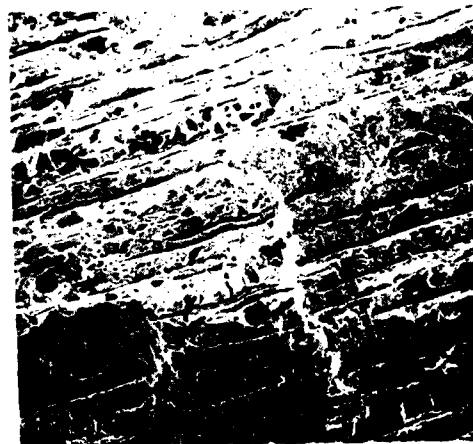
FIG. 4 - Scanning electron micrographs of fracture surfaces of tensile test specimens.

The matching halves of the tensile specimens were used to characterise the fracture surfaces prior to test in a scanning electron microscope (SEM). Typical fracture features are shown in Fig. 4.
