CRREL Report 77-21

Mid-winter installation of protected membrane roofs in Alaska

Haldor W.C. Aamot

August 1977

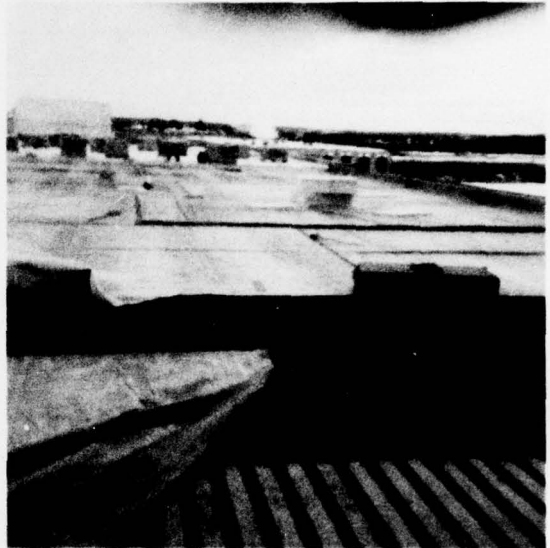
Figure 3. Metal deck, underlayment and sheet rubber membrane during roof installation.

A view of the Library building, showing snow on the ground, is given in Figure 2. Figure 3 shows the metal deck in the foreground and the rigid fiberboard underlayment; the rest of the roof is covered with the rubber membrane. In the left foreground, the corner of a piece of rubber sheet is displayed. Figure 4 shows an open lap joint between sheets in preparation. Figure 5 shows a large roof area with the membrane installation completed. Figure 6 shows the portable A-frame shelter on the roof; photograph on cover of report shows workers preparing a lap joint under the shelter.

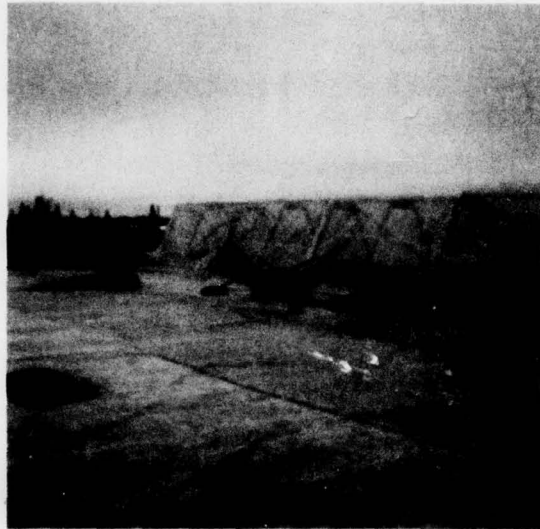
Figure 6. The A-frame shelter is placed over a lap joint to be made.

The main advantage of the loose-laid rubber membrane is the opportunity for cold weather installation. Butyl is flexible to -40°F (-40°C) and EPDM to -75°F (-57°C). Flashings and sheet splices can be made under portable shelters that are heated with portable space heaters. With this system the roofer's season is extended through the whole winter.
