USAAMRDL-TR-77-40B

HEAVY LIFT HELICOPTER FLIGHT CONTROL SYSTEM

Volume II - Primary Flight Control System Development and Feasibility Demonstration

Boeing Vertol Company  
P.O. Box 16858  
Philadelphia, Pa. 19142

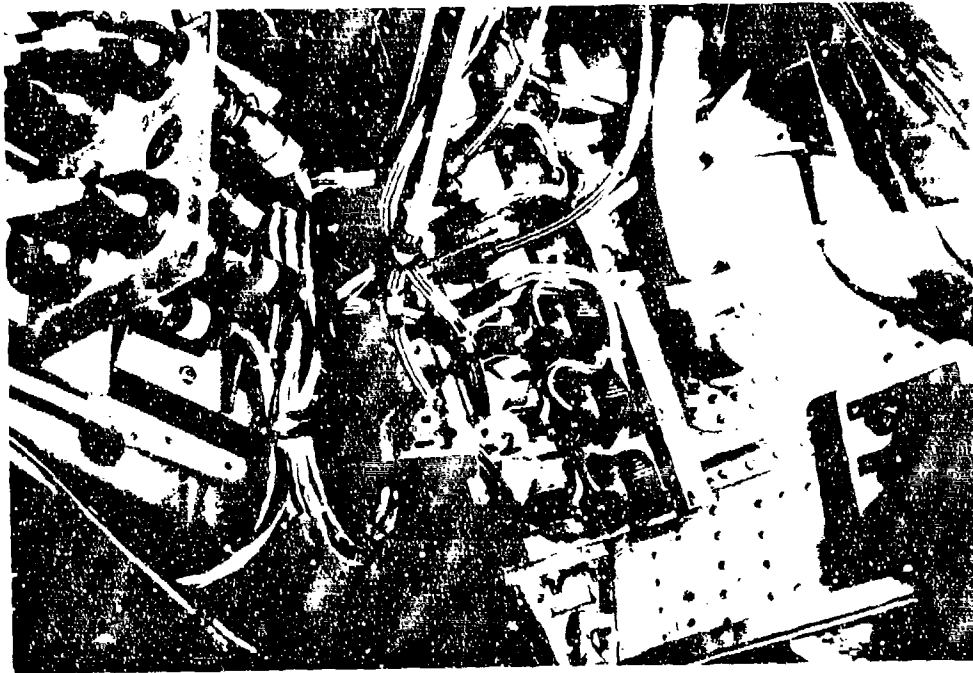
Figure 12. Left Aft Actuator Installed.

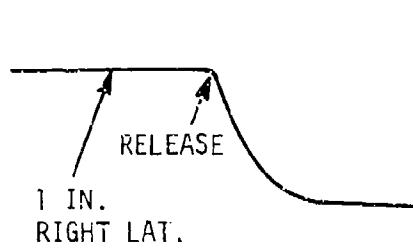
PFFU VOLTAGE - 10 VOLTS

PFFU VOLTAGE - 0 VOLTS

Figure 57. Typical Data, Input Damping, Lateral Axis.
