**ADVANCED DEVELOPMENT OF A HELICOPTER ROTOR ISOLATION
SYSTEM FOR IMPROVED RELIABILITY**

Volume II - Detailed Report

**Kaman Aerospace Corporation
Bloomfield, Connecticut 06002**

December 1977

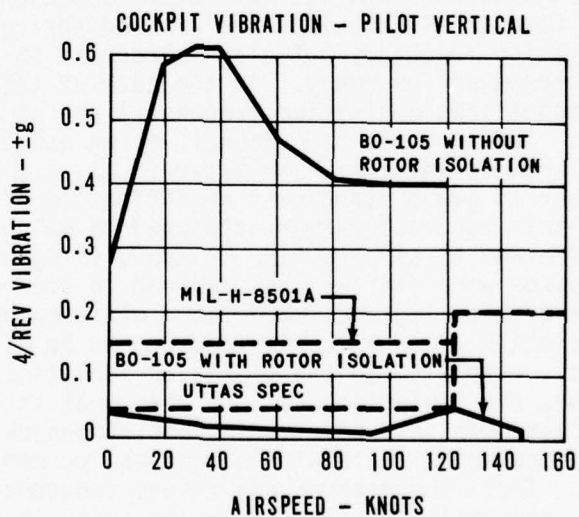
Figure 8. BO-105 Vibration Levels

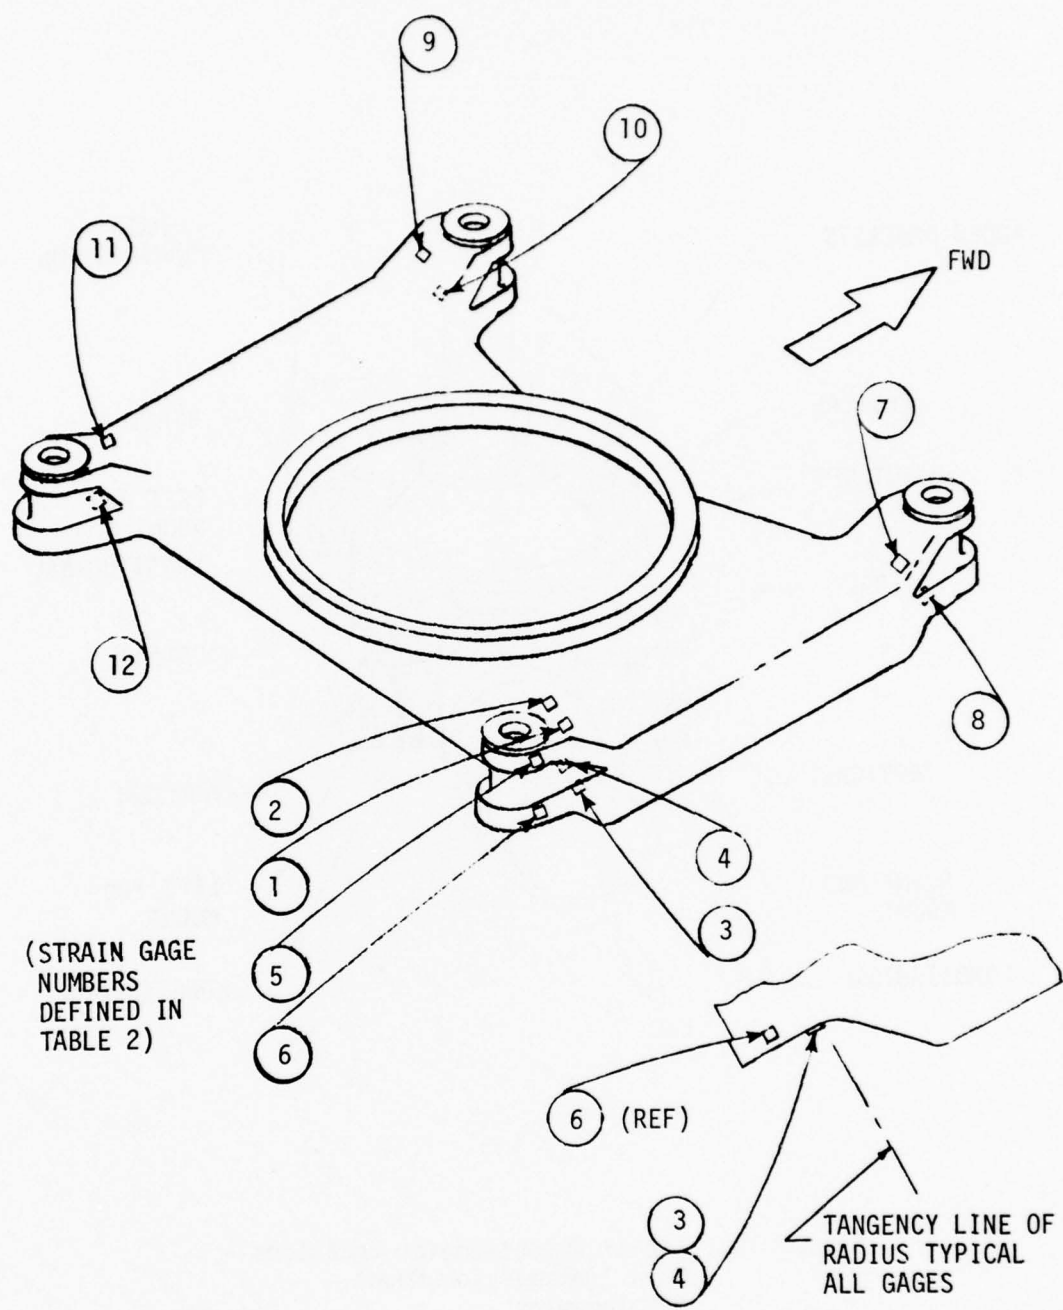
Figure 14. Strain Gage Locations - Lower Transmission Support Plate Assembly

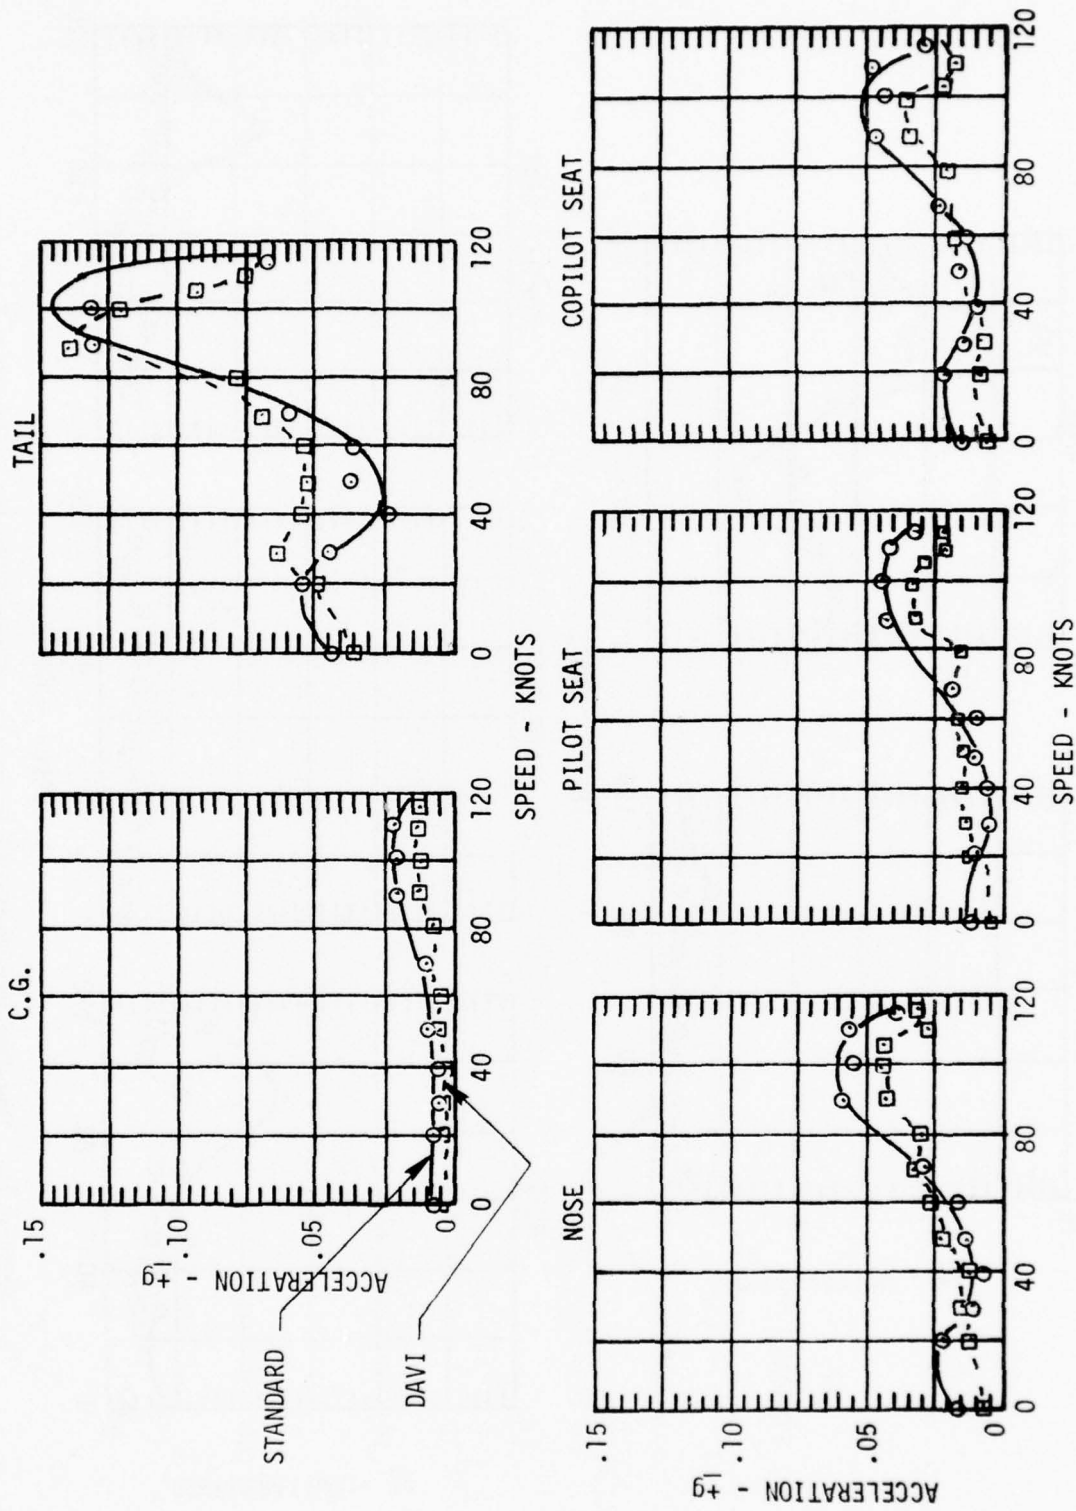
Figure 18. One-Per-Rev Vertical Response of the 8250-Pound UH-1H Helicopter

In order to determine the effectiveness of the DAVI isolation system, the response at each station of the standard vehicle was divided by the response of the DAVI-modified vehicle. Therefore, the larger the ratio, the better the isolation. Figures 24 and 25 show the results of these calculations. These results are the average of the 8250- and 9500-pound vehicles. It is seen from these effectivity curves that, in the vertical direction, the DAVI system had a lower one-per-rev response in the low-speed regime, a higher response at mid-speed, and a lower response at the high-speed conditions than the standard vehicle. In the lateral direction, it is seen that the DAVI-modified system had a lower response in the low-speed regime, a higher response at mid-speed, and essentially the same response at high speed as the standard vehicle.

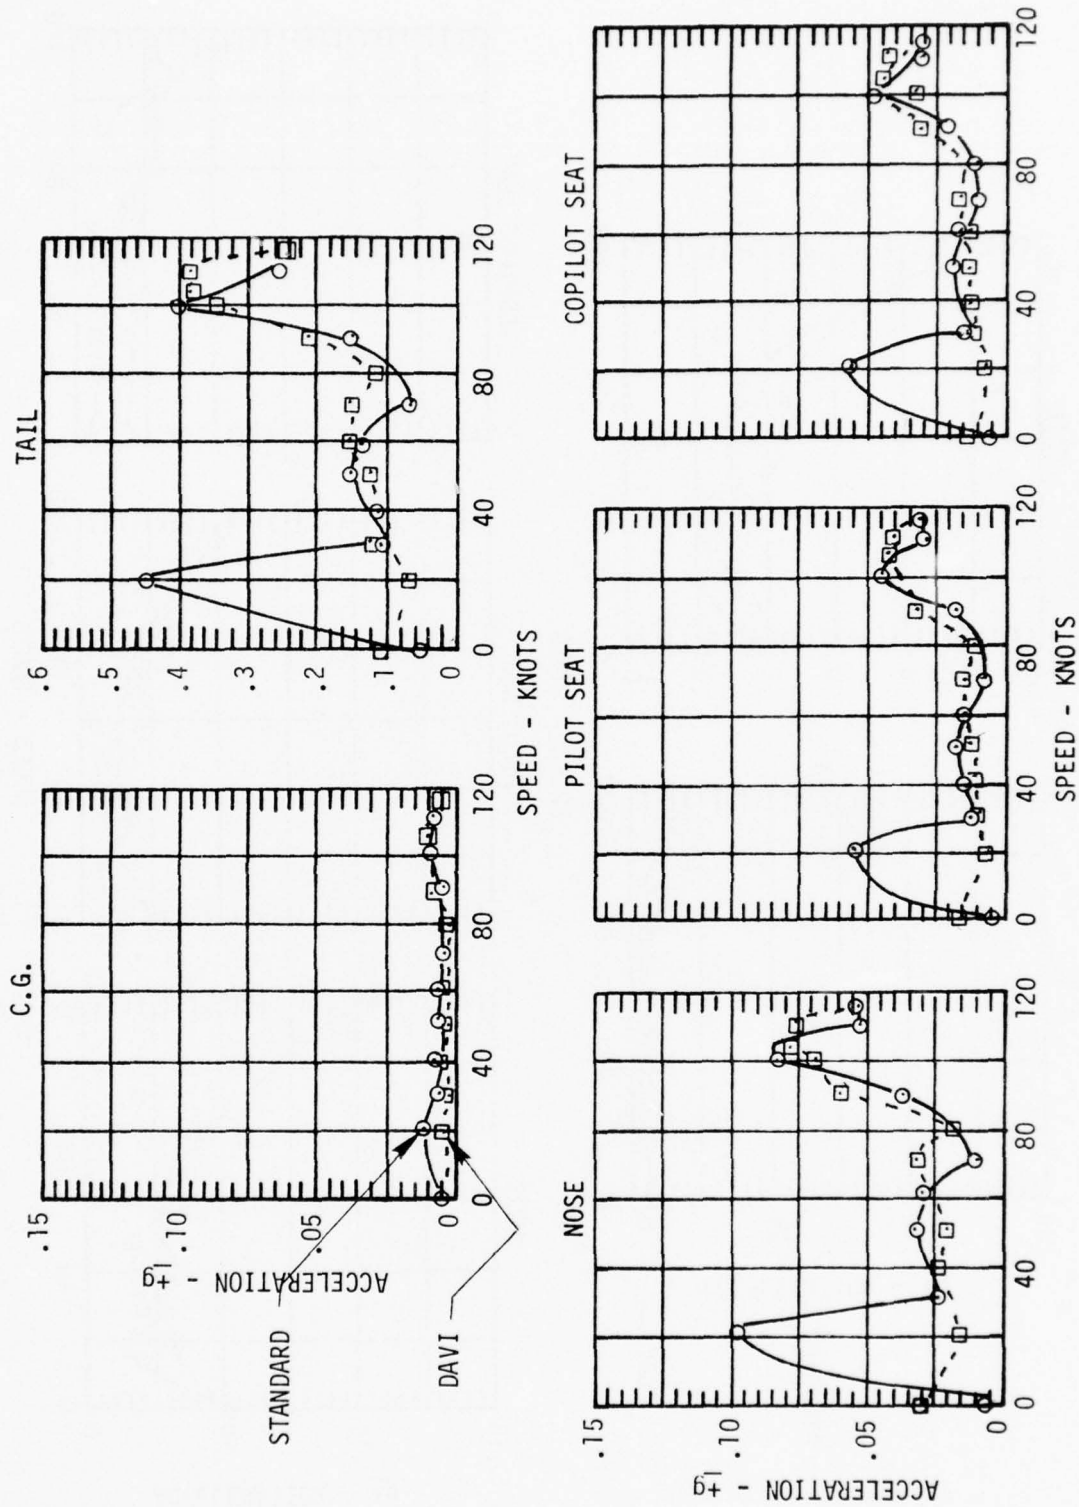
Figure 20. One-Per-Rev Lateral Response of the 8250-Pound UH-1H Helicopter

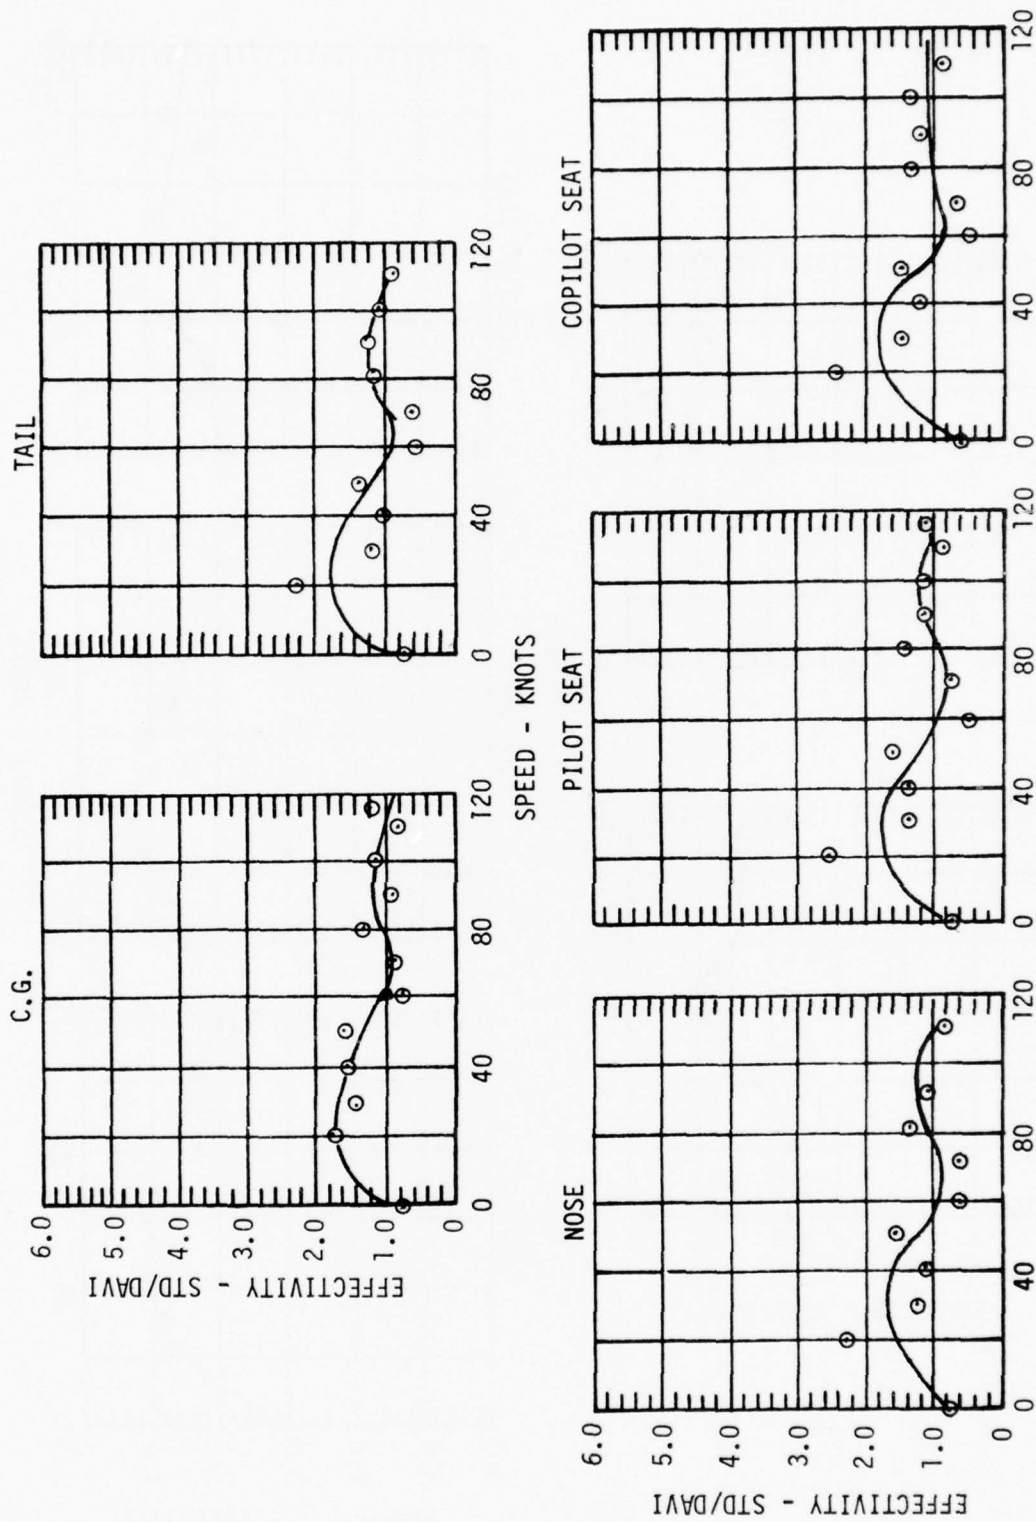
Figure 25. One-Per-Rev Lateral Effectivity

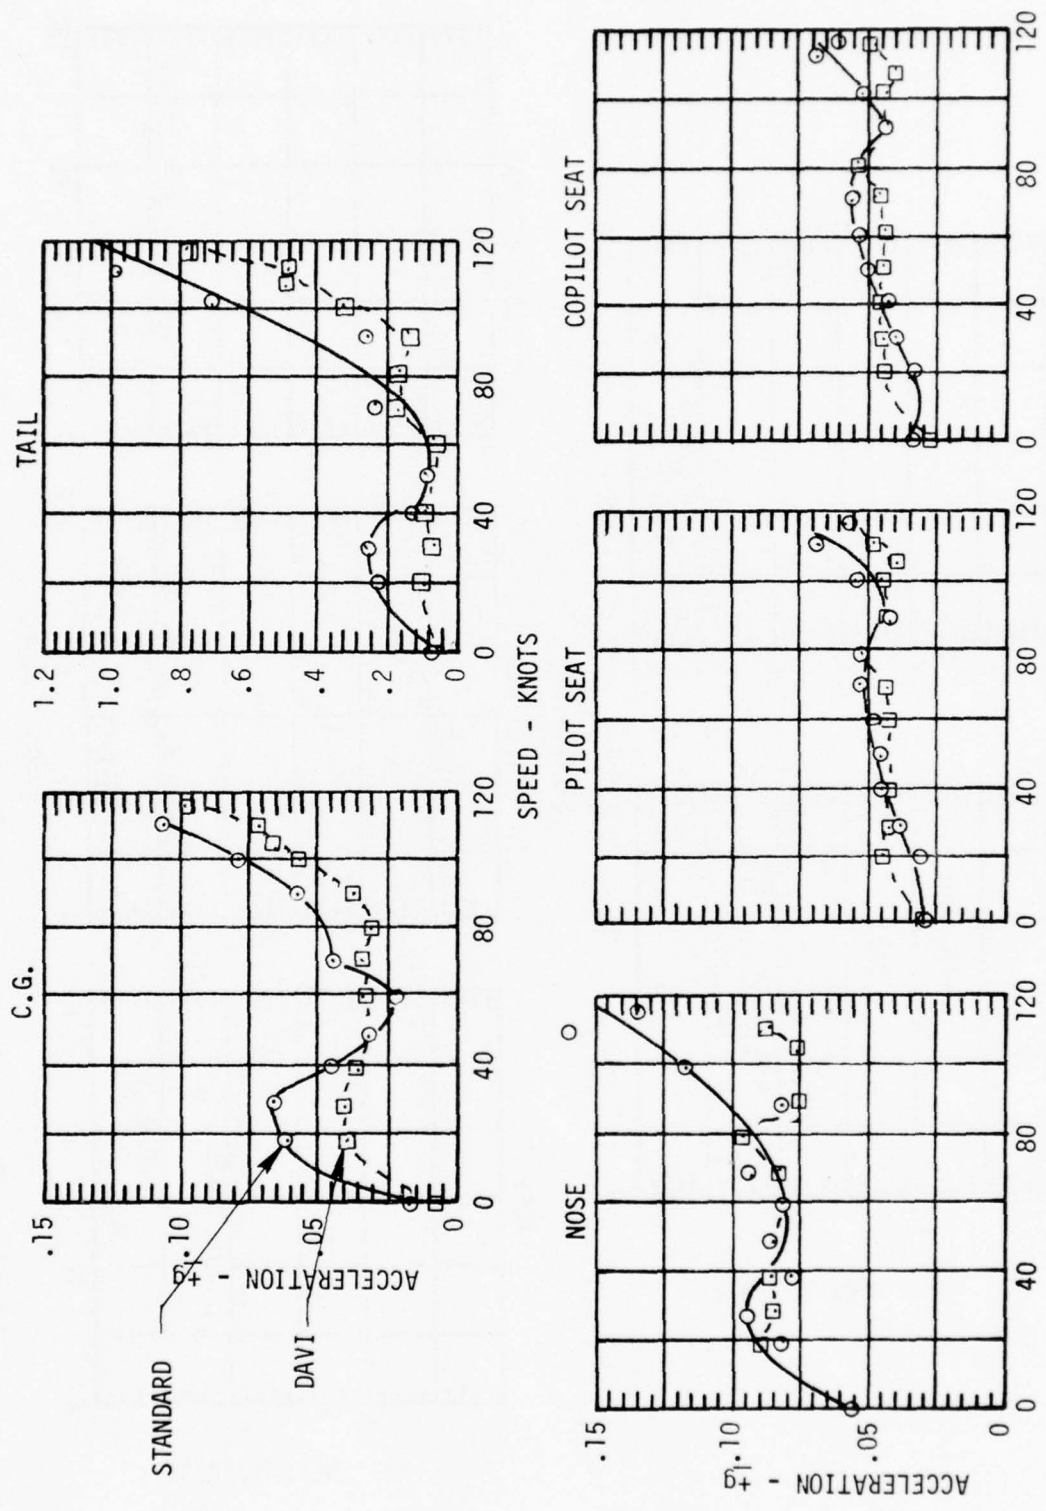
Figure 29. Two-Per-Rev Lateral Response of the 8250-Pound UH-1H Helicopter

It is seen from a comparison of Tables 5 and 6 with Figures 26, 27, 29, and 30, that for the straight and level flight conditions, the DAVI-modified vehicle had greater buildups in response in maneuvers than the standard vehicle. The average buildups for both gross weights and for the 50-knot and 90-knot turns for the standard vehicle were only 8 percent greater vertically and 27 percent greater laterally than the straight and level results at these speeds. For the same conditions, the average buildups for the DAVI-modified vehicle were 73 percent greater vertically and 116 percent greater laterally than the straight and level results at these speeds. The reason for the greater percentage buildups in the DAVI-modified vehicle is unknown. Possibly the nonlinearities in the spring

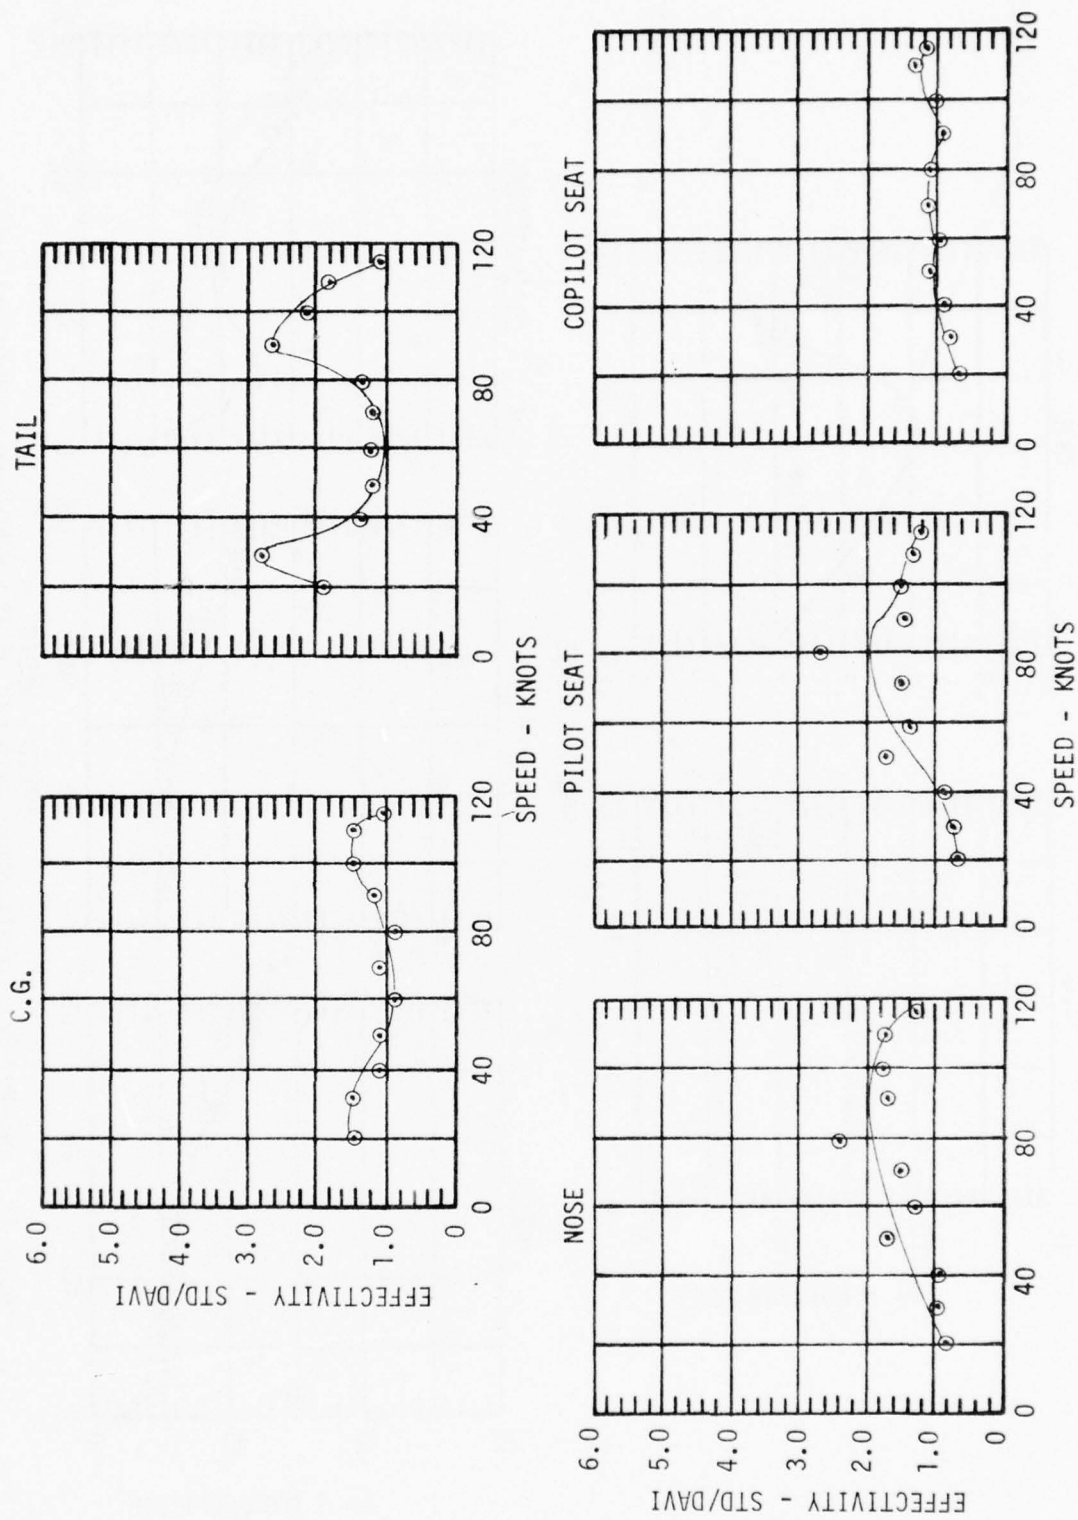
Figure 31. Two-Per-Rev Lateral Effectivity

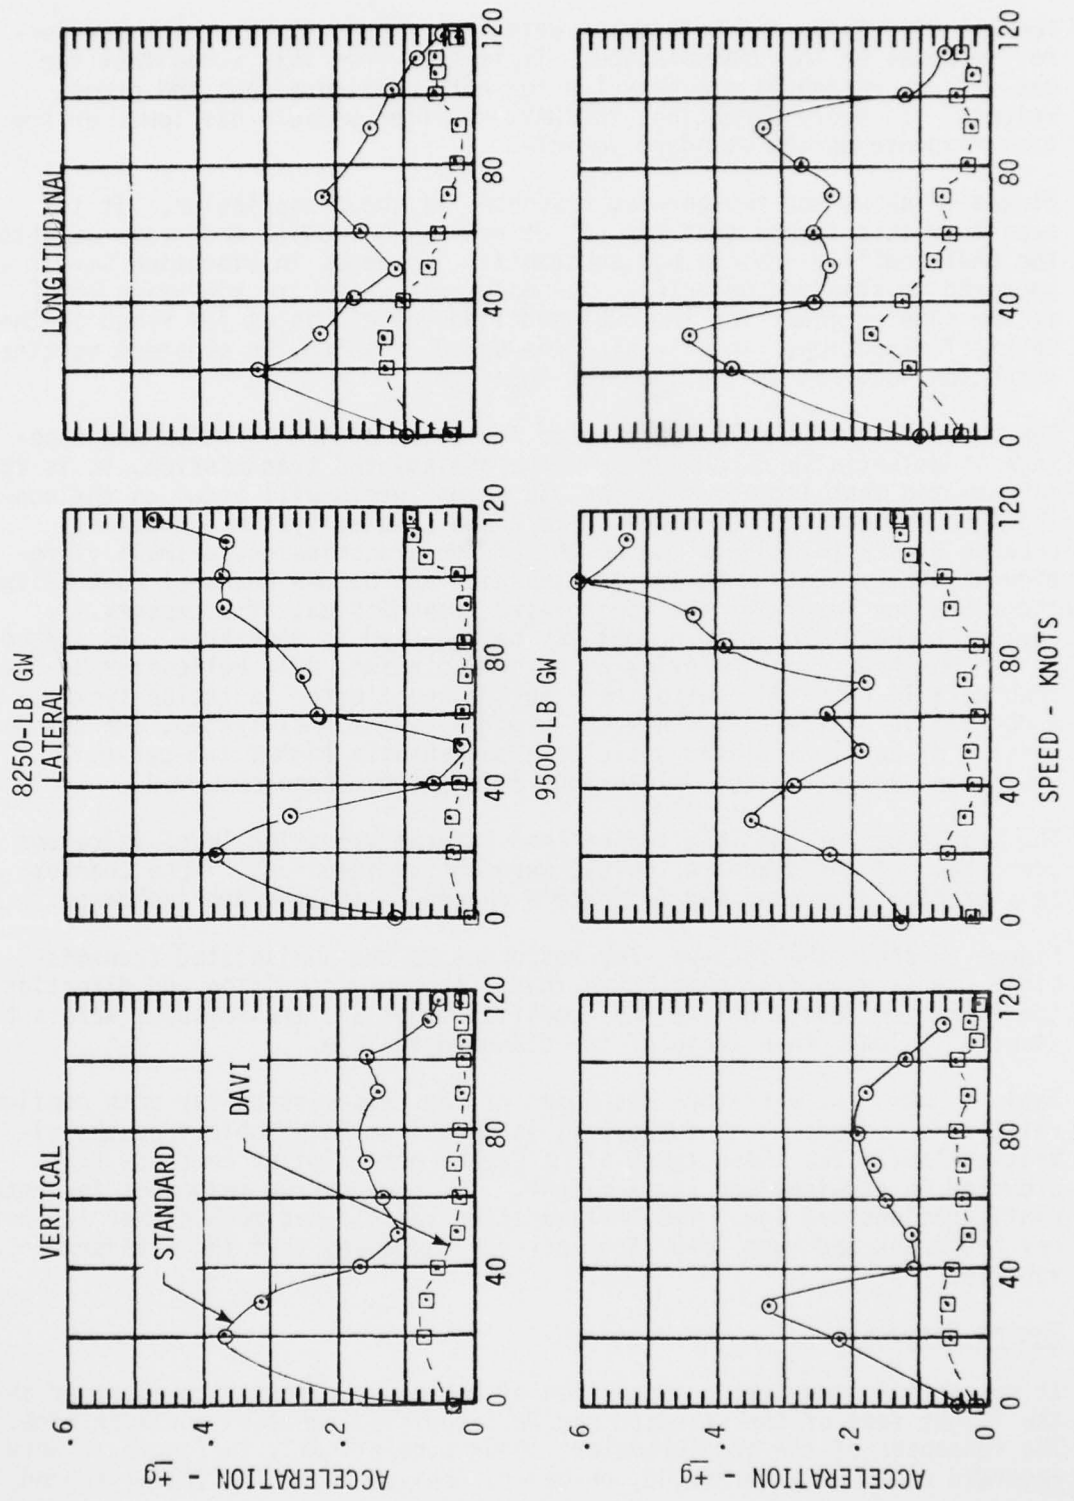
Figure 43. Four-Per-Rev Response of the Transmission

Figure 43 shows the four-per-rev responses of the nonisolated transmission. It is seen from this curve that, for every condition and direction, the vibration levels of the DAVI-modified vehicle's transmission were substantially lower than those of the standard vehicle.

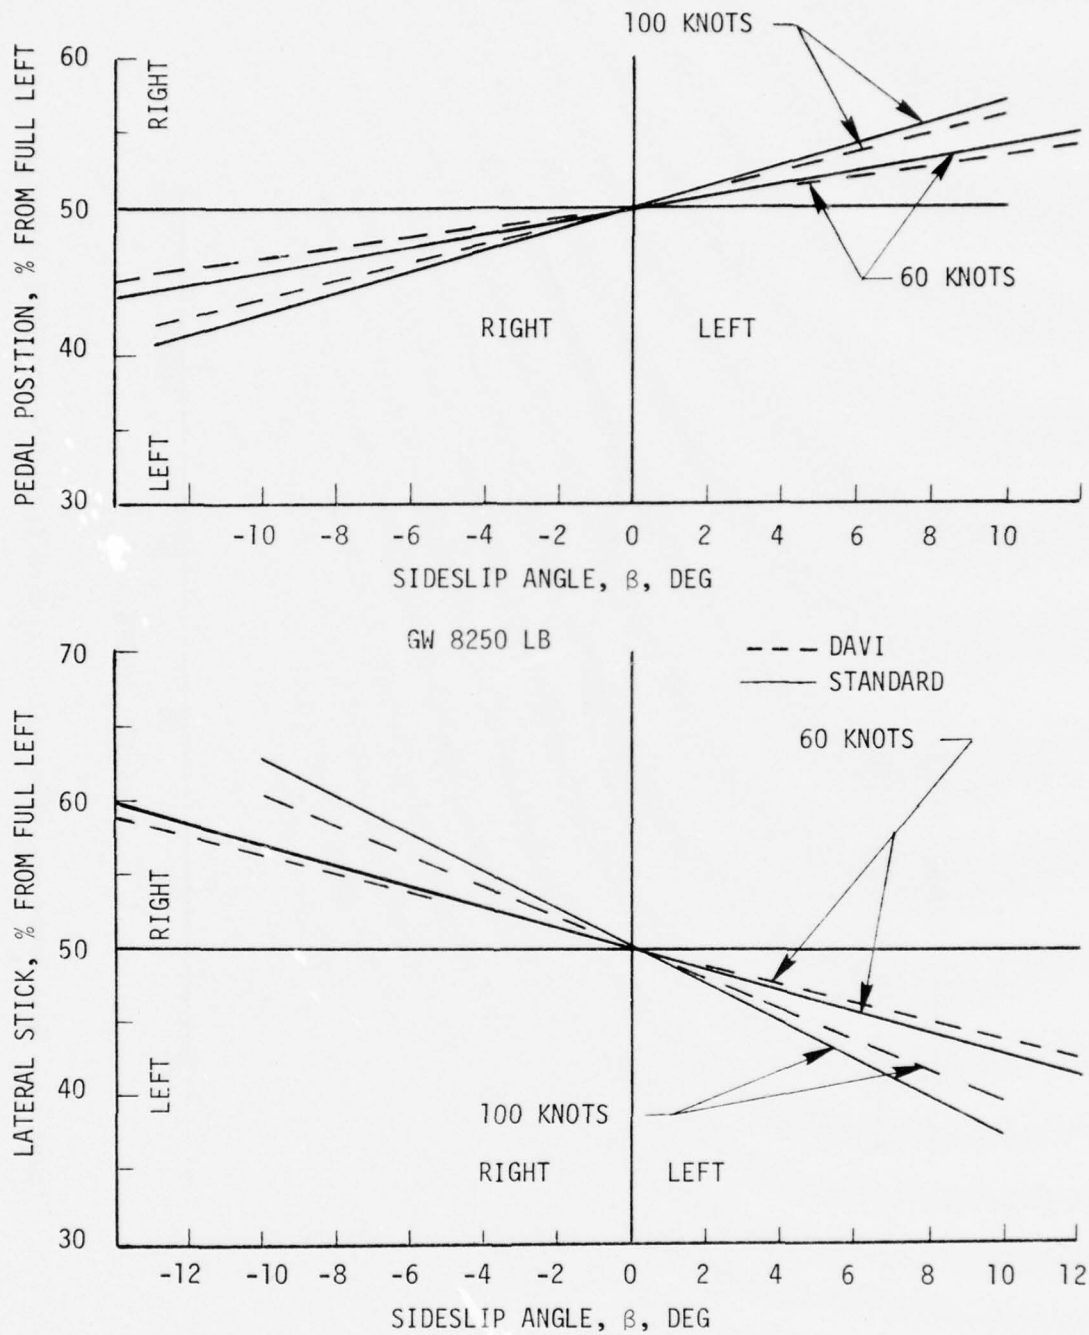
Figure 79. Effect of DAVI Isolation on UH-1H Steady Sideslip
