# Shoreline Plant Establishment and Use of a Wave-Stilling Device

by  
J.W. Webb and J.D. Dodd

MISCELLANEOUS REPORT NO. 78-1  
JANUARY 1978

Prepared for  
**U.S. ARMY, CORPS OF ENGINEERS  
COASTAL ENGINEERING  
RESEARCH CENTER**  
Kingman Building  
Fort Belvoir, Va. 22060

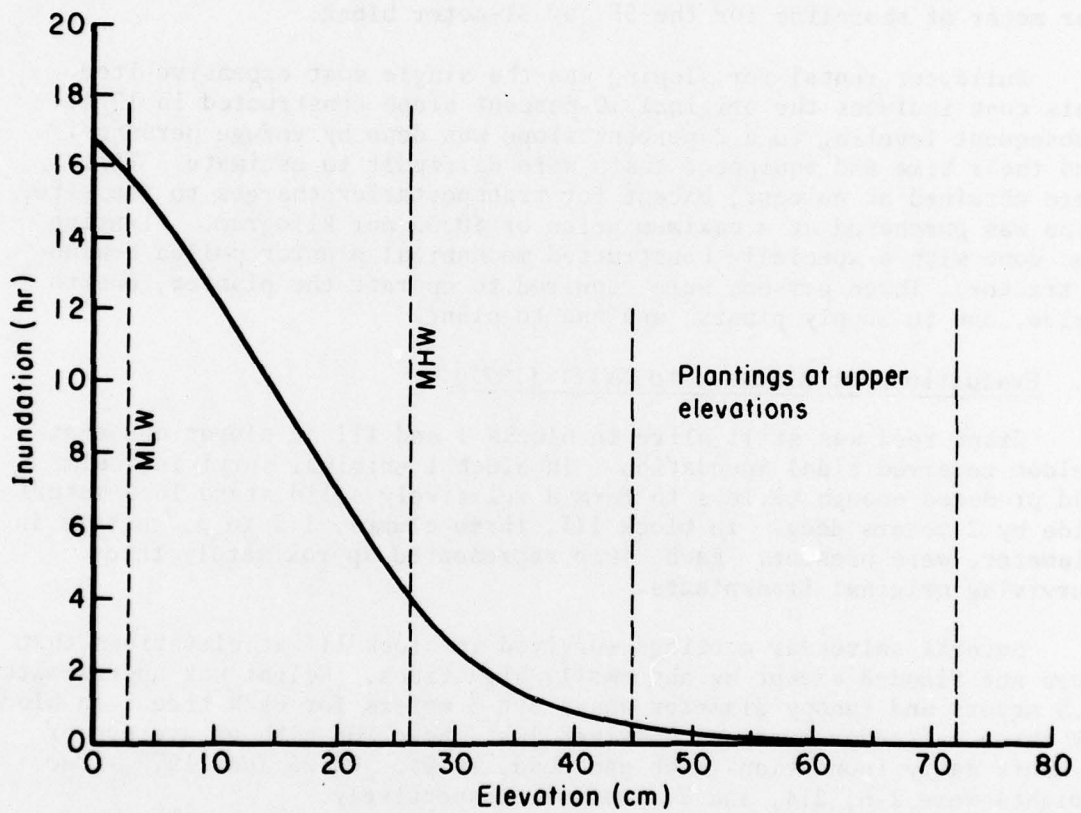
Figure 7. Mean daily hours of inundation in block XVII at each elevation from June 1976 to June 1977.

Inundation averaged less than 17 hours daily on any part of block XVII (Fig. 7). From June 1976 to June 1977, MHW was 27.5 centimeters. This represented a 15.3-centimeter decrease in MHW from 1976 to 1977.

Most of the difference was caused by the extreme low wintertides. The past winter (1976-77) was severe with many hours of strong north wind that pushed the tide out. MLW was 3.1 centimeters, the lowest planting elevation.

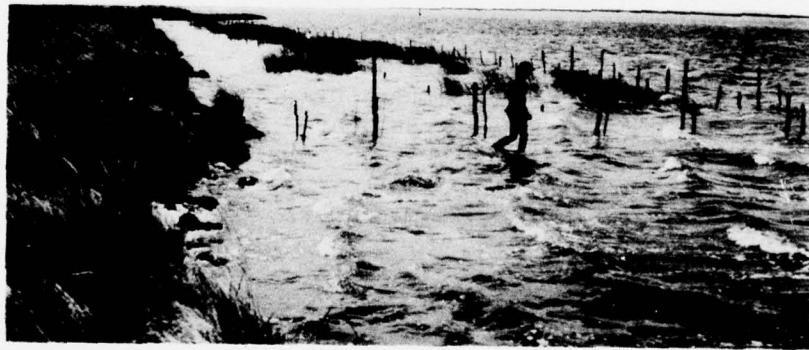
Figure 8. Growth of smooth cordgrass in block XI, 2.3 years after destruction of the wave-stilling device. Area in the foreground was the unprotected control area.

Block XI was originally protected in March 1975 with a wave-stilling device constructed of wire and hay bales; survival was only 8.9 percent in the protected areas (Webb and Dodd, 1976). Using the number of surviving transplants in October 1975 as a measure of survival, a range of 11 to 215 stems per surviving plant occurred in August 1976. By 23 June 1977 the number of stems had approximately tripled. The number of stems exceeded 1,000 per plot in several plots (Table 7, Fig. 8). It is possible that the hay deposited in the soil, or that the remaining fence modified soil parameters and wave action to allow growth and reproduction.
