RADAR STATION EVALUATION REPORT,  
Williams AFB, Arizona  
78/66R-115  
16-25 January 1978

RADAR STATION EVALUATION REPORT

Williams AFB, Arizona

78/66R-115

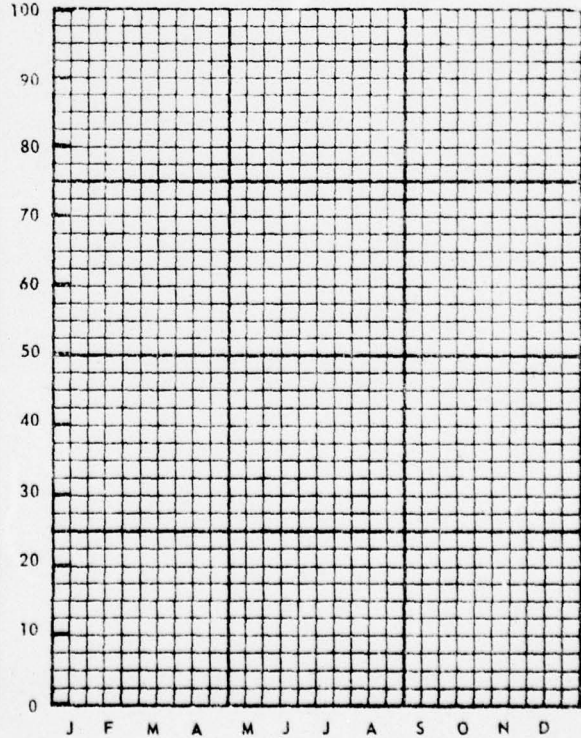
FREQUENCY OF REFRACTIVE CONDITIONS IN PERCENT

TRAPPING

SUPERREFRACTIVE

NORMAL

SUBREFRACTIVE

(d) Refractive Conditions: The chart "Frequency of Refractive Conditions in Percent" (see TAB G-2) is derived from summaries of atmospheric refractive index prepared by the USAF Environmental Technical Applications Center (AWS). It was computed for the nearest rawinsonde station considered to be representative of this site. The chart represents a count by month, over the period of record of three or more years, of the minimum gradient category in percent frequency of

occurrence. Only the one minimum gradient category in each upper air sounding has been counted. For this reason subrefraction is seldom shown on the chart, as more negative gradients will usually be found and counted. A discussion of refractive theory and a description of the refractive index categories and their corresponding gradients in N-units per 1000 feet is found in TABs G-1-1/2 and G-2.
