**STATIC AND DYNAMIC ANALYSIS OF CAST  
AND CAST CARCASS TIRES**

TECHNICAL REPORT AFFDL-TR-78-42  
Final Report for Period March 1974 - December 1975

AIR FORCE FLIGHT DYNAMICS LABORATORY  
AIR FORCE WRIGHT AERONAUTICAL LABORATORIES  
AIR FORCE SYSTEMS COMMAND  
WRIGHT-PATTERSON AIR FORCE BASE, OHIO 45433

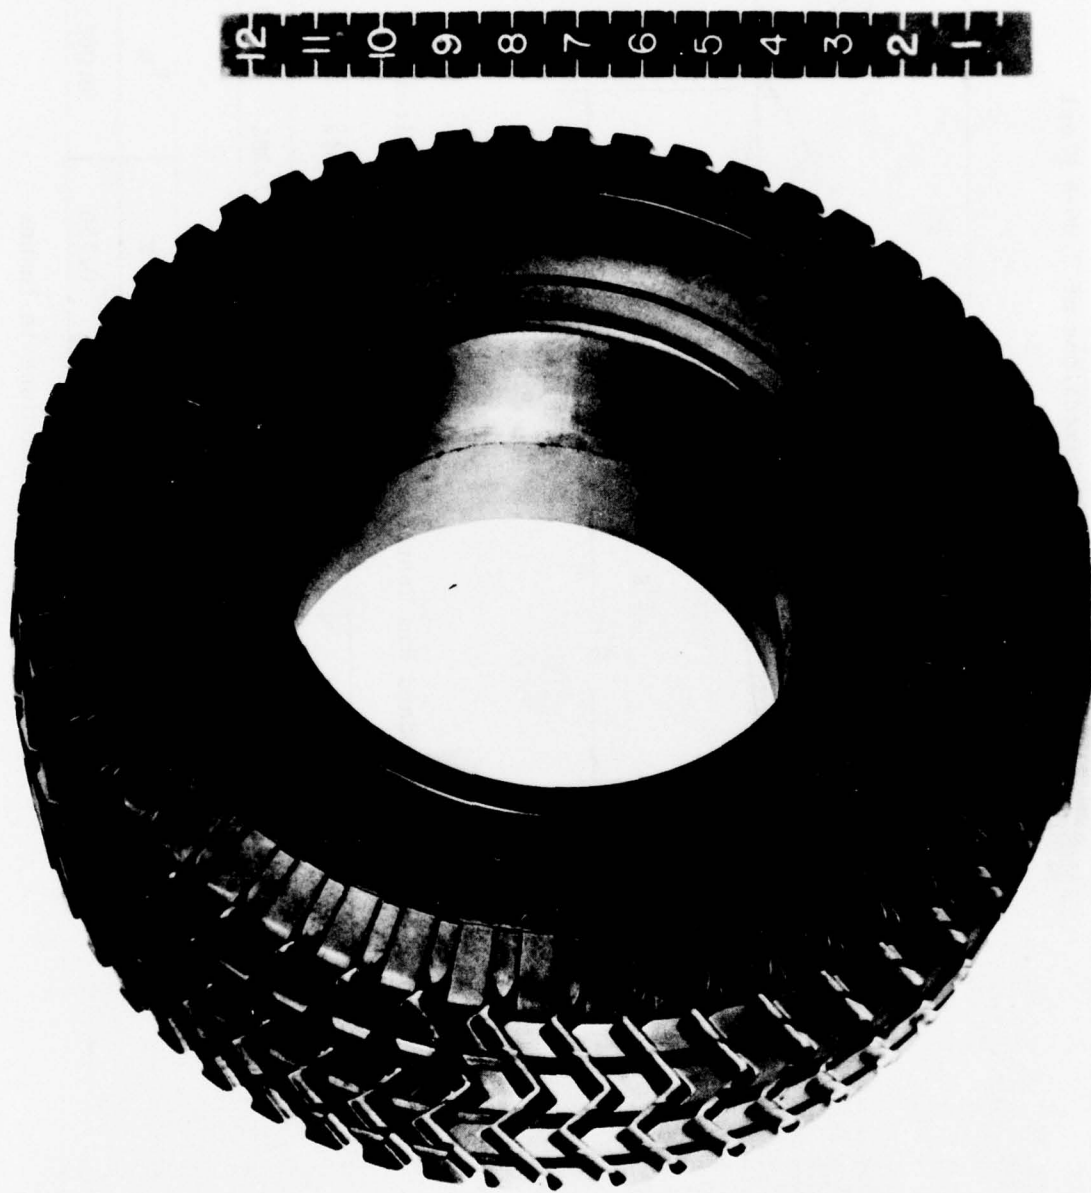
Figure 1 Cast 16 x 6.50-8 Turf Tread Tire

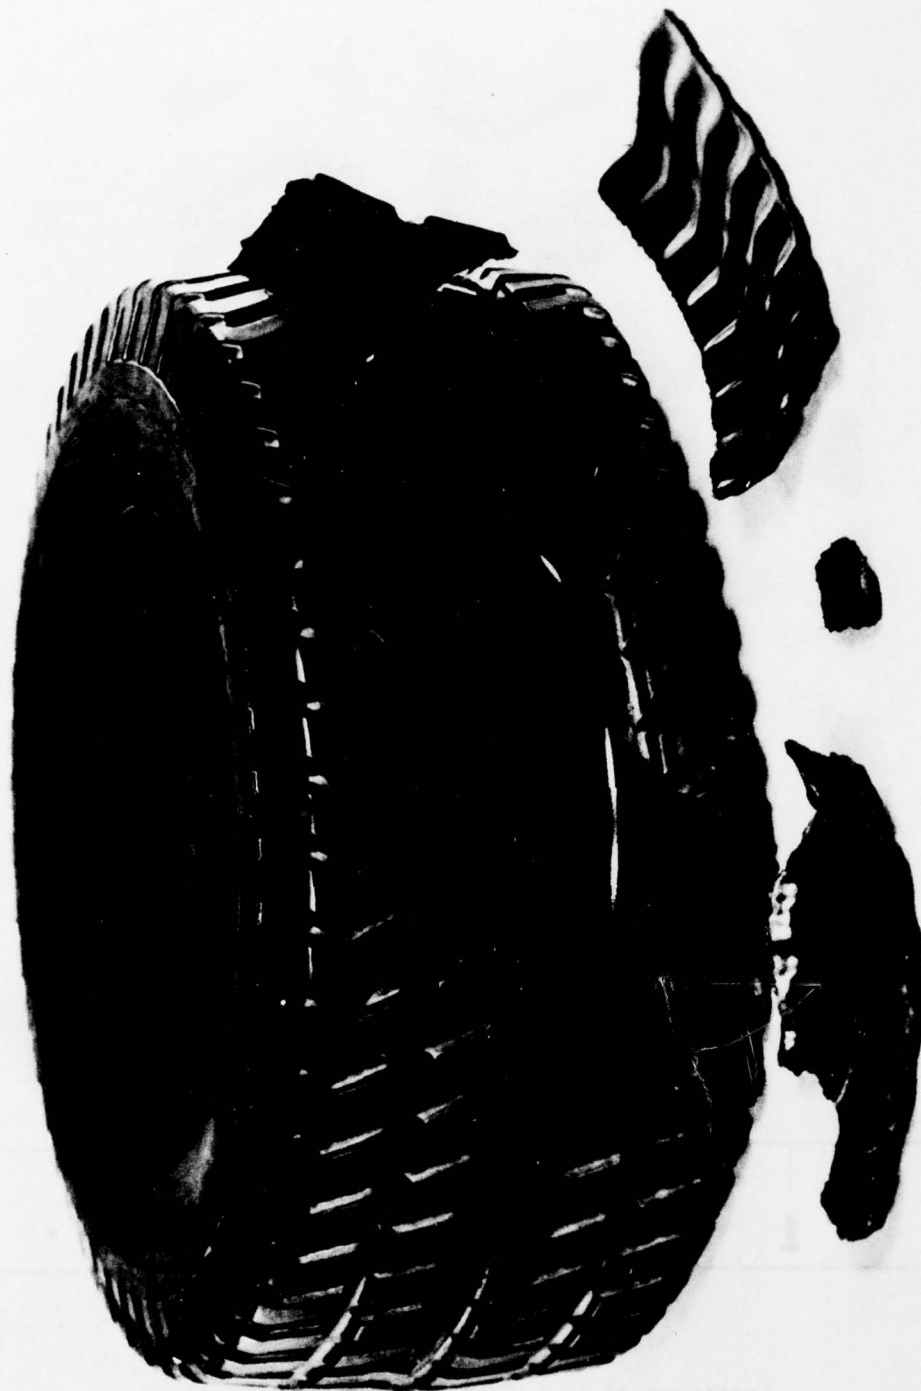
Figure 6 Dismounted 16 x 6.50-8 After Durability Failure

The test yielded three significant observations: 1) Transverse and circumferential stretch occurred between the tread lugs near the area of failure, which indicates that the material exceeded its elastic limit; 2) The two middle tread rows wore more than the two outer (shoulder) tread rows, as the footprint of Figure 3 would justify, with an apparent heel to toe wear pattern (i.e., the leading edge of the tread lugs wore more than the trailing edge); and 3) After traveling 65 miles up to speed of 140 miles per hour without any blowers for cooling, the tire exhibited only a small increase in temperature (i.e., it was moderately warm to the hand immediately after failure). Figure 4 shows a photograph of the tire during the durability test; Figure 5 and Figure 6 show the tire after failure

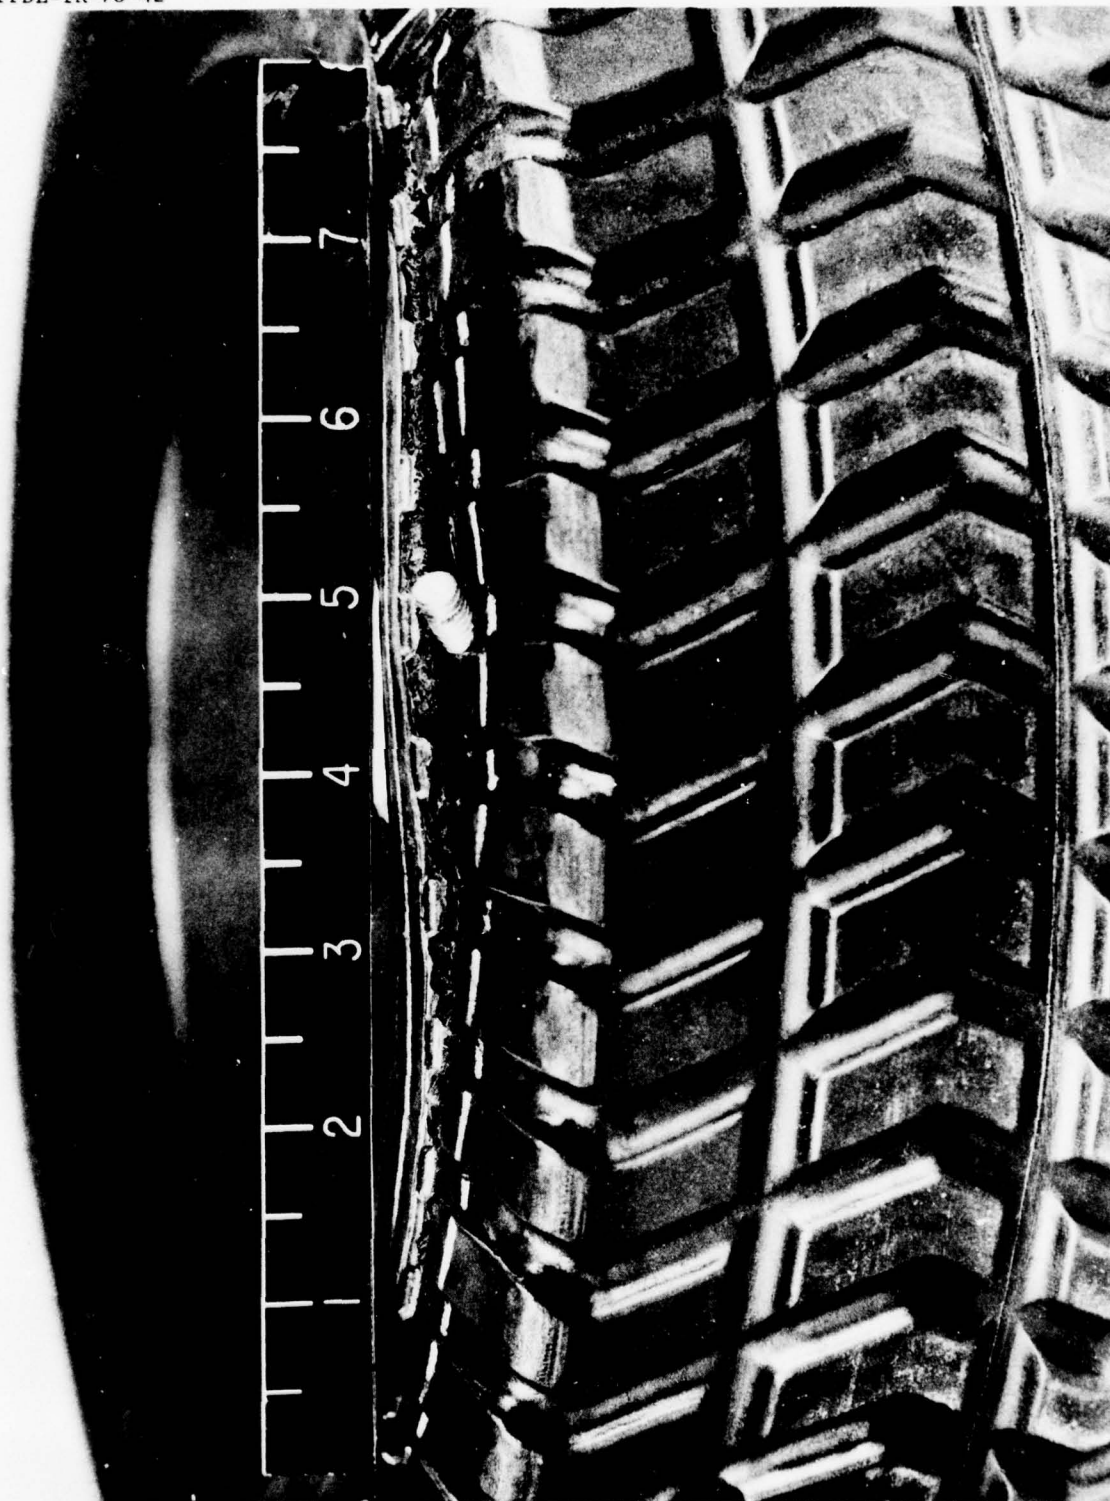
Figure 9 Close-up of 16 x 6.50-8  
After Taxi-Takeoff Failure

The 16 x 6.50-8 tire failed after rolling .9 miles of the thirty mile per hour taxi. The outboard shoulder separated from the tread. A footprint of the tire at its test condition of 907 pounds load and 14 psi inflation pressure is shown in Figure 7, while Figures 8 and 9 contain photographs of the tire after the failure occurred.

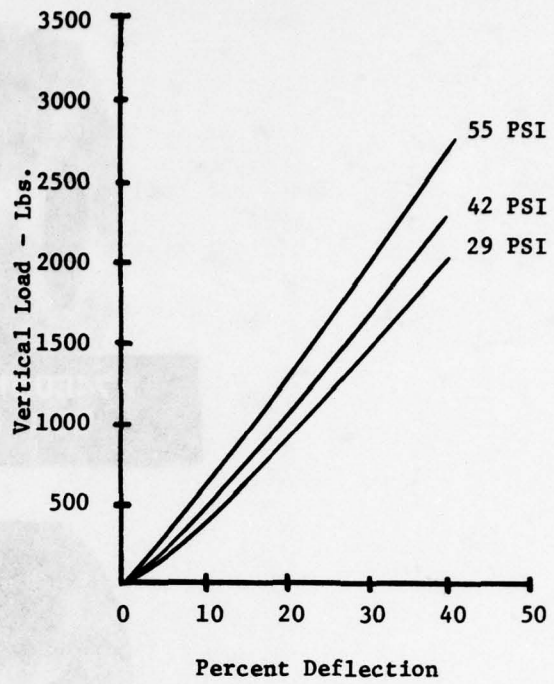
Figure 23 Load vs. Deflection of Cast Tires of 74E001

of inflation pressure, nor any difference in the vertical load vs. vertical deflection data. Therefore, Figures 21 and 23 are representative of the behavior of tires of design 74E001A. Burst tests also were not significantly affected, in that burst failures occurred in the vicinity of 220 psi inflation pressure. In addition, static data of tire designs 74E001 and 74E001A did not change as a result of changing the tread design from circumferential grooves to one of circumferential and lateral grooves. Therefore, the static data shown in Figures 21 and 23 apply to tires of design 74E001 and 74E001A with either the circumferential or the circumferential and lateral grooved tread design.

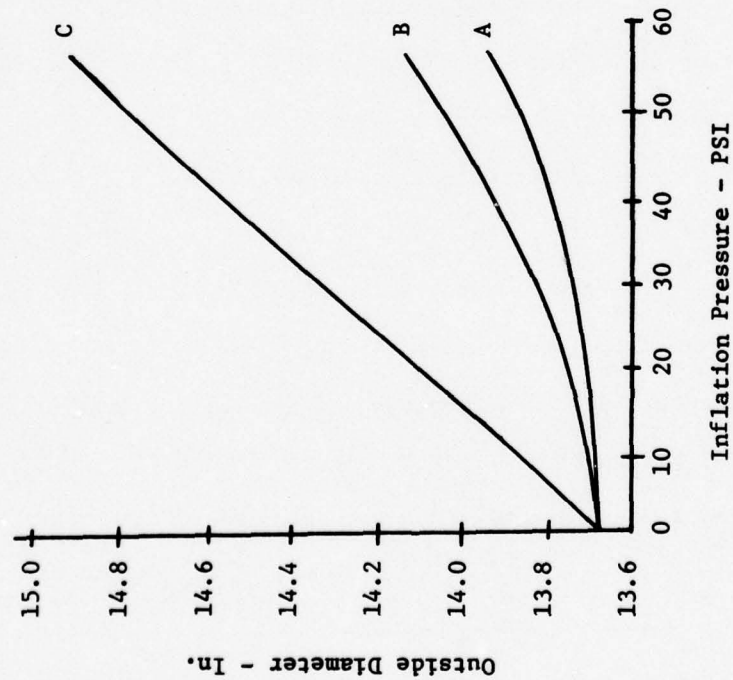
Tire A: Hytrel 55D - 2000 gms.  
Tire B: Hytrel 55D - 1500 gms.  
Tire C: Hytrel 40D - 2600 gms.

Figure 26 Static Measurements of Cast Tires of Design 74E002

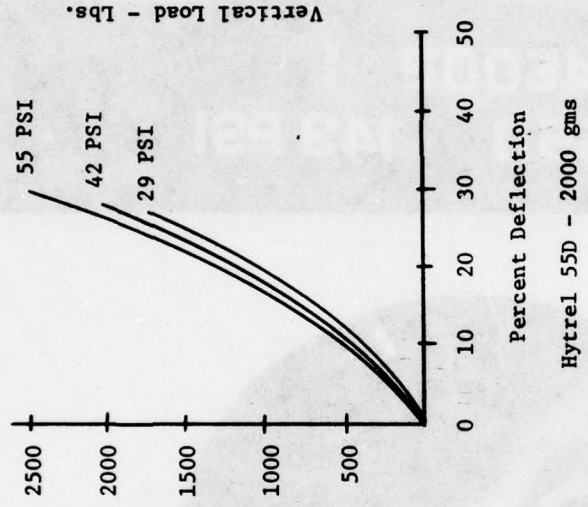
Figure 28 Load vs. Deflection of Cast Tires of Design 74E002

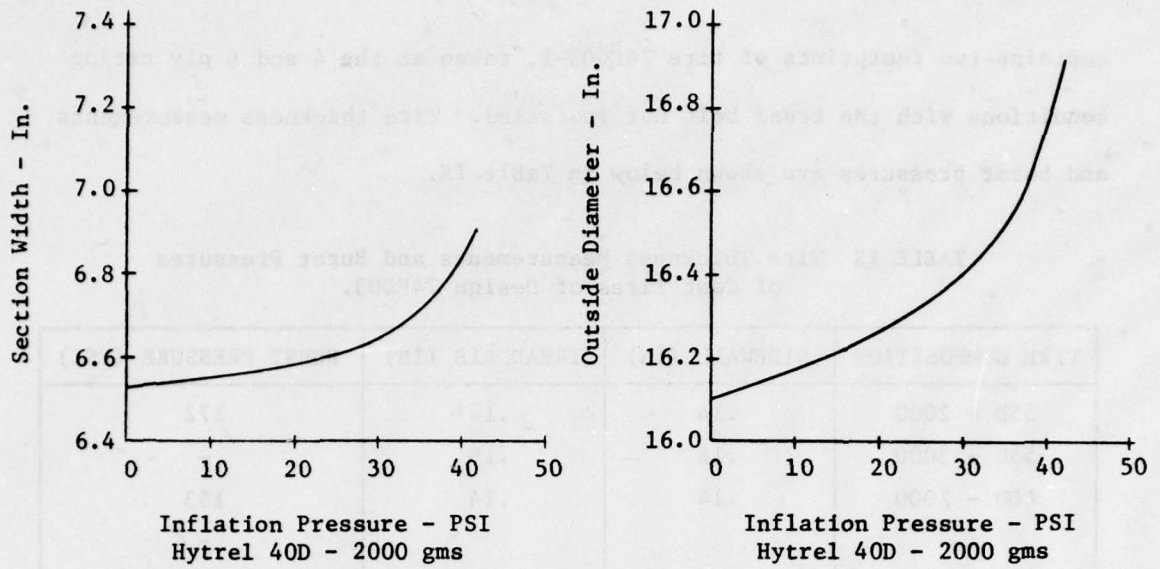
Figure 29 Static Measurements of Cast Tires of Design 74E003

All static dimensional measurements of design 74E003 (Cast Carcass/Replaceable Tread Tire) were taken with the tread belt installed. Burst tests and tire footprint measurements were taken without the tread belt installed. The tire section width and outside diameter as a function of inflation pressure is presented in Figure 29 for a tire composed of 2000 grams of 40D material. The vertical load vs deflection data for the same tire is presented in Figure 30 at three inflation pressures. Figure 31 depicts burst failures for tires 74E003-14 and 74E003-33 and specifies the material hardness and the internal pressure at which failure occurred. The appendix

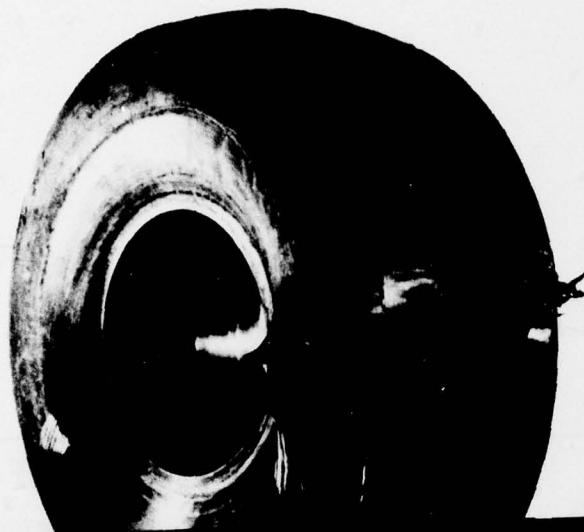
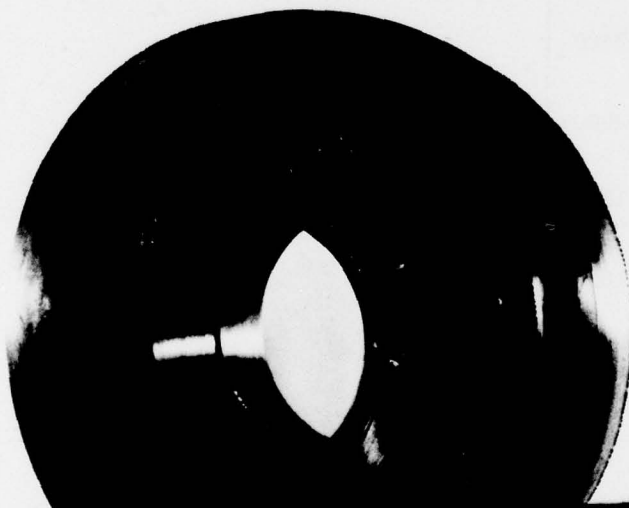
**74E003 14**  
**55D 172 PSI**

**74E003 33**  
**40D 153 PSI**

Figure 31 Burst Failures of Cast Tires of Design 74E003

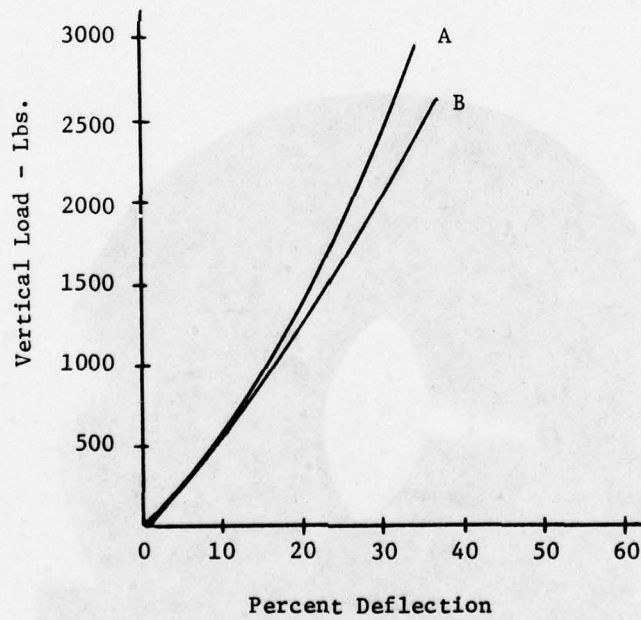
Tire A: Hytrel 40D-4000 gms, 55 PSI

Tire B: Hytrel 55D-3000 gms, 55 PSI

After the tread belt was installed and the tire inflated, a gap existed at the belt edge between the tread belt and carcass. During the dynamic testing of this design, the insufficient amount of interference between the belt and carcass resulted in lateral belt slippage. Therefore, a modification was made to decrease the shoulder radius of the cast carcass to achieve a better interference fit. This design change was designated as 74E003A. Static measurements and vertical load vs deflection curves for 40D/4000 gram tires and 55D/3000 gram tires of design 74E003A are shown in Figures 32 and 33, respectively.

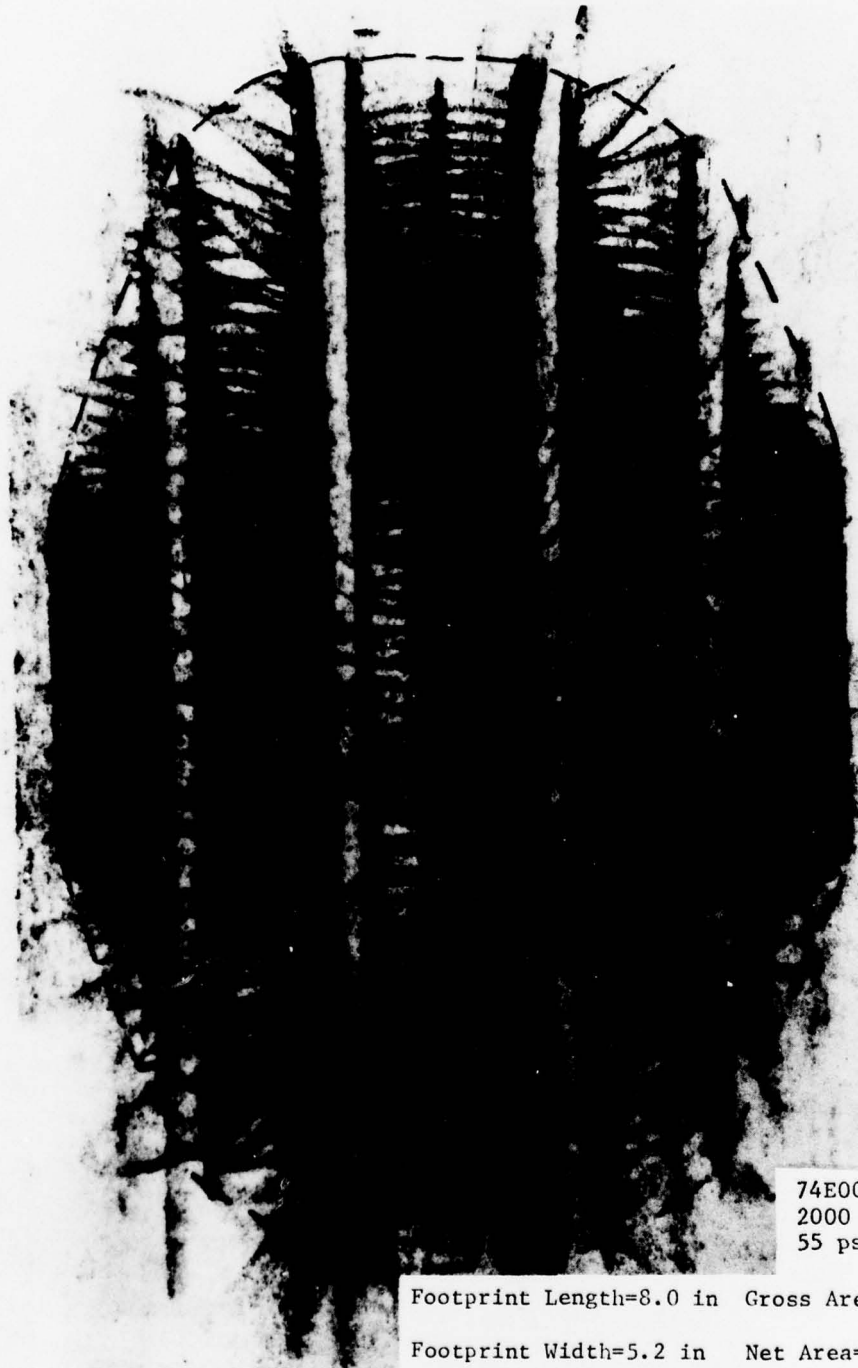
74E001-4  
2000 gms, 55D  
55 psi, 2350 lbs

Footprint Length=8.0 in Gross Area 30.9 sq in

Footprint Width=5.2 in Net Area=24.3 sq in

Footprints of the cast tires are shown in the Appendix. These footprints are from ten tires of various material hardness and amounts of material, and are obtained at either the four, six or eight ply rated conditions. For reference, Table III shows the three rated conditions for the 6.00-6 tires as prescribed by the 1974 Tire and Rim Association Yearbook.

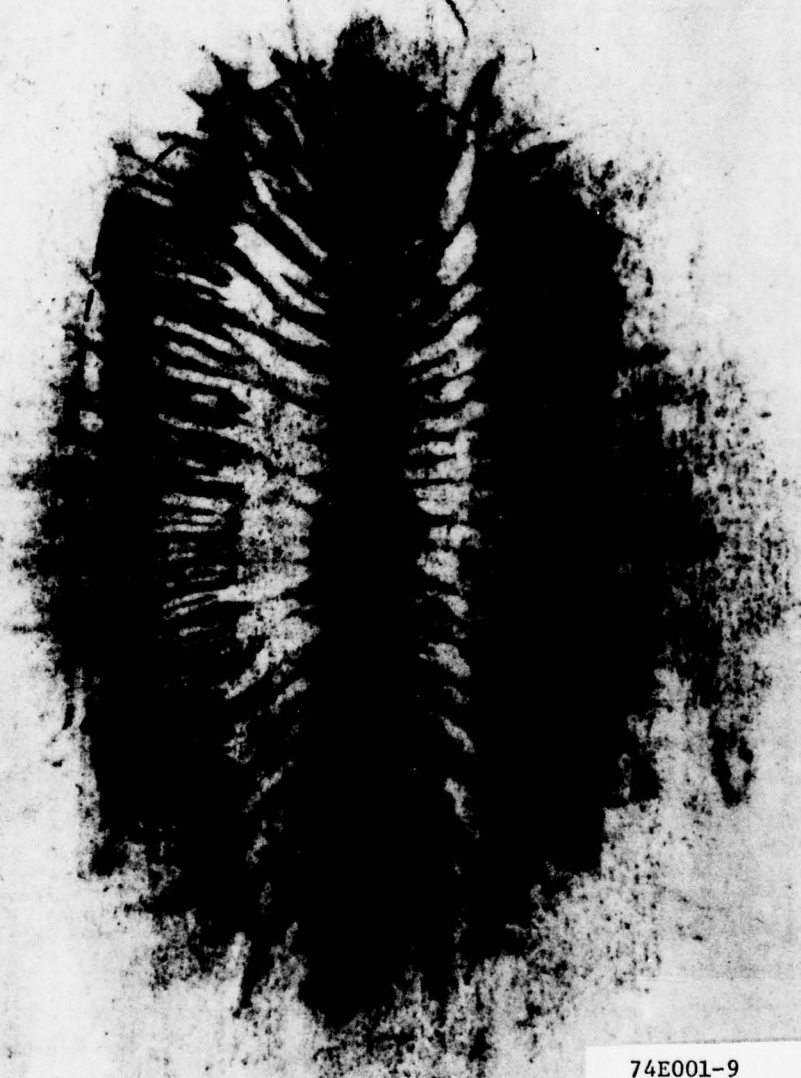
74E001-9  
3000 gms, 55D  
29 psi, 1150 lbs

Footprint Length=5.9 in Gross Area=20.1 sq in
