⑥ DIFFUSION AND TRANSFORMATION MICROMECHANISMS FOR SUPPRESSION OF  
DAMAGE AND FAILURE IN HIGH-STRAIN RATE DEFORMATION

⑩ V. A. Greenhut

⑨ Final Technical Report, 27 Jun 76-37  
Aug 77

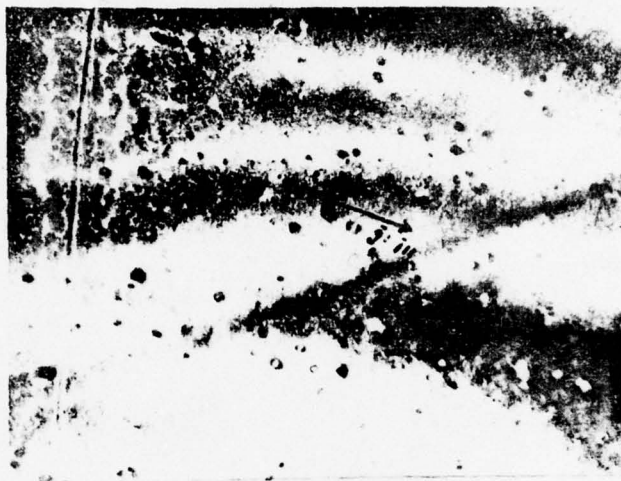
Fig. 7. Bright-field image of Al-Zn after solution heat treatment. Zone axis [110]. Mag. 50,000. Dislocation loops and G.P. zones (35 A) are seen.

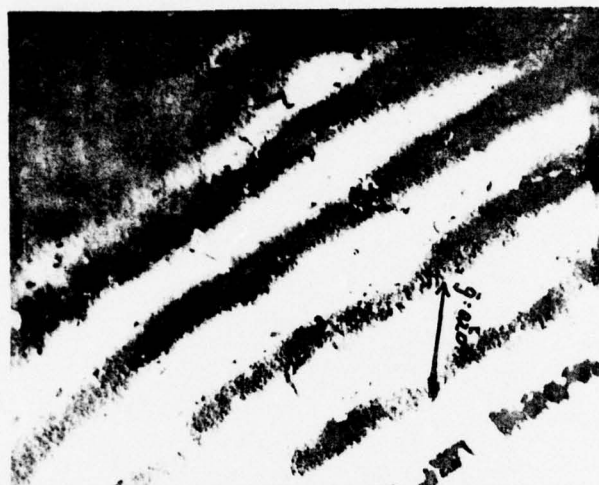
Fig. 9a. Al-Zn specimen after ageing at 100°C for 7 days. Zone axis [100]. G.P. zones appear to have grown to about 120 Å. Also seen are larger Zn particles. Mag. 15,000.

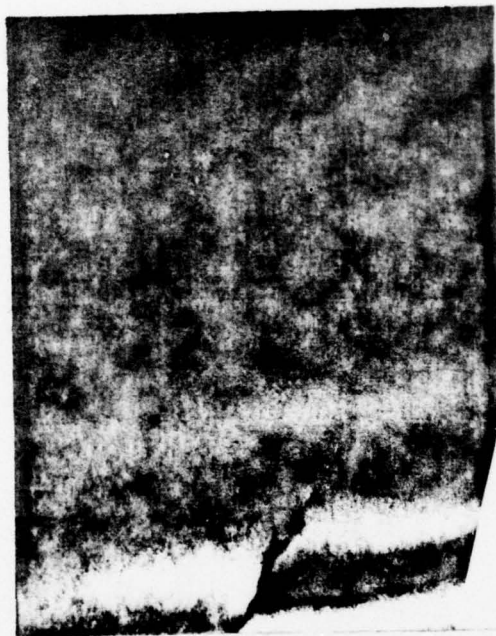
Fig. 10. Bright-field image of Al-Zn-Si specimen after solution heat treatment. Zone axis [110]. Mag. 50,000. G.P. zones of size 40 A can be seen.

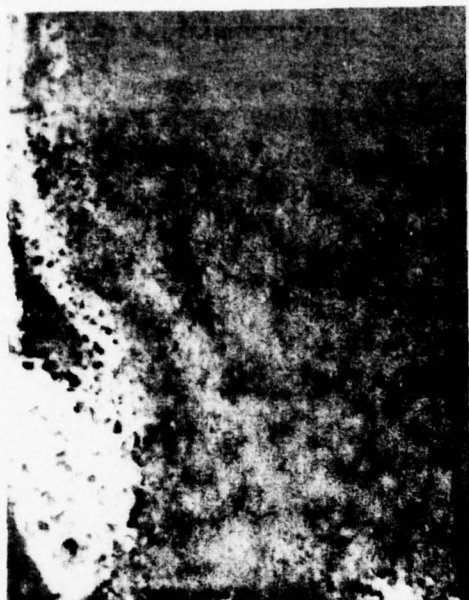
Fig. 11. Bright-field (11a) and dark-field (11b) images of Al-Zn-Si after 3-min treatment at 300°C. Grain boundary region (110) showing P.F.Z.

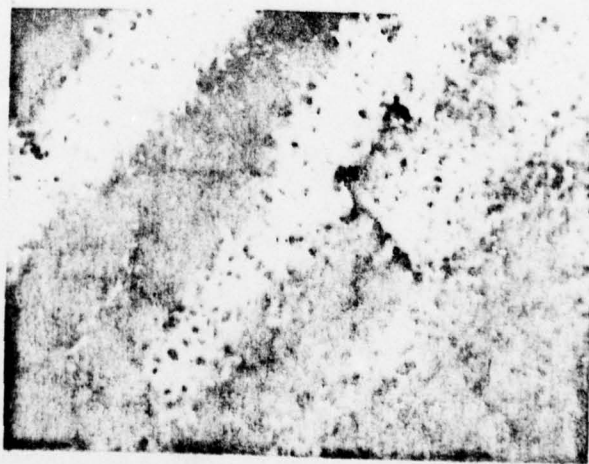
Fig. 13. Bright-field image of Al-Zn-Si after 24 hours at 100°C. Zone axis [211]. Mag. 50,000.

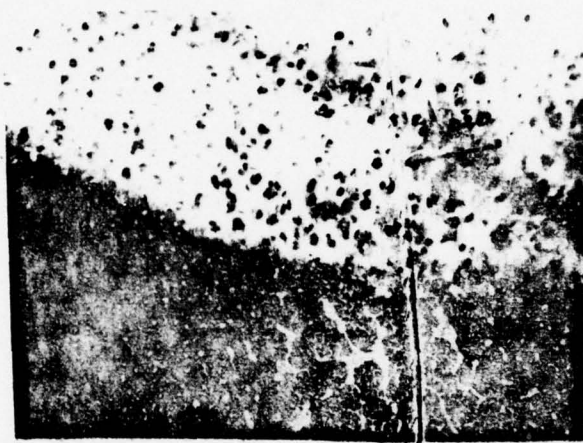
Fig. 15a. Bright-field image of Al-Si alloy after 7 days' ageing at 100°C. Zone axis [211]. Mag. 50,000.

Al-Si alloys were examined for ageing times of 1 hr to 7 days at 100°C. These specimens showed incoherent platelike precipitates. After 7 days' ageing, the structure was as shown in Fig. 15. The diffraction patterns showed a complex pattern of additional spots (Fig. 15b). Three rings could be identified as coming from (111), (220), and (311) planes.

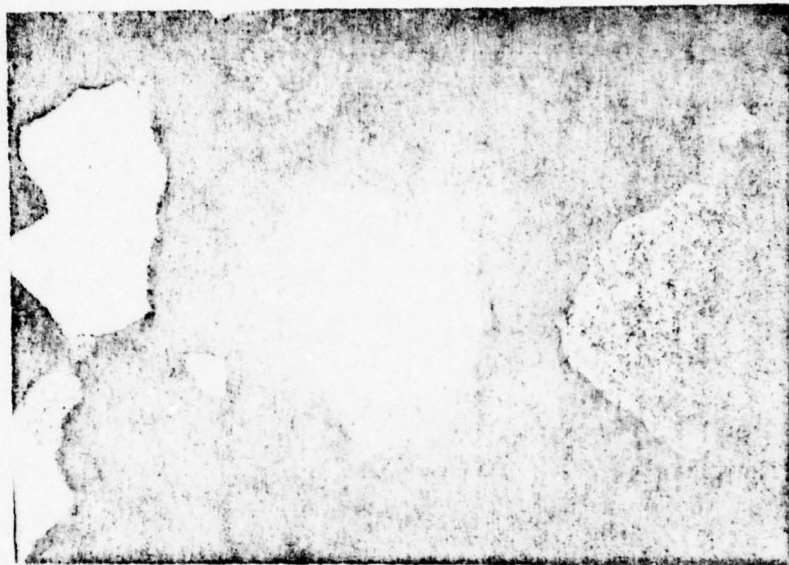
Fig. 16a. Optical micrograph of solution heat-treated Al-Zn showing the grain size (850  $\mu$ ). Mag. 20.

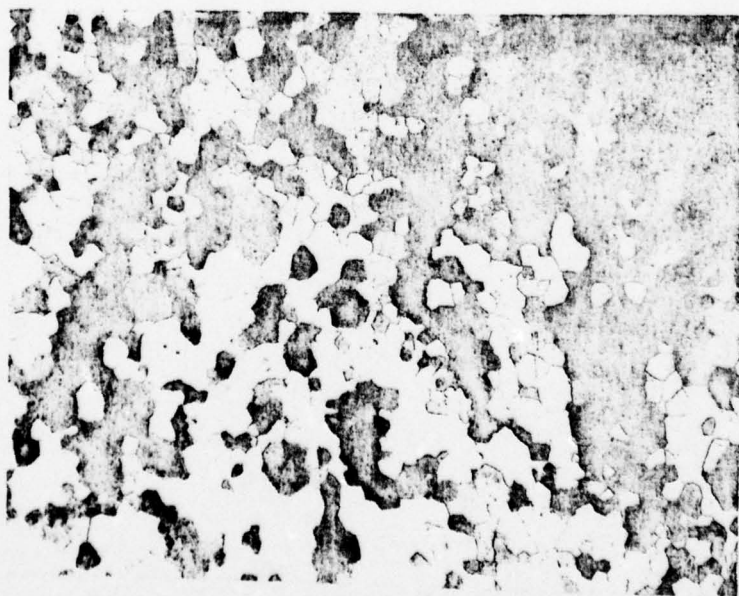
Fig. 16b. Optical micrograph of solution heat-treated Al-Zn-Si showing the grain size (150  $\mu$ ). Mag. 20.

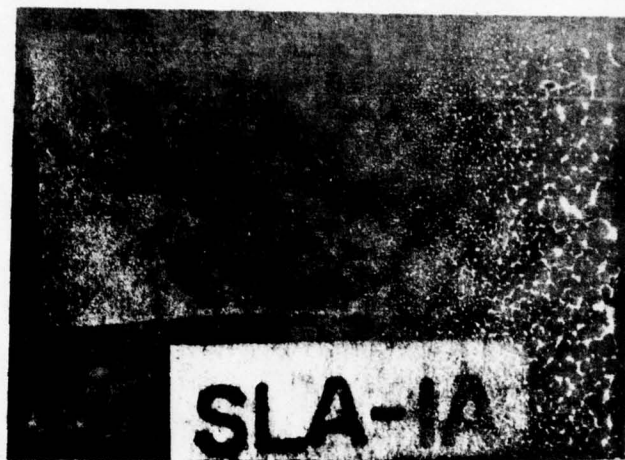
Fig. 17. Macrographs of sections of room-temperature-aged  
and shock-loaded aluminum alloys.

Figures 17a, b, and c show macrographs of sections of the three alloys which were aged at room temperature and then shock-loaded. It can be seen that the least damage occurred in the Al-Zn-Si alloy (SLA-1A) and the maximum in the Al-Si alloy (SLC-1A). Figure 18 is a plot of the specimen diameter at different positions from the loaded end. The relative necking was a maximum for Al-Si, and for each case the minimum in diameter occurred near the region of maximum damage.

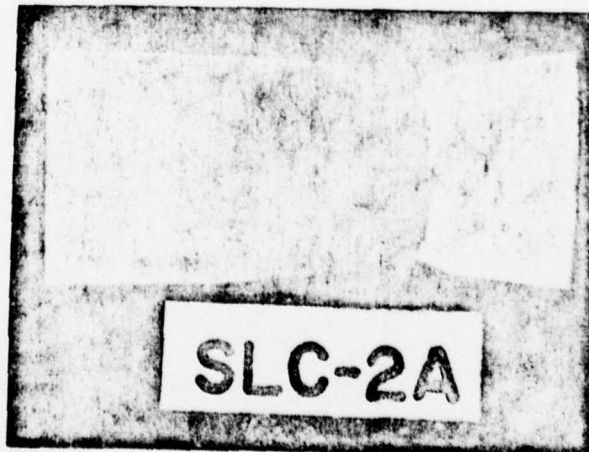
Fig.19. Macrographs of sections of aluminum alloys shock-loaded  
after ageing at 100°C for 24 hr.

Figures 19a, b, and c are macrographs of Al-Zn-Si, Al-Zn, and Al-Si which were shocked after an ageing treatment at 100°C for 24 hr. Al-Si showed a complete spall, and the least damage was found in the Al-Zn-Si alloy. Figure 20 is a plot of the change in specimen diameter vs distance. Comparison of the shock damage of the same alloy at two different heat treatments showed that in the case of Al-Zn-Si and Al-Zn, greater damage occurred for the specimens aged at room temperature. For Al-Si the shock damage was greater (complete spall) when aged at 100°C for 24 hr before shock loading.

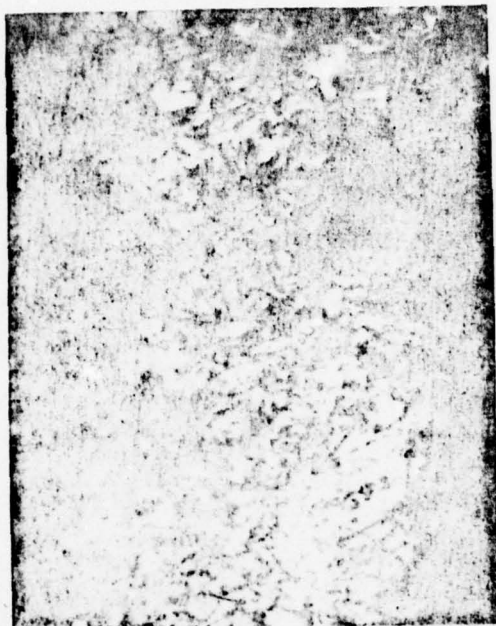
Fig. 25. Planar dislocation substructure in shock-loaded Al-Zn-Si alloy. Mag. 35,000.

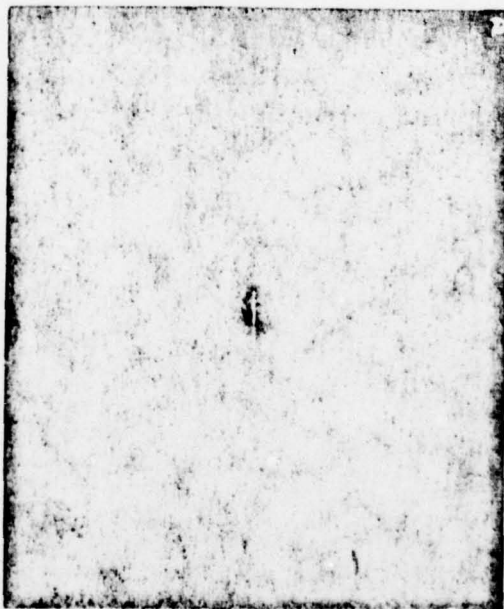
Fig. 26. Dark-field image of shock-loaded Al-Zn-Si (SLA-2A #6). Foil normal is [100]. Mag. 50,000.

the TEM specimen is from near the top end. Several dislocation loops and precipitates can be seen.

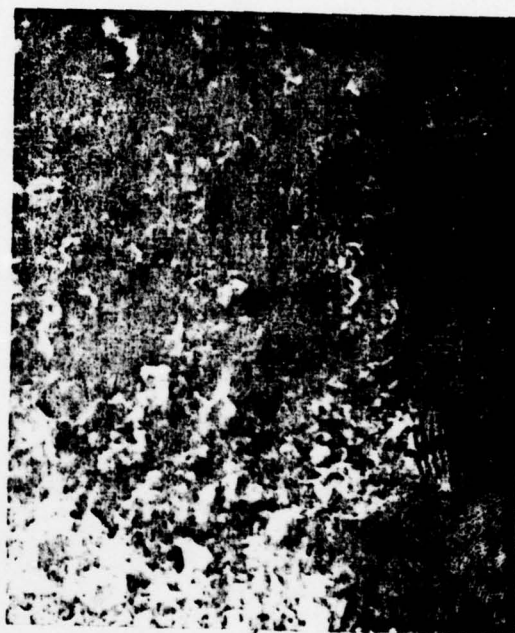
Fig. 27. Bright-field (a) and dark-field (b) image of Al-Zn-Si alloy after shock loading (SIA-2A #2) showing dislocations, precipitates and a grain boundary. Mag. 35,000.

Figures 27a and b are a dark- and bright-field pair showing the dislocation structure and precipitates in SLA-2A No. 2 from a region near the loaded end. The precipitates were found to be about 200 Å. Some dislocation loops can also be seen. Smaller loops gave contrast effects similar to the precipitates. Figures 28a and b are a pair of electron micrographs of SLA-2A No. 12 specimen 0.95 cm from the loaded end. The foil normal was  $[110]$  and the  $(002)$  matrix spot was deflected to obtain the dark-field image.

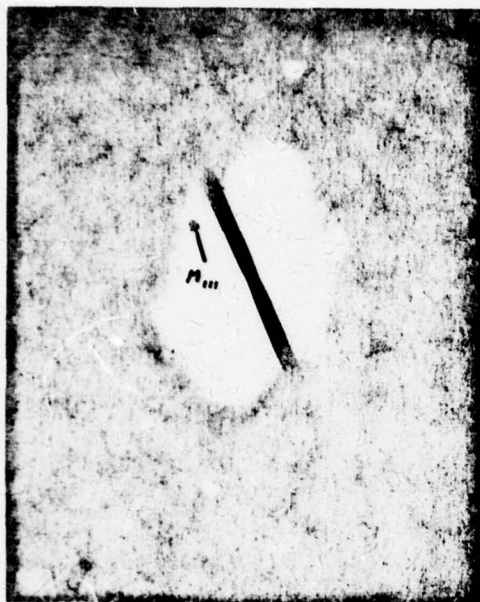
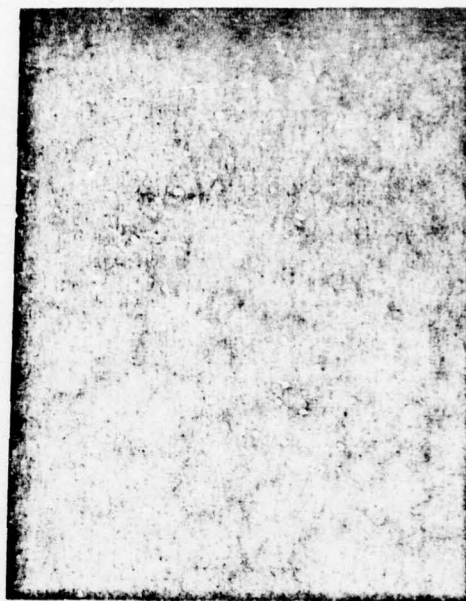
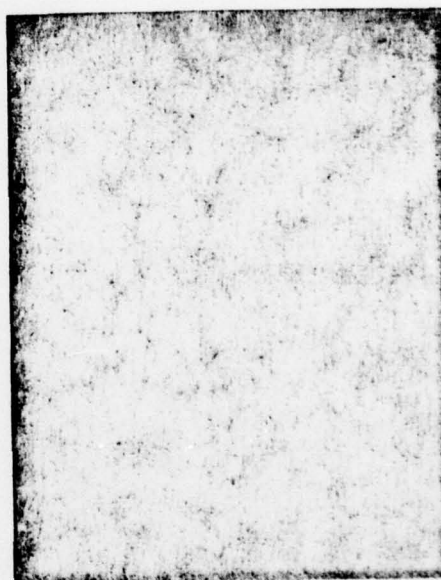
Fig. 31. (a) Selected-area diffraction pattern from shock-loaded Al-Zn specimen (SLB-1A #34); (b) dark-field image obtained when all the spots near the (111) matrix spot were used; (c) dark-field image when spot 1 was used; (d) dark-field image when spot 2 was used. Mag. 15,000.

Figure 31a is a selected-area diffraction pattern from an Al-Zn specimen (SLB-1A No. 34) 2.8 cm from the top end. Near the (111) matrix spot, three additional spots can be seen. Figure 31b is a dark-field image obtained when all the spots were used. The micrograph shows a distribution of large and small precipitates. When spot 1 was used, only the larger precipitates were seen (Fig. 31c). Their mean size is about 460 Å. When spot 2 was used to get the dark-field image, only the smaller precipitates were seen (Fig. 31d). This effect is not yet fully understood.
