Report No: C-118 WSM 1-78

⑥ EVALUATION OF A COMMERCIAL OMEGA
NAVIGATION SYSTEM INSTALLED IN
THE C-118 AIRCRAFT,

EVALUATION OF A COMMERCIAL OMEGA NAVIGATION SYSTEM
INSTALLED IN THE C-118 AIRCRAFT

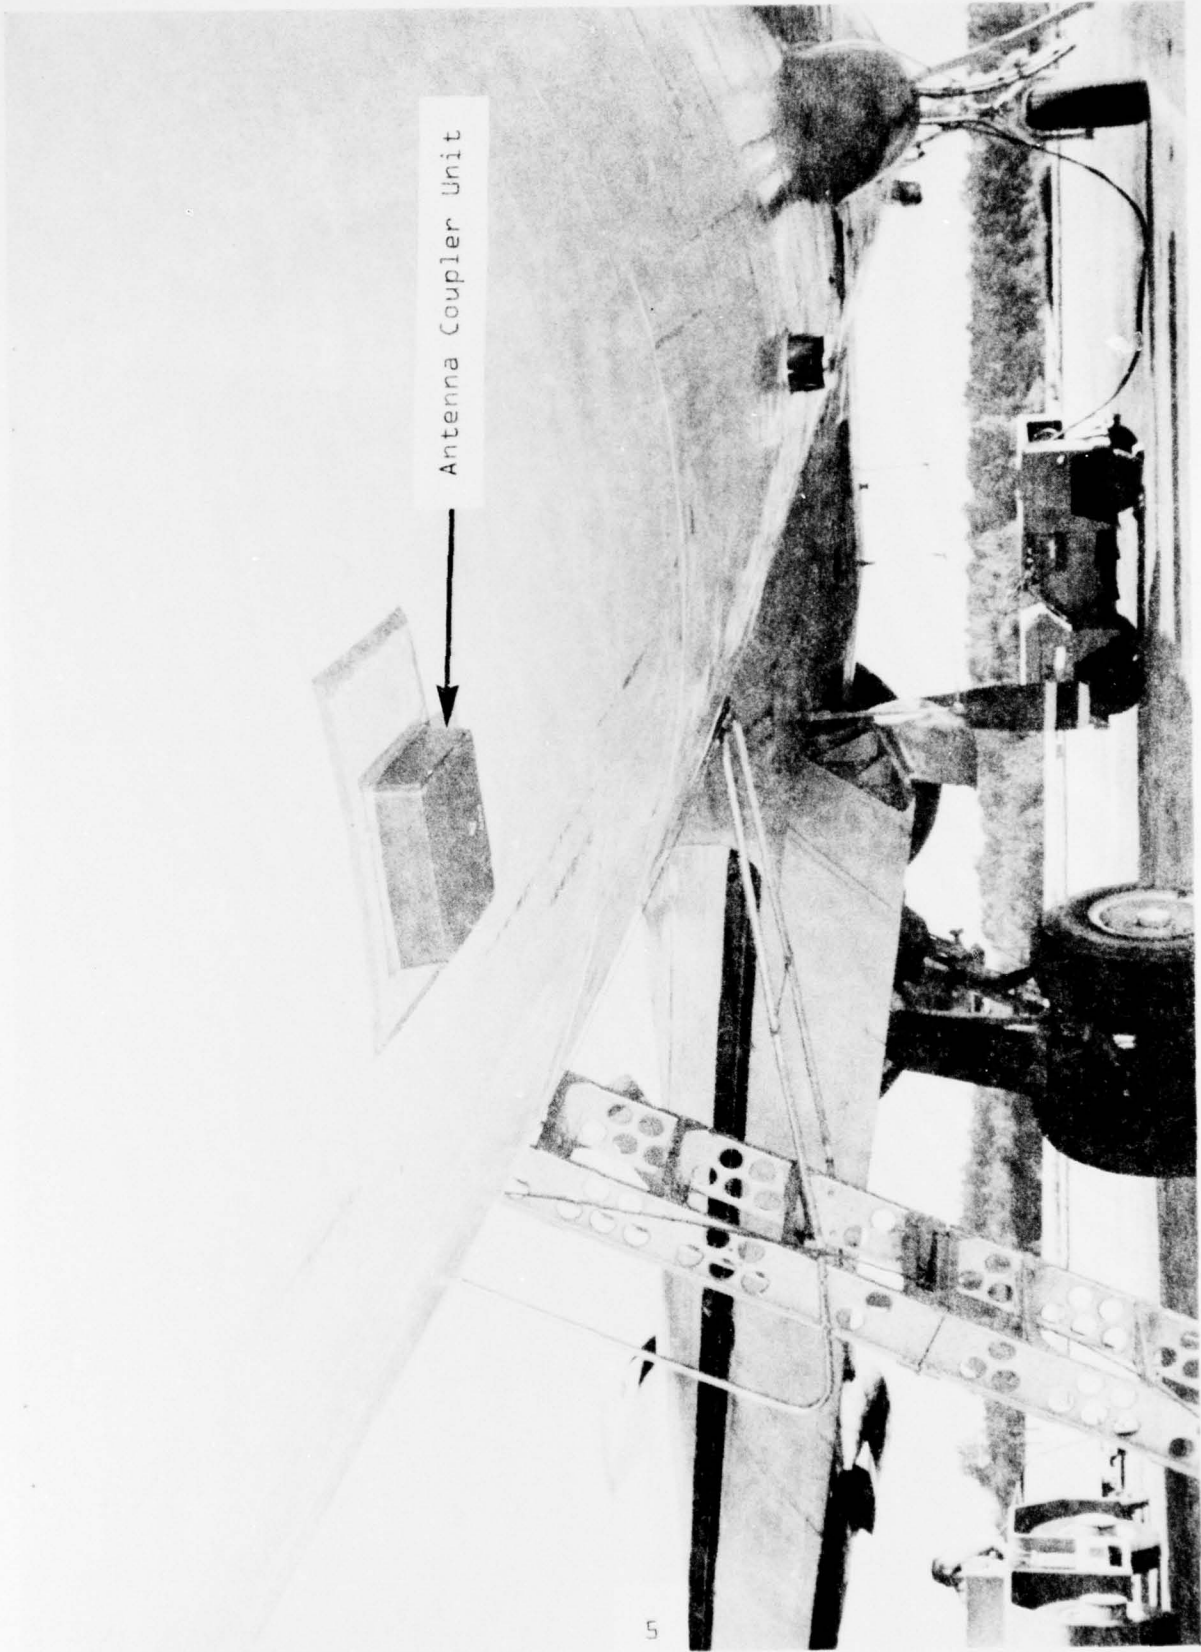
FIGURE 1 Omega Antenna Coupler Unit mounted on underside of aircraft at Station 7&0.

a. The antenna coupler unit was located on the underside of the aircraft. It was on the vertical line of symmetry at station 780 and it is shown in figure 1. The location was determined by skin mapping in accordance with procedures of reference (e).

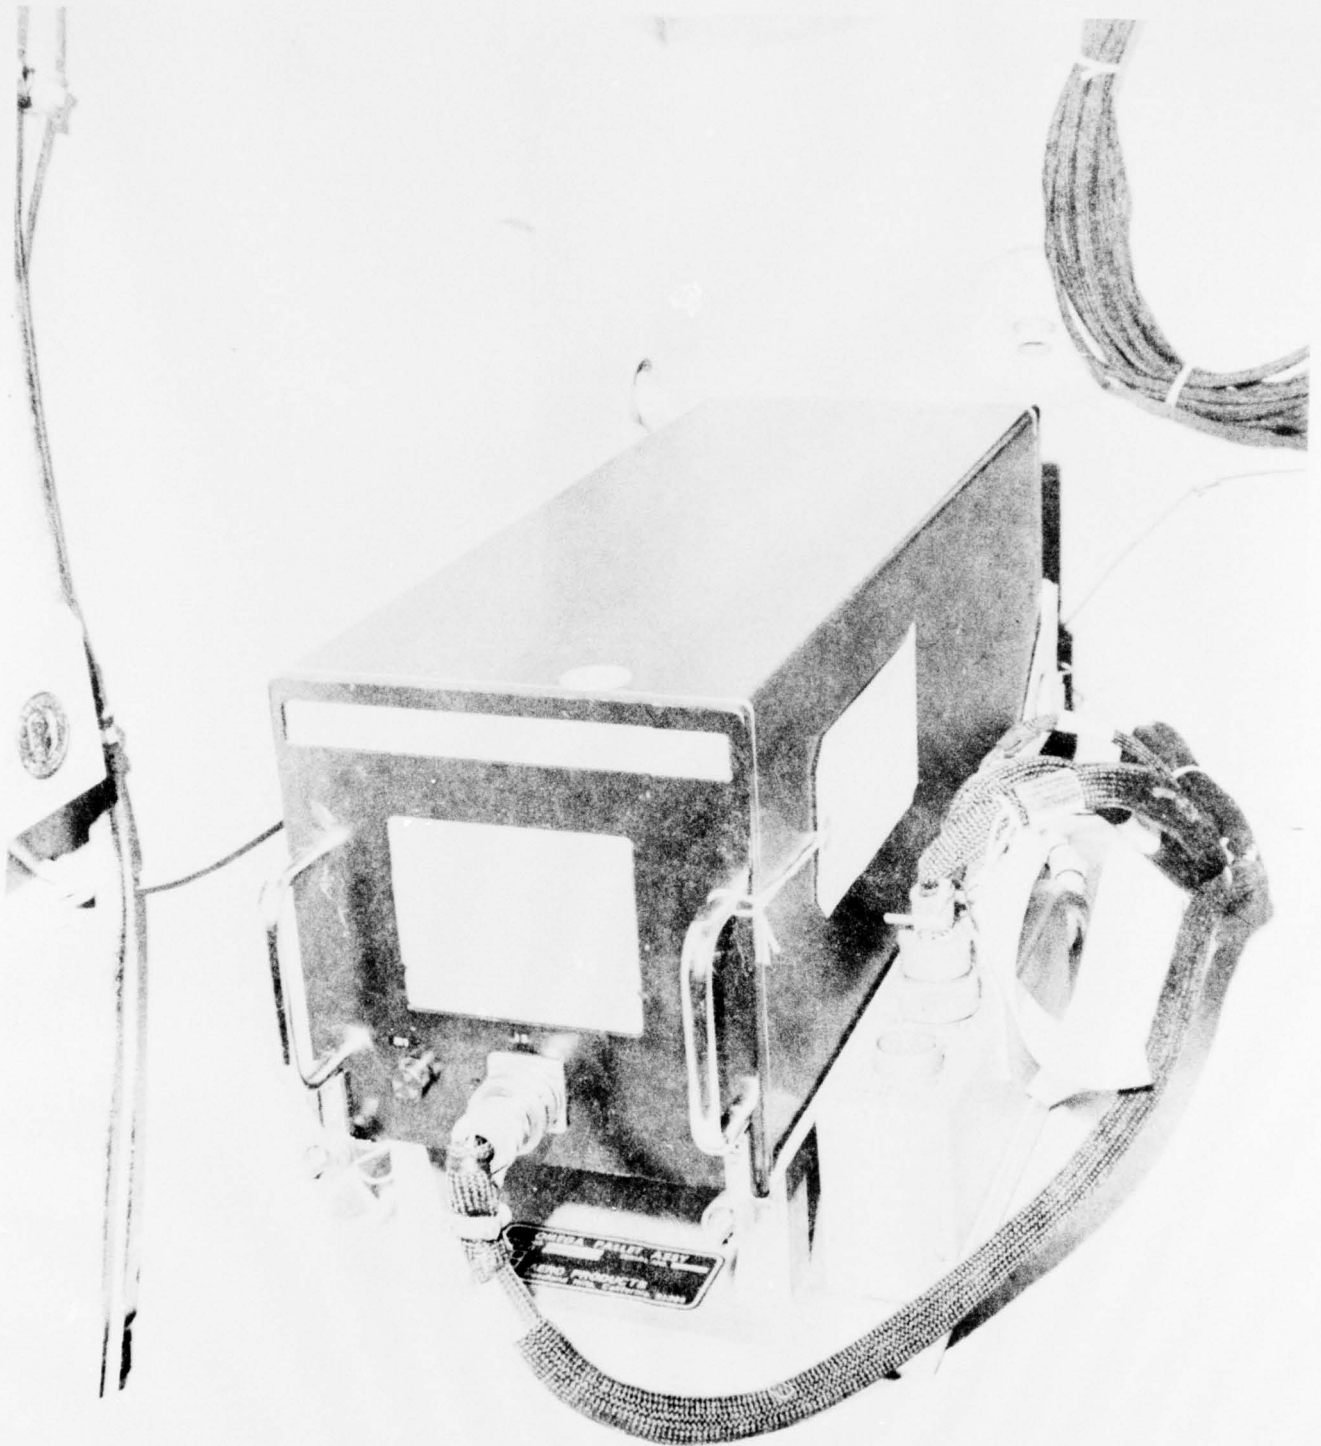
FIGURE 2. Omega Receiver Processor Unit installed.

b. The pallet mounted receiver processor unit was located in the forward head which had been converted to a locker. The location is not significant to the operational performance of the RPU but the locker provided physical security of this equipment which was on loan to the U. S. Navy. Figure 2 illustrates the RPU installation.

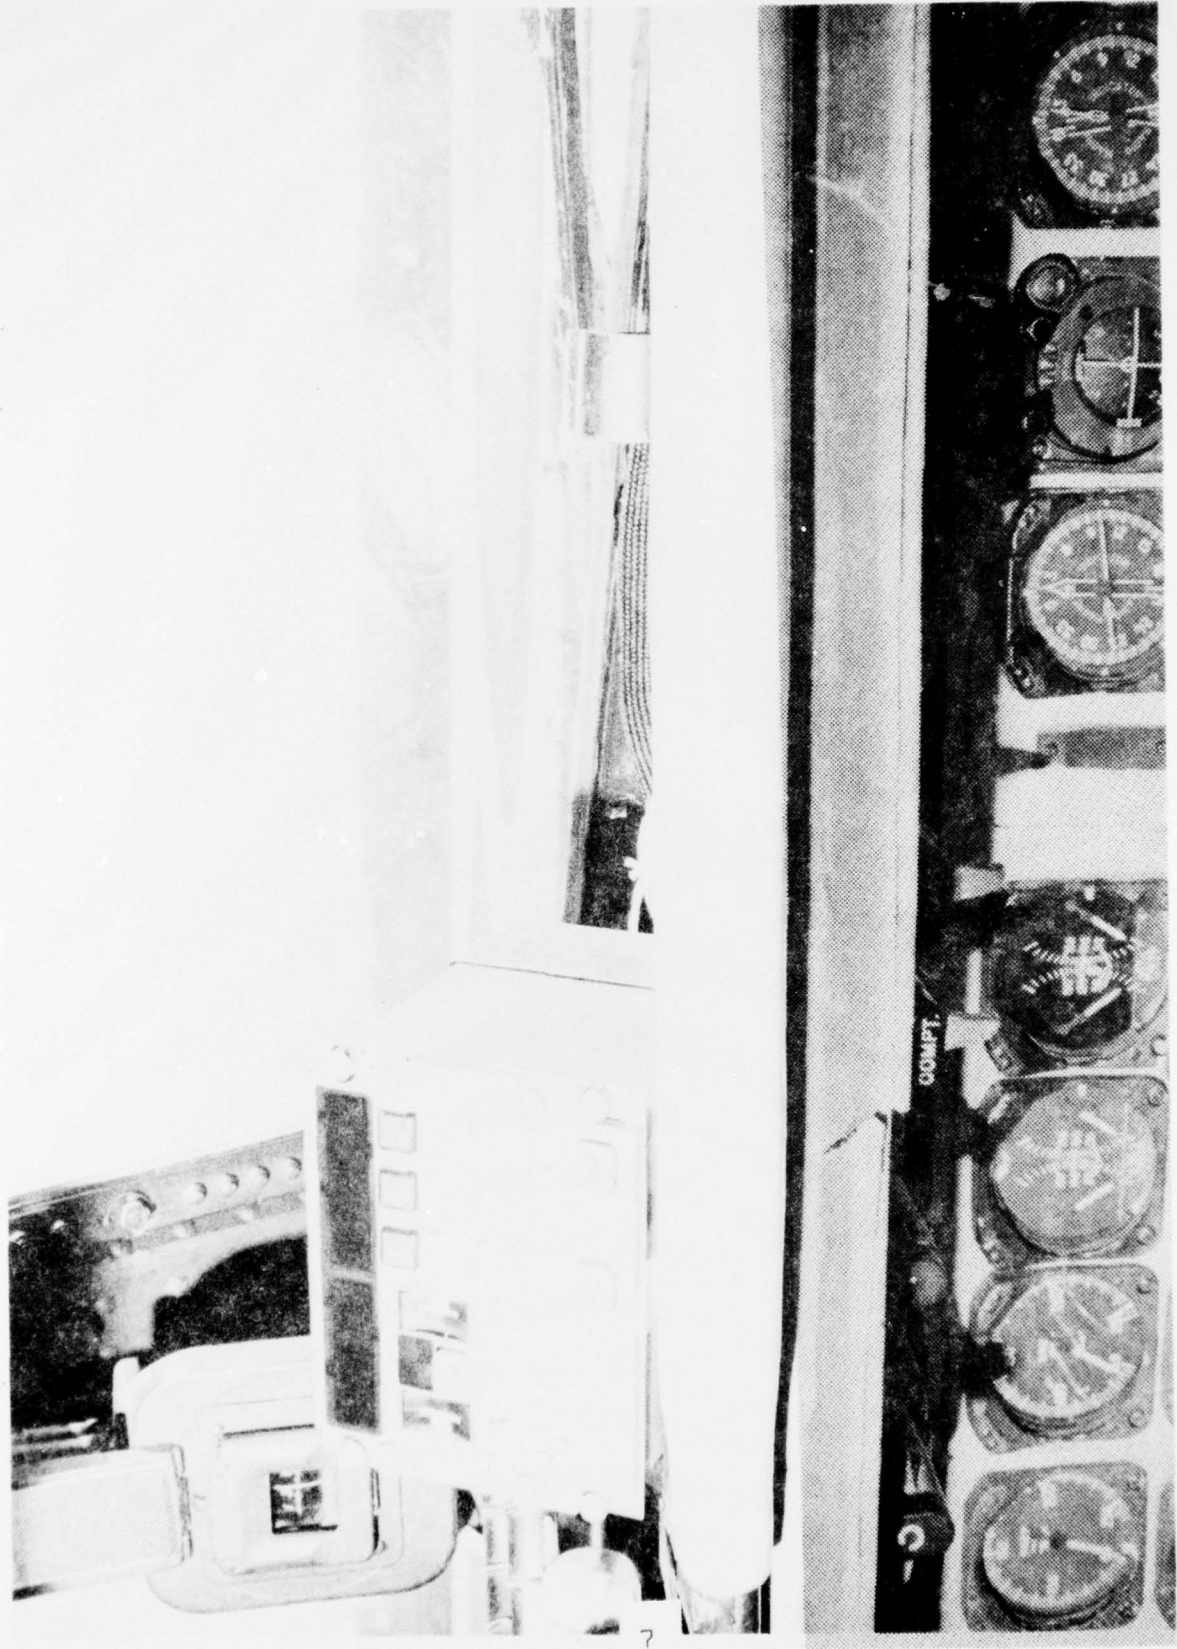
FIGURE 3. Omega Control Display Unit mounted on glare shield as viewed from copilot's seat.

c. The control display unit (CDU) installed for operation by copilot was tried. Due to size of CDU, the only convenient location was on the glare shield. Figures 3, 4, and 5 show the location of the CDU and impact on outside view. The final location of the CDU when evaluated was at the flight communication operator's station. The true airspeed syncro was located directly over the CDU. Figure 6 illustrates the installation. The syncro was provided to make the manual true airspeed entry easier and faster.

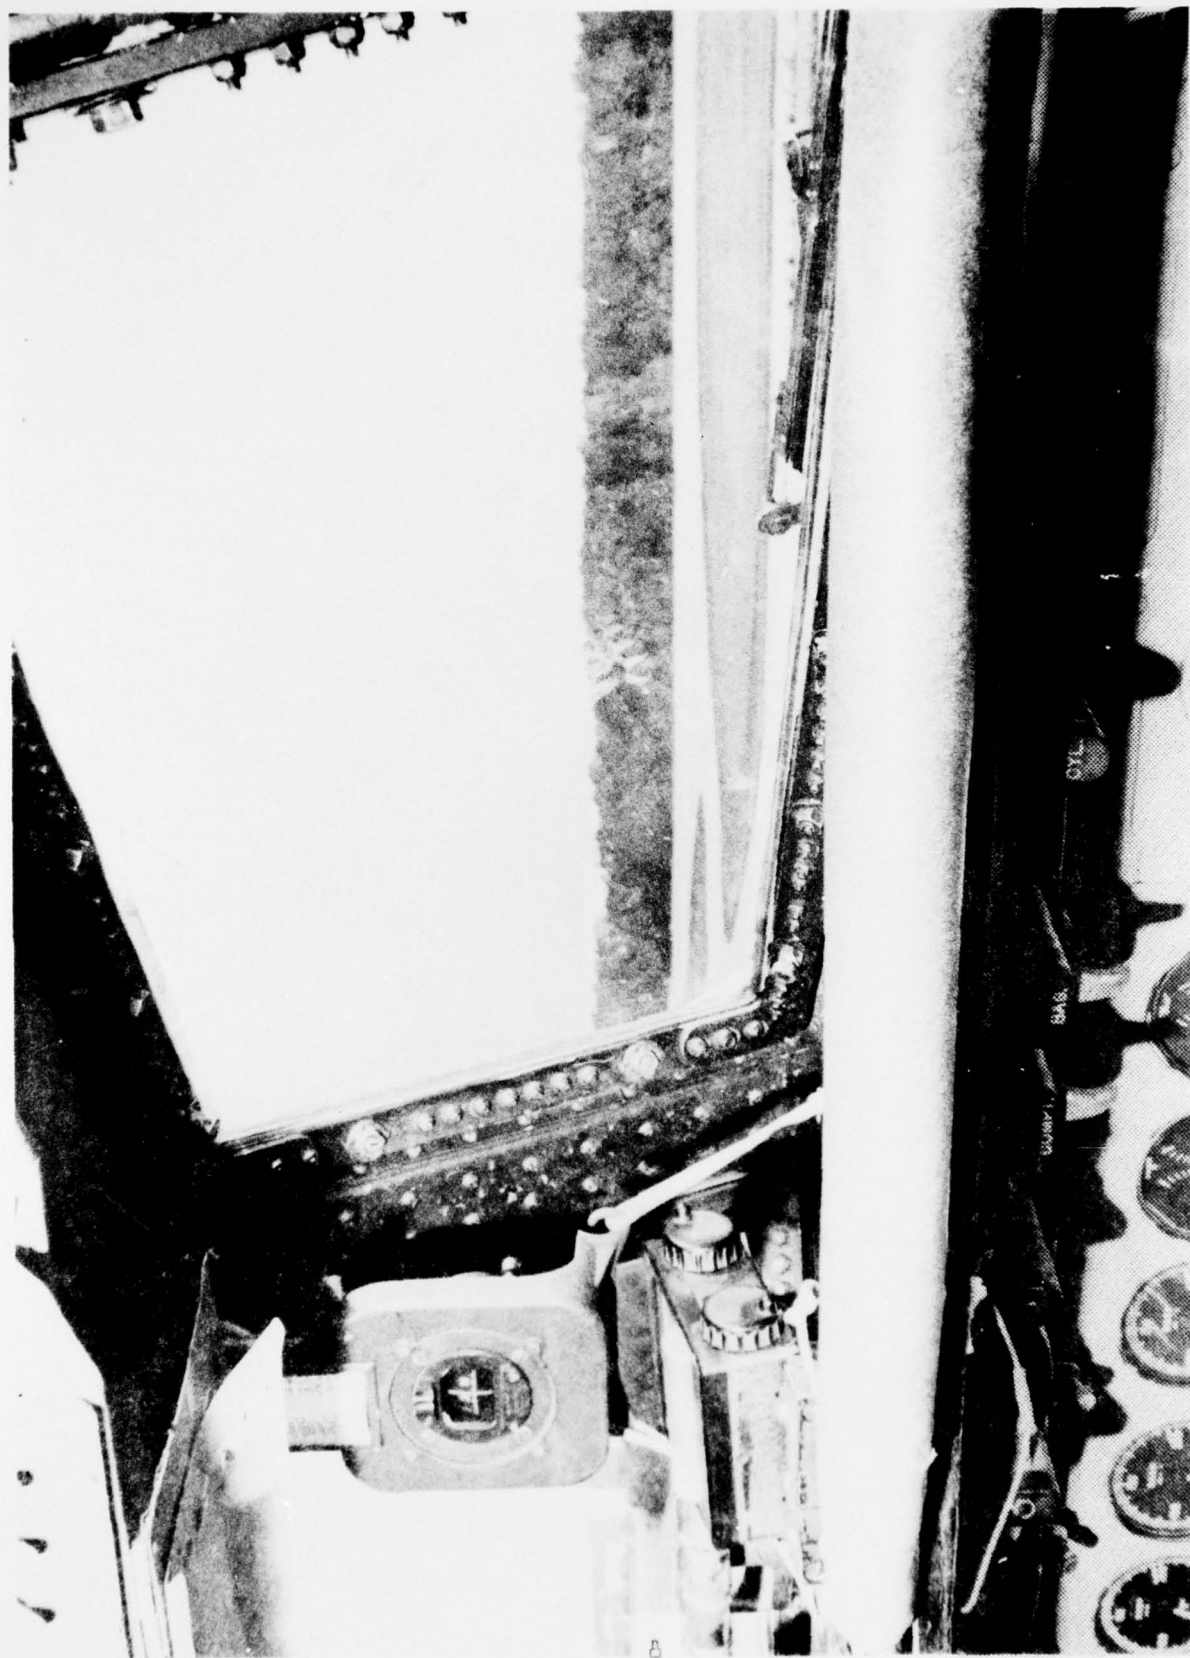
FIGURE 4. View from copilot's seat without Omega CDU.

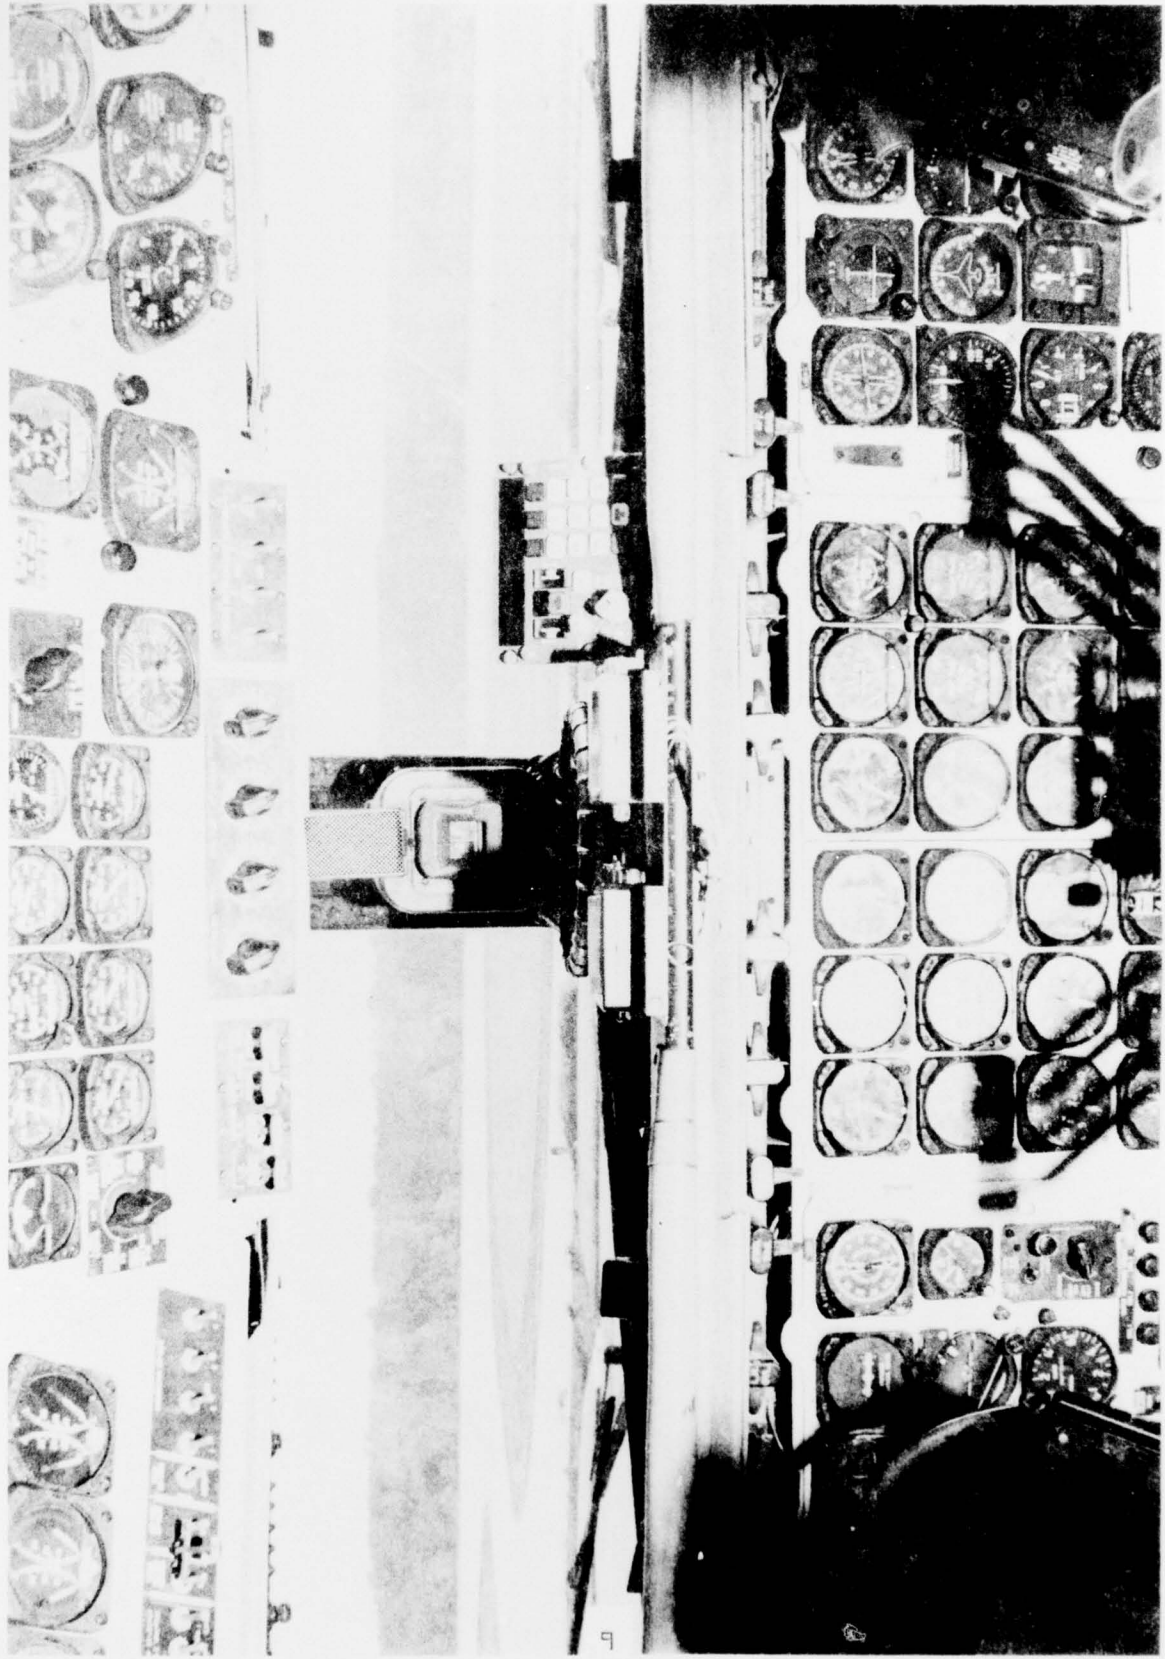
FIGURE 5.

Omega Control Display Unit mounted on glare shield as viewed from engineer's position.

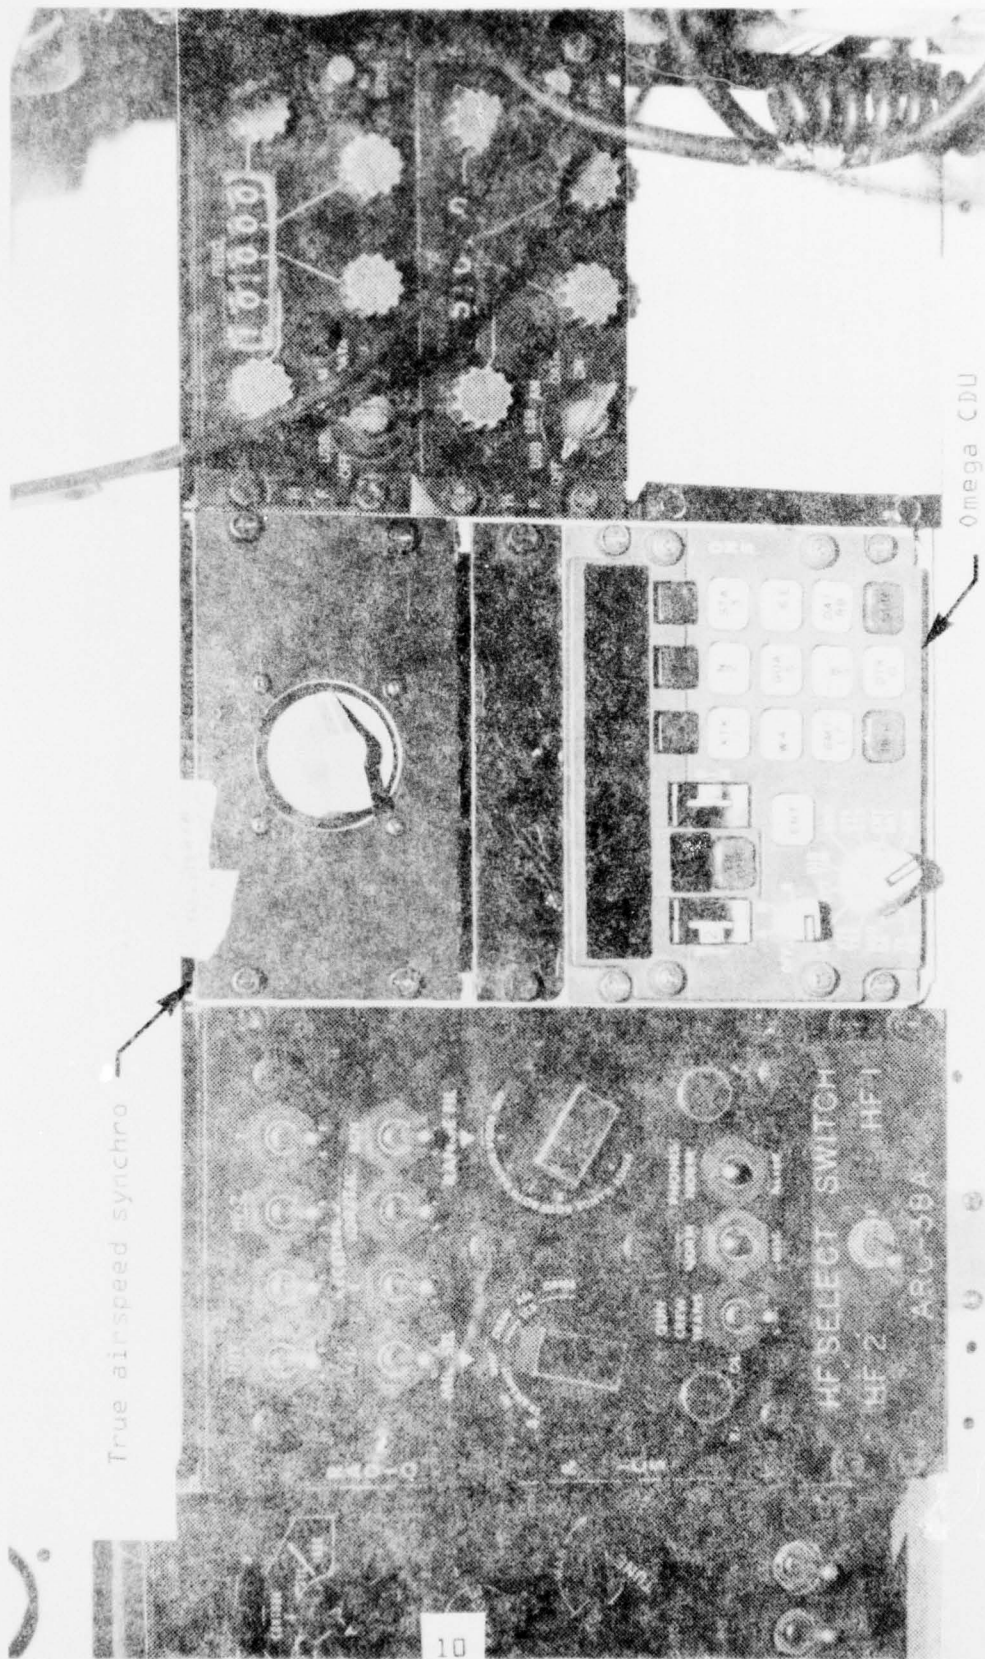
FIGURE B. Omega Control Display Unit mounted at navigator's station.

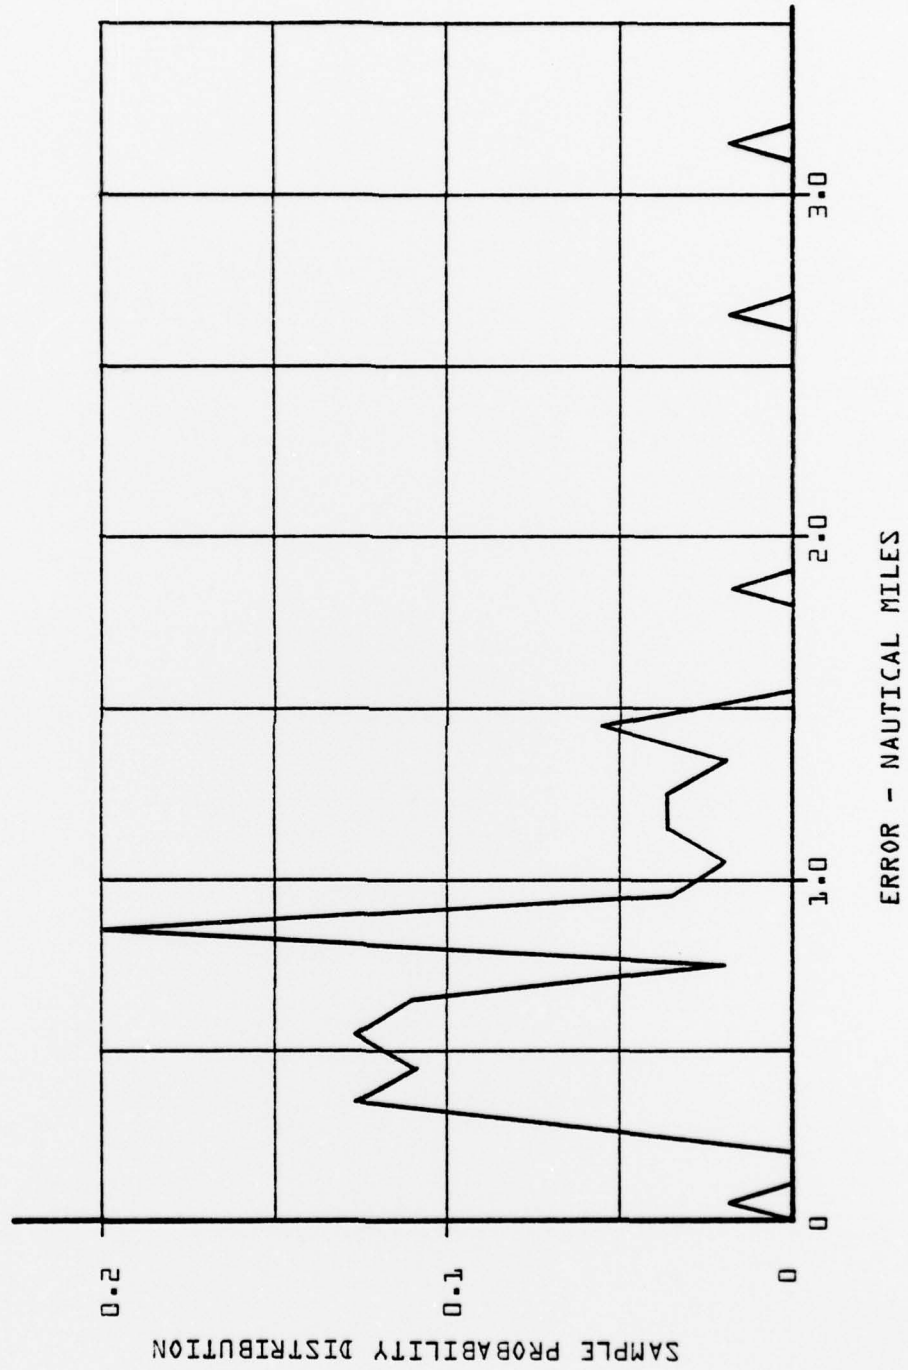
FIGURE 7. PROBABILITY DISTRIBUTION FOR MARK-ON-TOP DATA SAMPLE

a. TEST. The 55 mark-on-top data points showed an average error of 0.76 nautical miles with the standard deviation of 0.4457. Within this population there were seven data points taken at night. These seven showed the average error to be 0.50 nautical miles. The sample probability distribution is shown in figure 7. The 40 electronic data points showed an average error of 0.77 nautical miles and a standard deviation of 0.3287. The sample probability distribution is shown in figure 8. Figure 9 shows the probability distribution for the combined data represented in figures 7 and 8. Signal quality data appears in table 2 to portray the percent of samples for a given minimum value of SNR and the minimum number of stations which meet SNR on all three frequencies. All 96 samples were included.

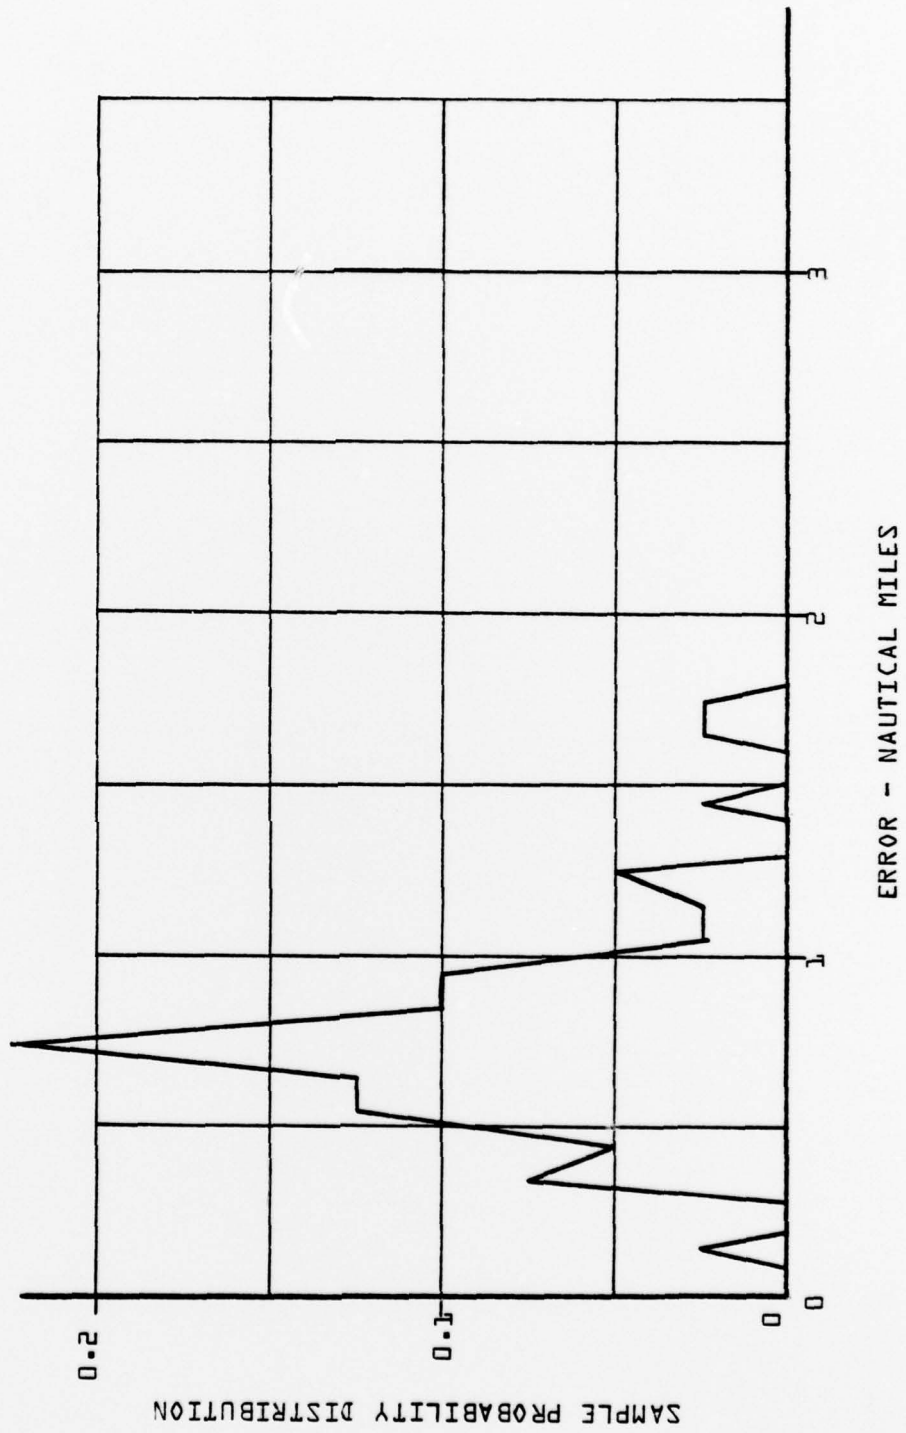
FIGURE 8. SAMPLE PROBABILITY DISTRIBUTION FOR DATA TAKEN USING ELECTRONIC FIXES

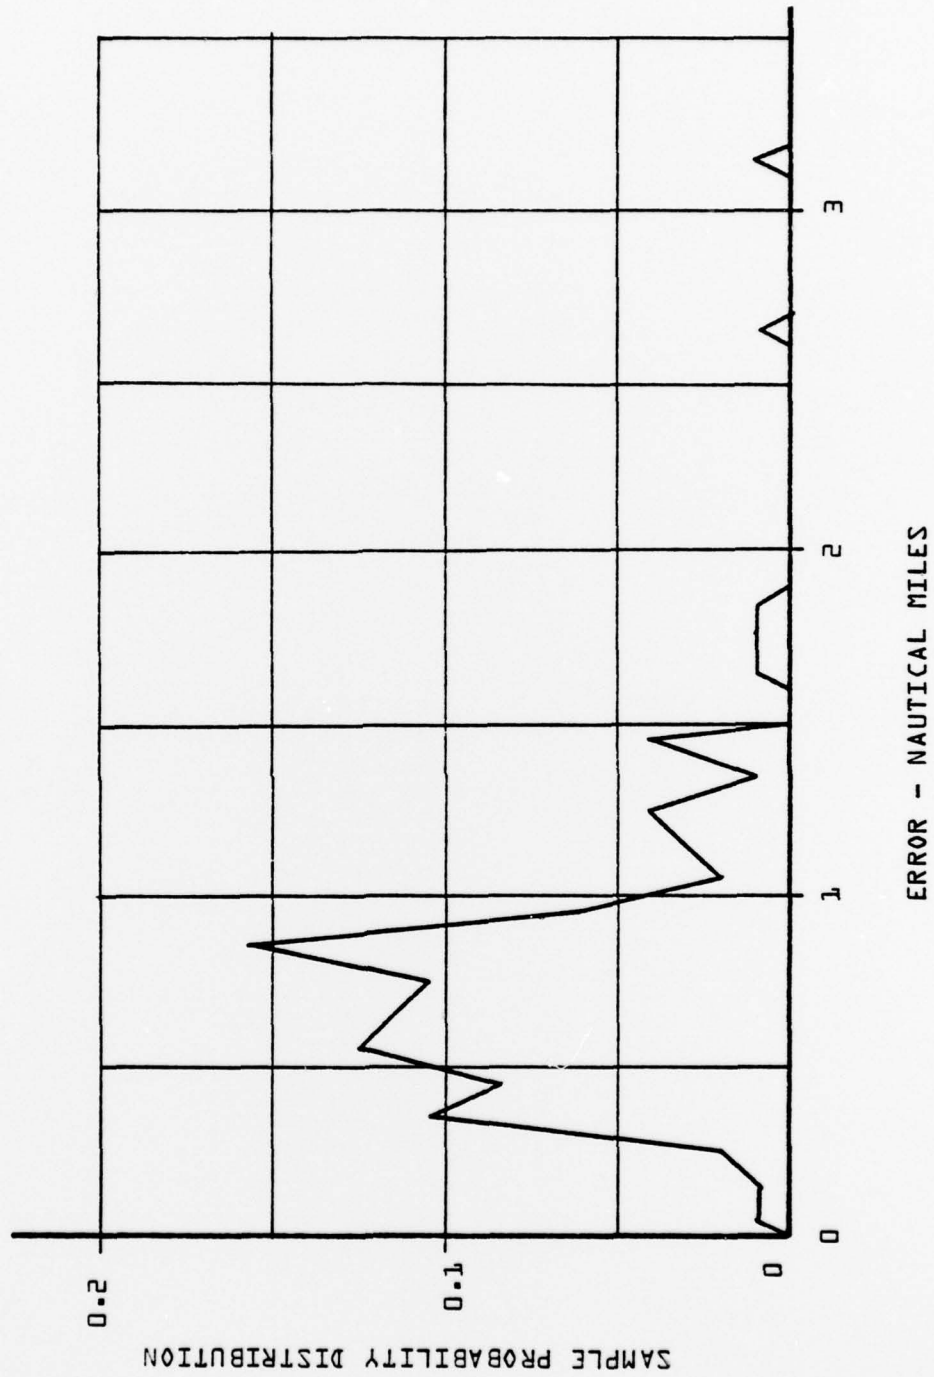
FIGURE 9. SAMPLE PROBABILITY DISTRIBUTION FOR DATA COLLECTED USING BOTH METHODS, MARK-ON-TOP AND ELECTRONIC FIXES
