SANTA CRUZ HARBOR SHOALING STUDY

FOR U.S. ARMY CORPS OF ENGINEERS
SAN FRANCISCO DISTRICT
MOFFATT & NICHOL, ENGINEERS

JUNE 1978

Prepared for
U.S. ARMY CORPS OF ENGINEERS
San Francisco District

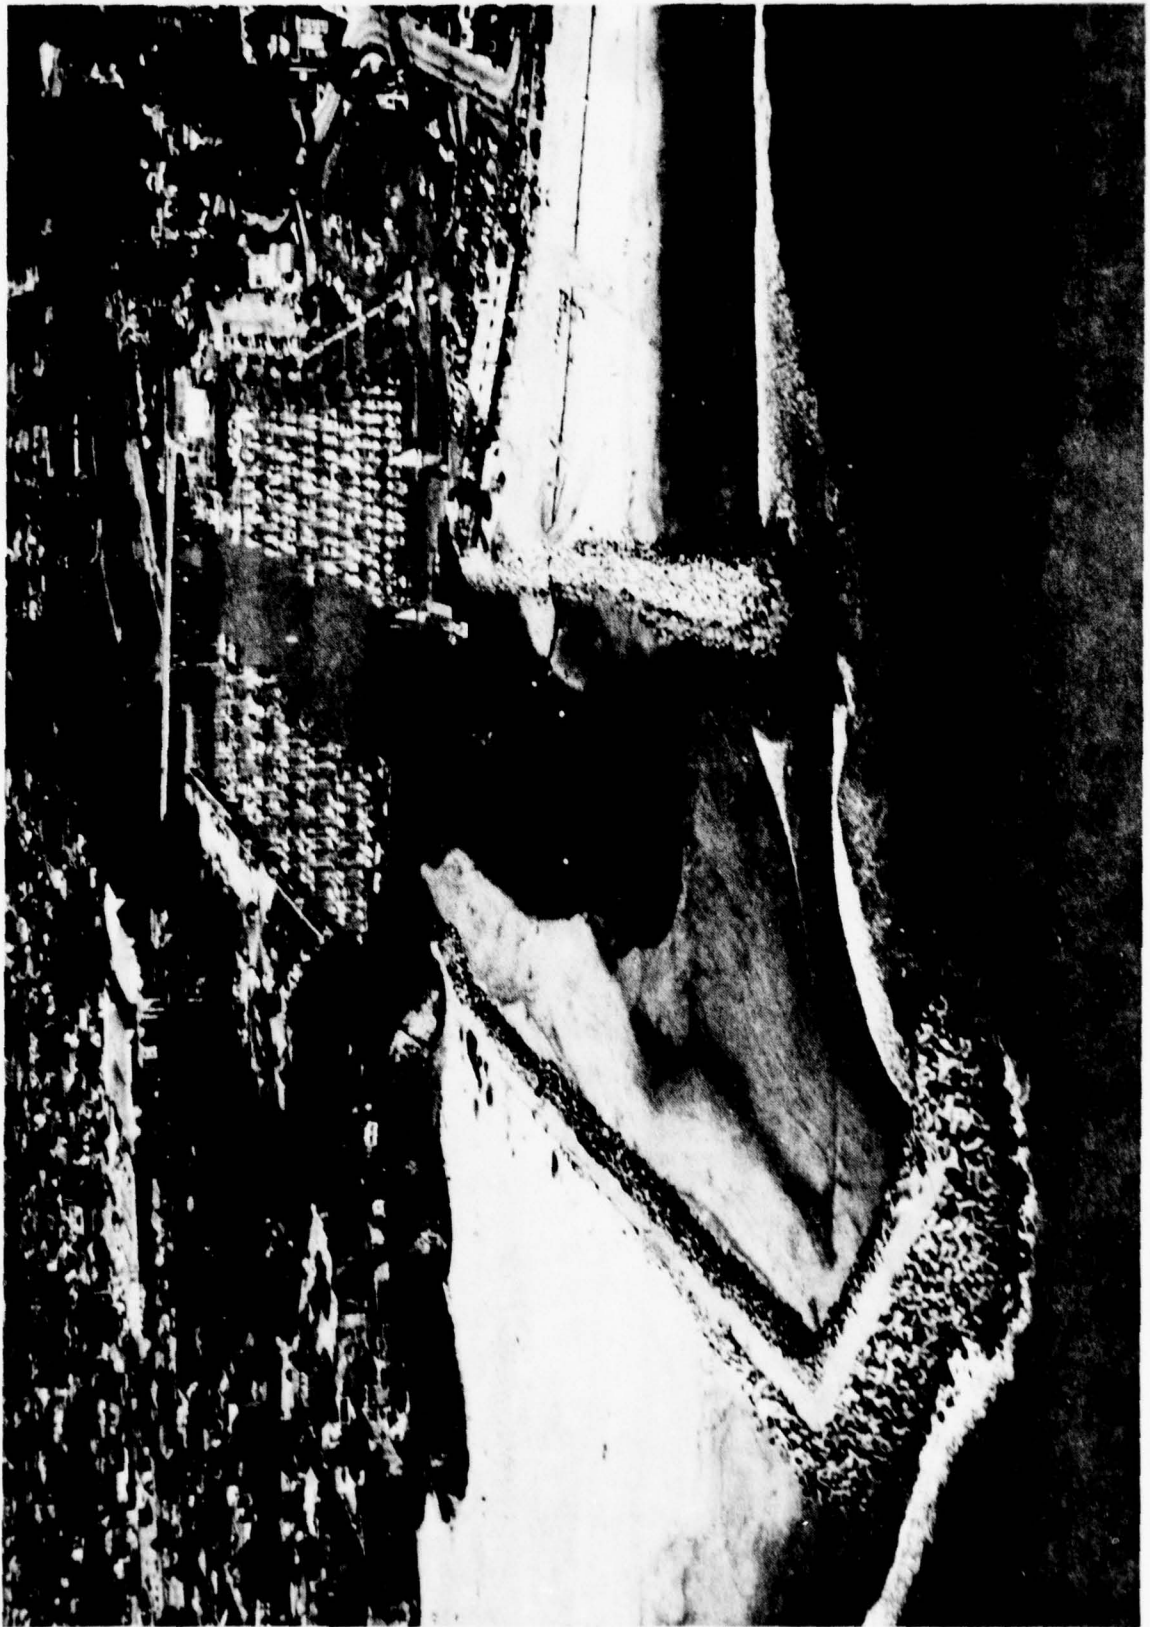
Photograph B1: Shoaled Entrance Channel
