ade 000212
NRL Memorandum Report 3810

Effect of Heat Treatment on Fatigue Crack Propagation and Deformation Mode in Alloy 718 at Elevated Temperatures

H. H. SMITH AND D. J. MICHEL

July 1978

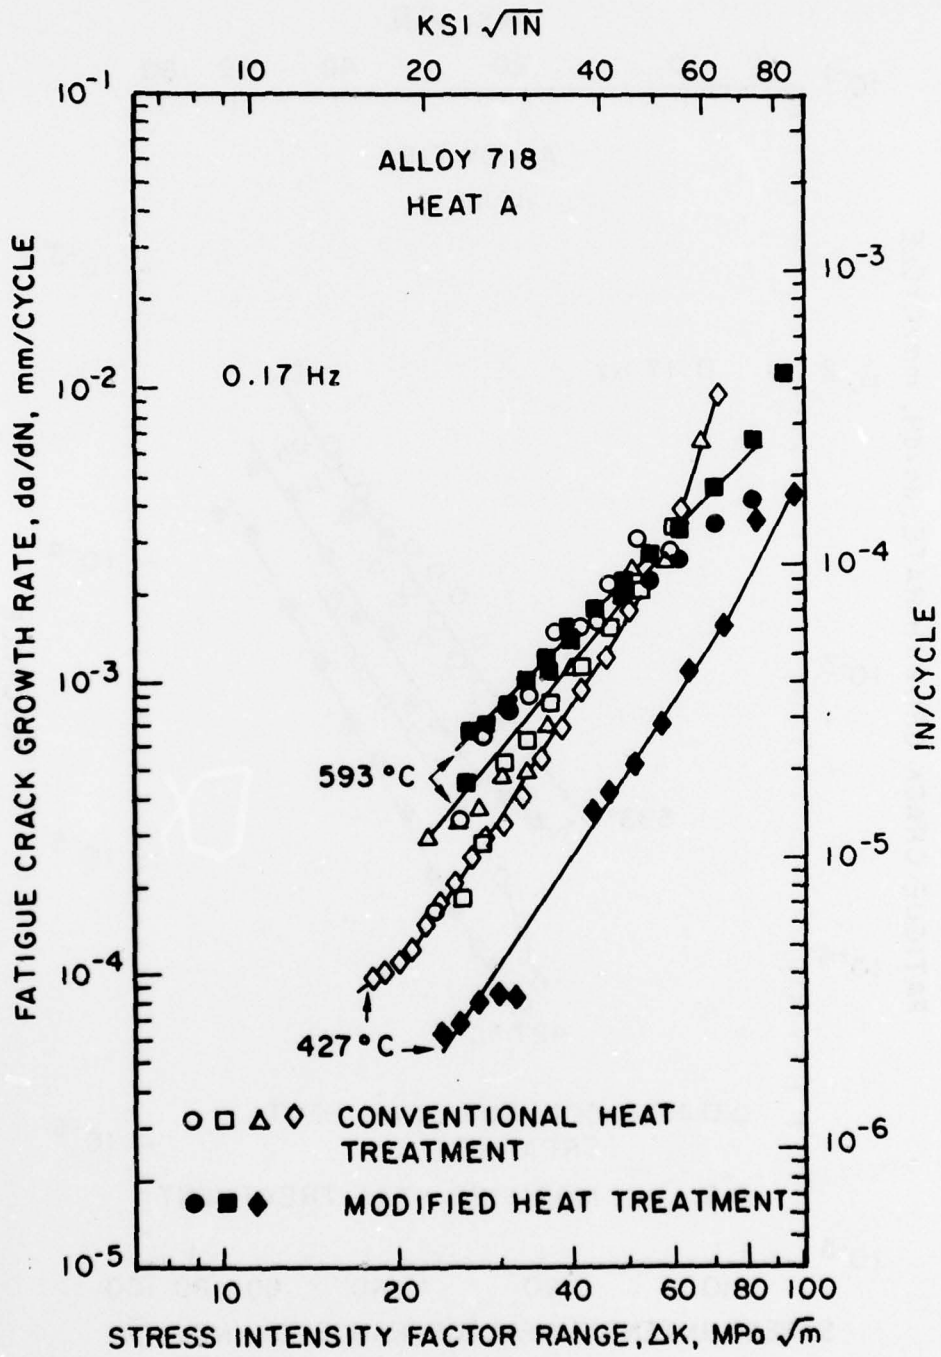
Fig. 2 - Effect of heat treatment on fatigue crack propagation rate in air for Heat A Alloy 718 at 427 and 593 deg C.

The fatigue program was undertaken to examine the effect of heat treatment, test temperature, and hold time on the fatigue crack propagation (FCP) response of two heats of Alloy 718. The data obtained from the fatigue crack propagation tests are shown in Figs. 2 through 6.

Results of fatigue crack propagation investigation of the Alloy 718 material, designated as Heat A, are shown in Fig. 2. The effect of the conventional and modified heat treatments on the fatigue crack propagation resistance of this heat were evaluated at 427 and 593 deg C. The most significant effect of heat treatment was seen at 427 deg C where a large increase in crack propagation resistance was realized from the modified heat treatment. At 593 deg C, the fatigue properties of this heat of Alloy 718 appear to be similar or slightly reduced by the modified heat treatment. Similar FCP evaluations of the effect of heat treatment, which were made for the Alloy 718 material designated Heat B, are shown in Fig. 3. In this instance, the modified heat treatment produced an increase in the crack propagation resistance of the Heat B material at both 427 and 593 deg C.

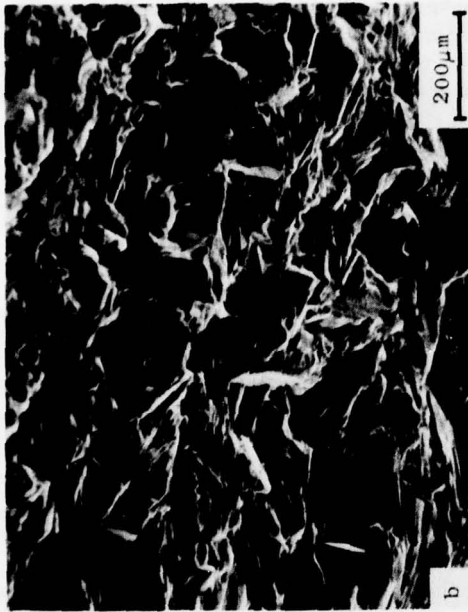
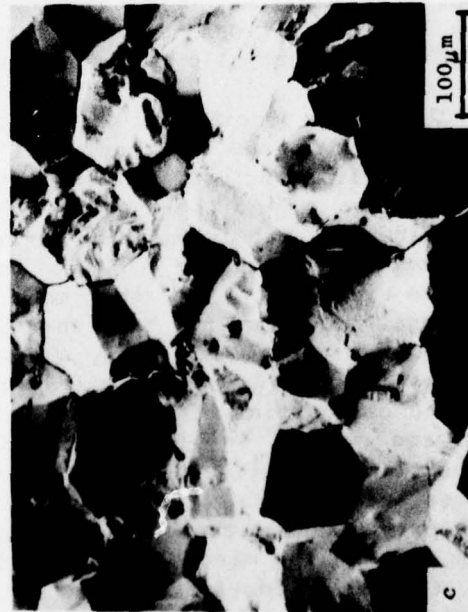
Fig. 10 - Micrographs of Alloy 718, Heat A, modified heat treatment; (a) optical micrograph of a polished and etched sample, (b) SEM micrograph of fracture surface after test at 427 deg C, (c) SEM micrograph of fracture surface after test at 539 deg C. Direction of crack growth was from left to right.

In the modified heat treatment, one of the principal functions of the solution anneal is the ductilization of the alloy by depletion of the Laves phase during heating above 1040 deg C. The Heat A microstructure resulting from the modified (1093 deg C anneal, 718/621 deg C age) heat treatment is shown in Fig. 10. The microstructure appeared fully recrystallized with many annealing twins. The modified treatment produced a fairly uniform grain size of approximately 125μ m, Fig. 10a. with many large carbides in evidence throughout the microstructure. At 427 deg C, the fracture surface showed considerable faceting indicating a crystallographic cleavage mode of fracture, Fig. 10b. In contrast at 593 deg C, Fig. 10c, the fracture mode was clearly intergranular with appreciable secondary cracking along grain boundaries. An intergranular fracture mode also was observed for the one minute hold time test at 593 deg C. Whereas the conventional heat treatment showed little dependence of fracture mode on test

temperature, the modified treatment produced a microstructural condition which was highly sensitive to test temperature.

Deformation in air, in contrast to vacuum, produced a more planar type slip with large slip offsets. At 427 deg C, Fig. 15c, slip appeared to produce offsets at twin boundaries and would be expected to produce fracture surfaces similar to that shown in Fig. 10b. At 593 deg C, deformation occurred by grain boundary separation, Fig. 15d. Slip line deformation appeared to be related to the grain boundary cracks; however, it was not certain whether the grain boundaries cracked first or separated because of the interaction of the slip with the grain boundary. It would be expected, then, that the specimens given the modified heat treatment and tested in air would exhibit intergranular failure as shown in the SEM micrograph, Fig. 10c.

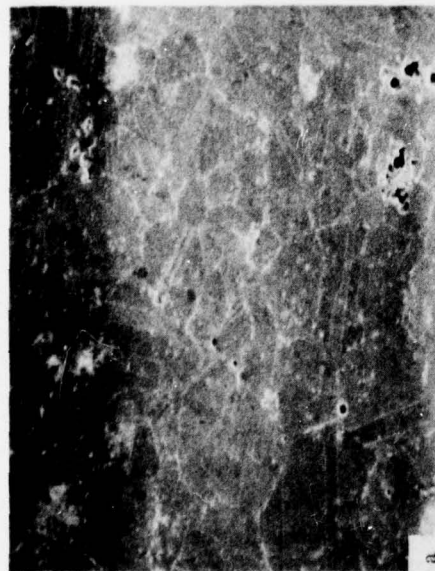
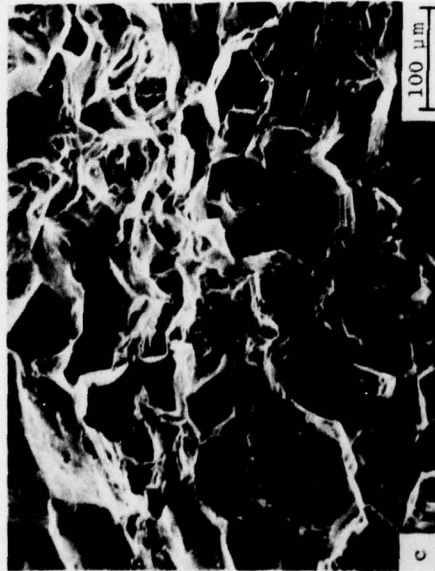
Fig. 11 - SEM micrographs of Alloy 718, Heat B, modified heat treatment; (a) polished and etched sample, (b) fracture surface after test at 427 deg C, (c) fracture surface after test at 593 deg C. Direction of crack growth was from left to right.

A similar effect was seen for the Heat B material given the modified heat treatment. The higher temperature anneal of the modified treatment produced grain growth and cleaner grain boundaries as shown in Fig. 11a. At 427 deg C, fracture was predominantly transgranular but with occasional intergranular fracture areas where grain boundaries were parallel with the fracture path, Fig. 11b. The mixed mode of failure at 593 deg C was predominantly intergranular, Fig. 11c, but clearly exhibited a larger proportion of transgranular failure mode than Heat A material.

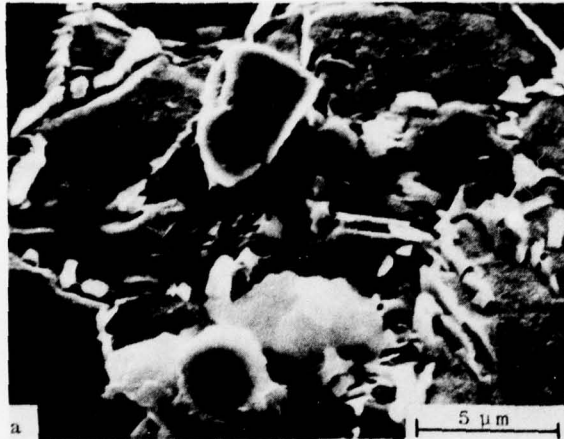
Fig. 12 - SEM micrographs of Alloy 718, Heat A microstructure showing the nature of (a) the large Cb carbides and grain boundary phases (Laves and CbC) in the conventional heat treatment condition, and (b) the large Cb carbides, fine grain boundary phases, and carbide films (CbC) in the modified heat treatment condition.

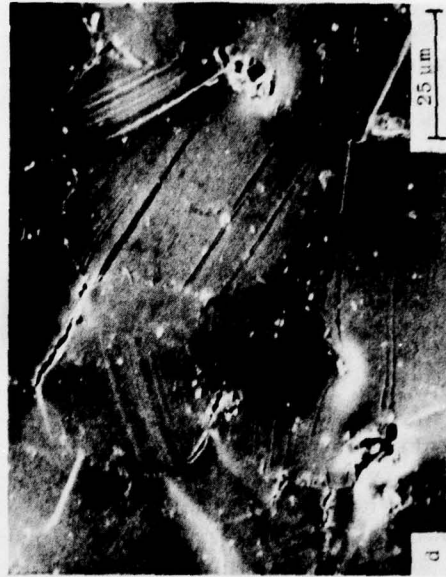
Fig. 15 - SEM micrographs of slip behavior in plane strain bend samples of Alloy 718, Heat A, deformed in air: (a) conventional heat treatment, 427 deg C; (b) conventional heat treatment, 593 deg C; (c) modified heat treatment, 427 deg C; (d) modified heat treatment, 593 deg C.

For deformation in air at 427 and 593 deg C, Figs. 15a and 15b, show typical deformation processes prevalent on plane strain specimen surfaces of material given the conventional heat treatment. In air at 427 deg C, Fig. 15a, the nature of the slip deformation was similar to that in vacuum at 427 deg C where localized planar slip was the prevalent mechanism. However, the air environment appeared to have produced a more even distribution of slip through the duplex grain size, whereas in vacuum, the slip lines were generally found within the larger grains. Under these conditions, the fracture mode was predominantly transgranular as would be suggested by the tendency for slip localization and large slip offsets shown in Fig. 15a. At 593 deg C, Fig. 15b, it was still evident that slip tended to concentrate on localized planes, but there also was a considerable amount of grain boundary cracking in small grains adjacent to large grains. The intergranular cracking was seen to be associated with the intersection of persistent slip lines with grain boundaries or fractured precipitates within the grain boundaries. The mixed fracture mode in Fig. 8c concurs with the observed planar slip and grain boundary cracking seen in Fig. 15b.

The effect of environment on slip deformation was more pronounced in the material given the modified heat treatment, Figs. 15c and 15d.

Previous work (29) has shown that air environments accelerate slip band development and increase transgranular crack propagation rates in Alloy X-750 when compared to vacuum. As shown in Fig. 14d, deformation in vacuum produced slip accumulation at grain boundaries which, in turn, produced the tendency for intergranular failure. The air environment at 593 deg C produced accelerated slip band formation and higher fatigue crack growth rates for both material conditions in air. However, the fracture surfaces indicated that, for the conventional treatment, the large grains fractured transgranularly and, where these slip planes intercept grain boundaries in adjacent grains, intergranular failure was observed at 593 deg C, Fig. 15b.
