PTPT REPORT NO. 78-18
AFPEA PROJECT NO. 78-P7-12

PACKAGING AND HANDLING ANALYSIS OF A
POLYETHYLENE, REUSABLE, LOW FRAGILITY, SHIPPING CONTAINER

HQ AFALD/PTP
AIR FORCE PACKAGING EVALUATION AGENCY
Wright-Patterson AFB OH 45433

August 1978

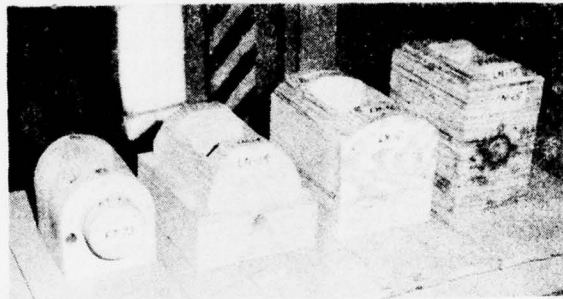
Figure 3. Test Loads

The pack was subjected to vibration and free fall drop tests, except as noted, in accordance with Federal Test Method Standard 101B. Four simulated inertial platforms, (wood models), the Transportation Environment Recorder (TER) and Inertial Measurement Units (IMU) used as test loads are shown in Figure 3. The test load weights and dimensions are listed in Table 2.
