MISCELLANEOUS PAPER H-78-12

**SOUTH JETTY STABILITY STUDY  
MASONBORO INLET, NORTH CAROLINA**

Hydraulic Model Investigation

Prepared for U. S. Army Engineer District, Wilmington  
Wilmington, N. C. 28402

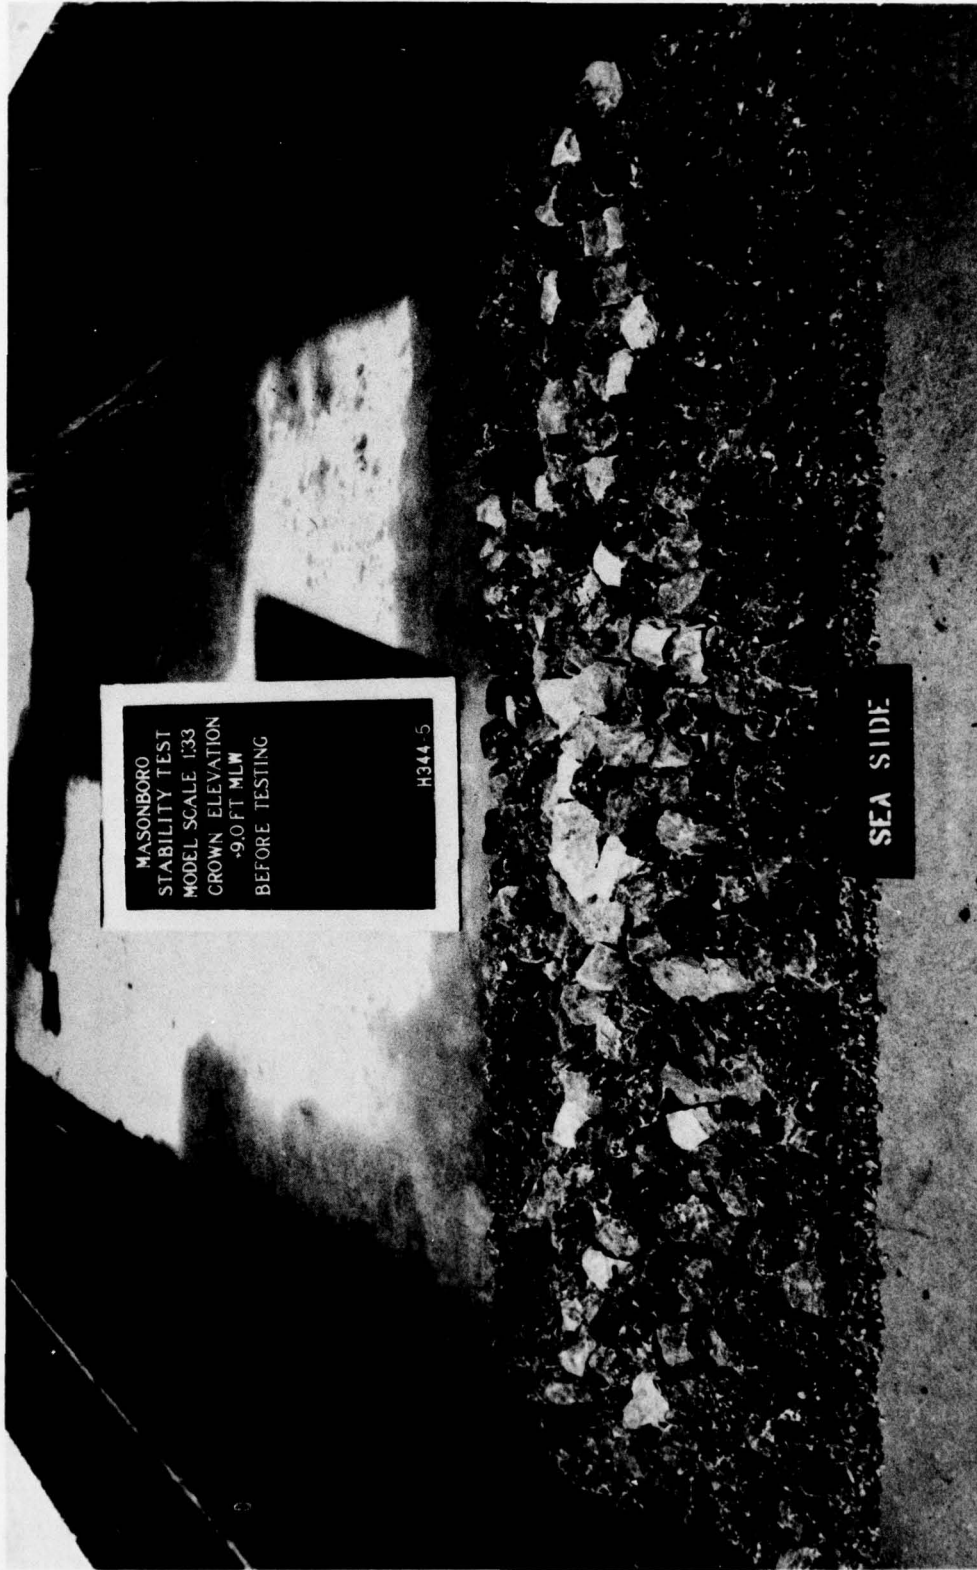
Photo 5. Sea-side view of Plan 2 before wave attack

12. Plan 2 (Plate 4 and Photos 5 and 6) was similar to Plan 1 except the crown elevation was raised to +9.0 ft mlw, the sheet piling was eliminated, and the armor weight was increased to 15 tons. The structure was initially subjected to 15-sec, 13.5-ft waves at an swl of +8.5 ft mlw for 2 prototype hours. Moderate damage was observed; however, the structure's stability response was judged to be marginally acceptable. The swl was then raised to +12.5 ft, and the structure was subjected to 15-sec, 16.9-ft waves for 2 prototype hours. As shown in Photos 7 and 8, this wave condition produced extensive damage. The average crown elevation was lowered 3 to 5 ft. Both the sea-side and beach-side slopes were flattened to approximately 1:3, and the core material was exposed in several places.

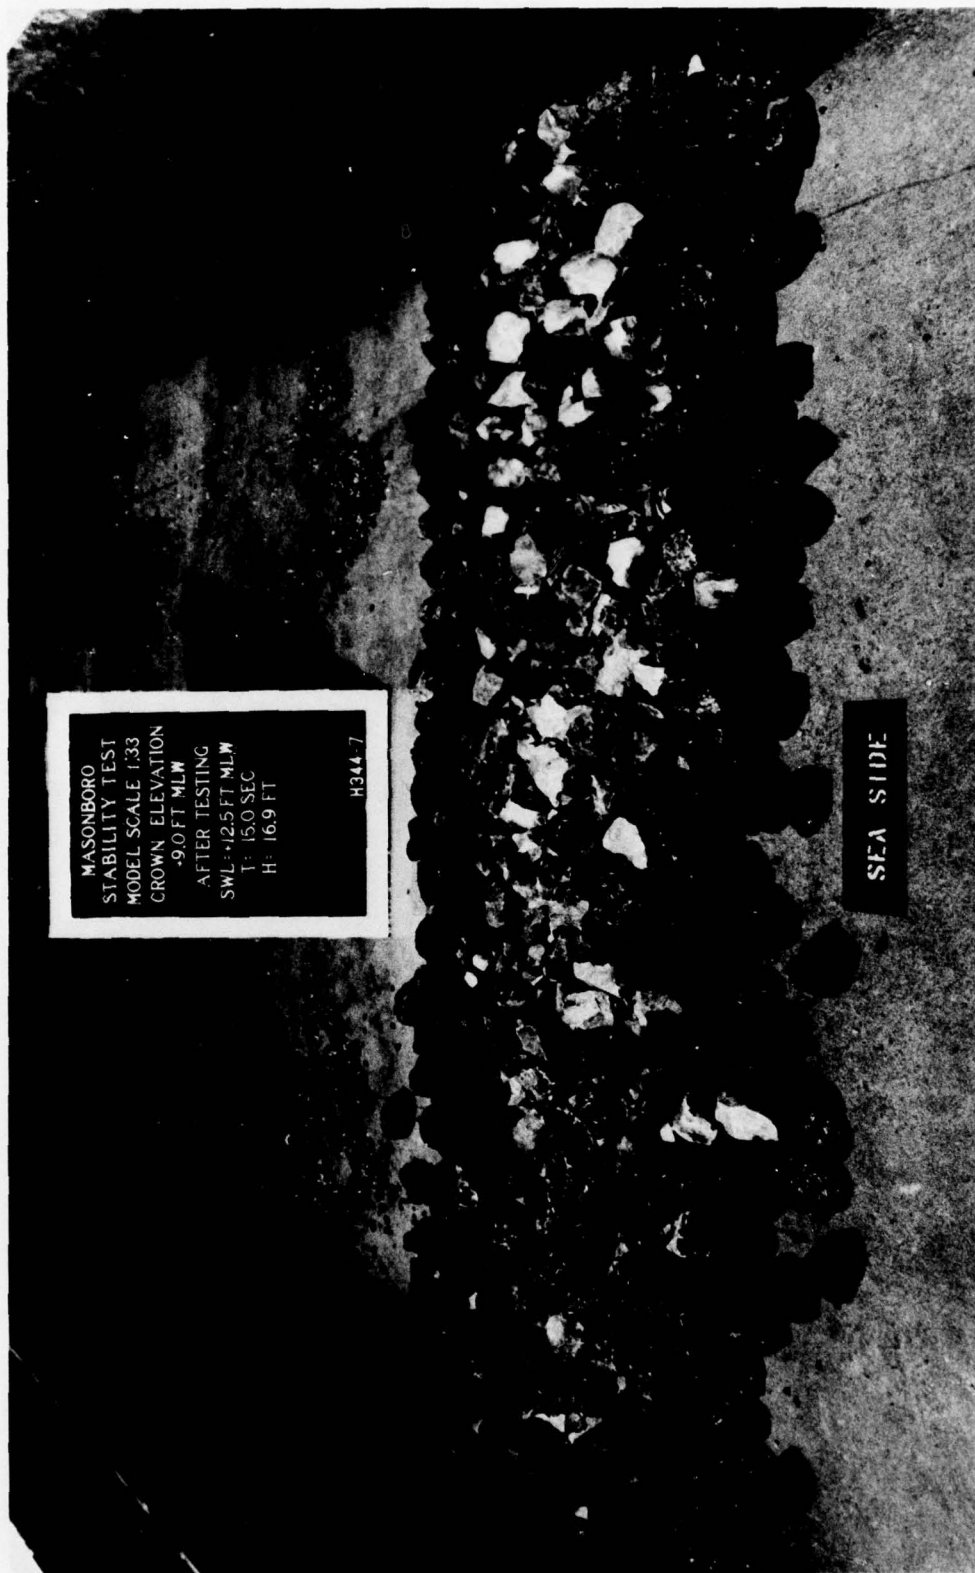
MASONBORO  
STABILITY TEST  
MODEL SCALE 1:33  
CROWN ELEVATION  
-9.0 FT MLW  
AFTER TESTING  
SWL = +12.5 FT MLW  
T = 15.0 SEC  
H = 16.9 FT  
H344-7

Photo 7. Sea-side view of Plan 2 after attack of 15-sec, 16.9-ft waves at an swl of +12.5 ft mlw for 2 prototype hr

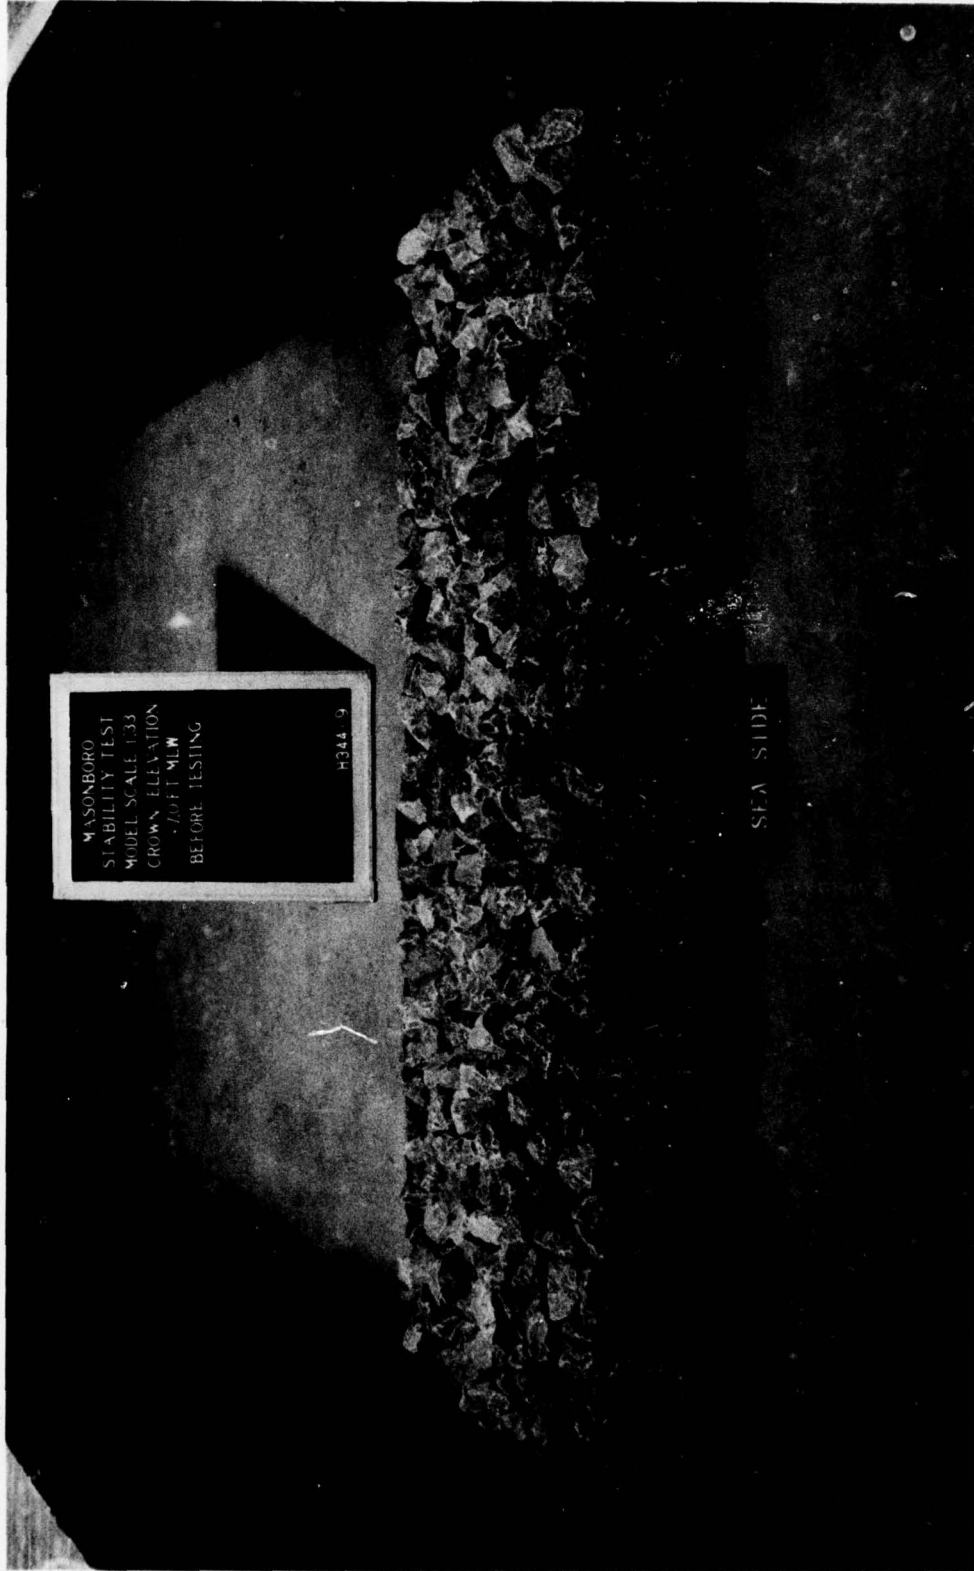
Photo 9. Sea-side view of Plan 3 before wave attack

13. Plan 3 (Plate 5 and Photos 9 and 10) was constructed to a crown elevation of +7.0 ft mlw and again excluded the sheet pile wall. Eighteen-ton armor was used both sea side and beach side. The bedding material ( $W_3$ ) was covered with screen in an effort to simulate gabion mats which are to be used during prototype construction. Attack of 15-sec, 13.5-ft waves at an swl of +8.5 ft mlw for 2 prototype hours produced very minor damage to the first row of sea-side toe armor. The swl was then raised to +10.5 ft mlw and the structure was subjected to 15-sec, 15-ft waves for 2 prototype hours (it had been decided between the testings of Plans 2 and 3 to add an swl intermediate to the +8.5-ft and +12.5-ft swls). The +10.5 ft swl produced extensive damage to the sea-side toe. Also, the average crown elevation was lowered 1 to 2 ft and the core stone was exposed on several areas of the crown. Finally the swl was raised to +12.5 ft mlw and the structure was subjected to 15-sec, 16.9-ft waves for 2 prototype hours. As evidenced in Photos 11-13, this wave condition produced extensive damage. Seaward migration of both crown armor and core material resulted in an additional 2 to 3 ft lowering of the crown, and the core was randomly exposed such that it would take about 10 armor stones to cover the exposed areas represented

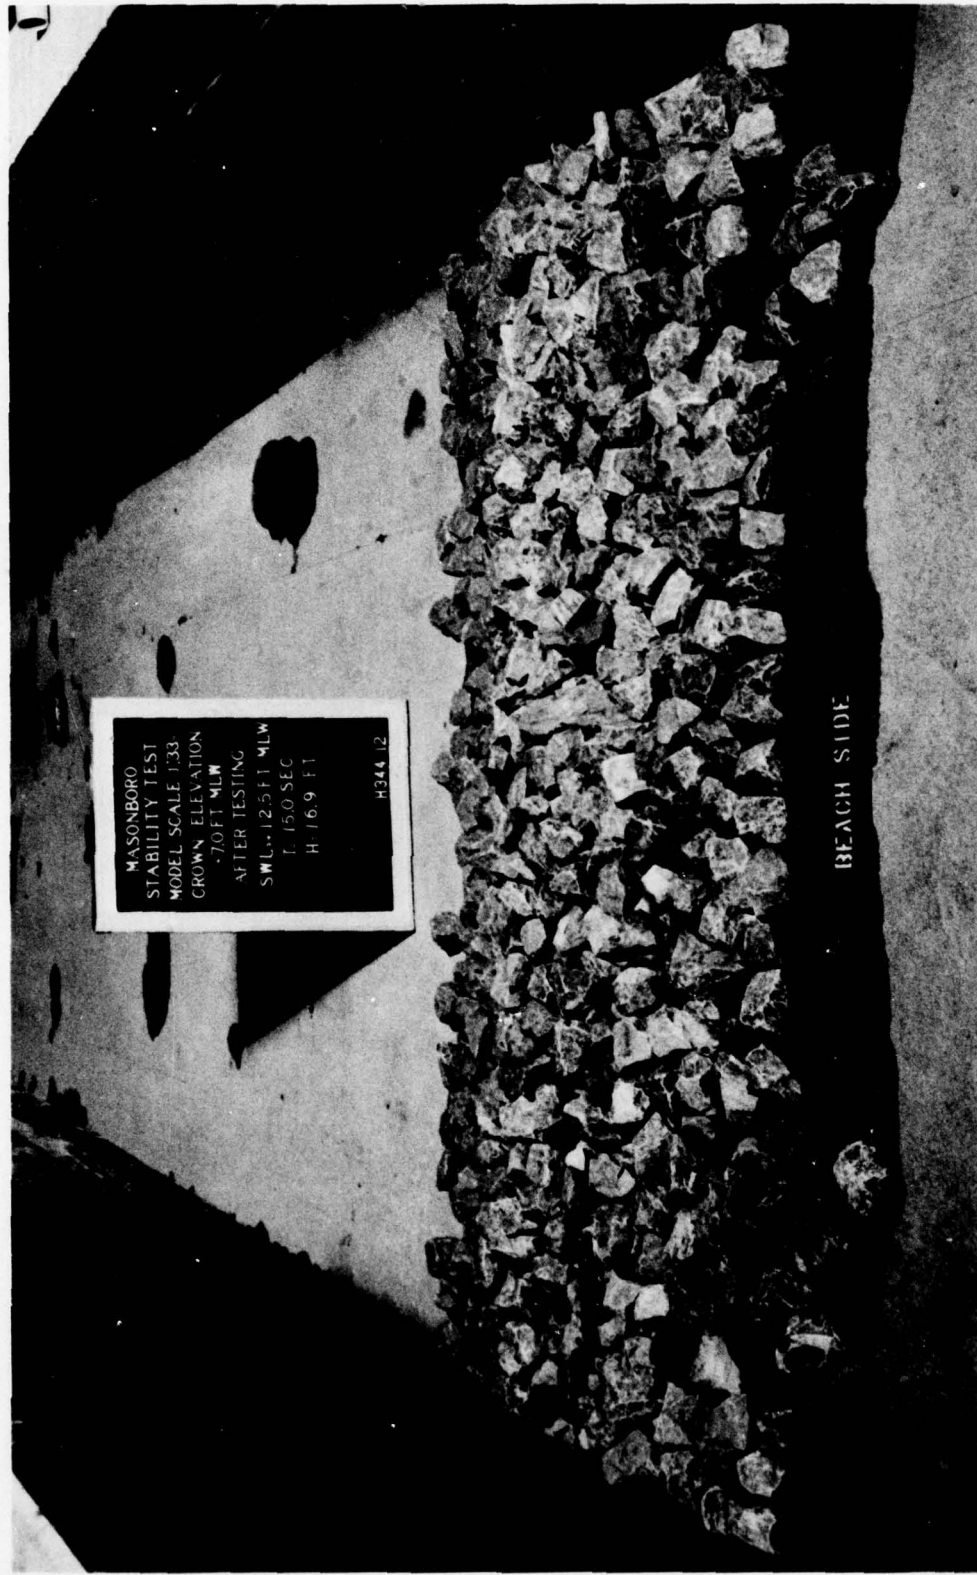
Photo 12. Beach-side view of Plan 3 after attack of 15-sec, 16.9-ft waves at an swl of +12.5 ft mlw for 2 prototype hr

14. Observations of Plan 3 under wave attack indicated that some of the damage to the crown area may have been initiated by sliding of the toe armor. It is felt that the sliding of the toe armor which occurred in the model may not be a realistic simulation of the prototype because sand impoundment and differential settlement of the gabion mats may increase prototype toe stability above that predicted by Plan 3 in the model. It was, therefore, decided to determine the stability response of the 18-ton armor in the absence of toe slippage.

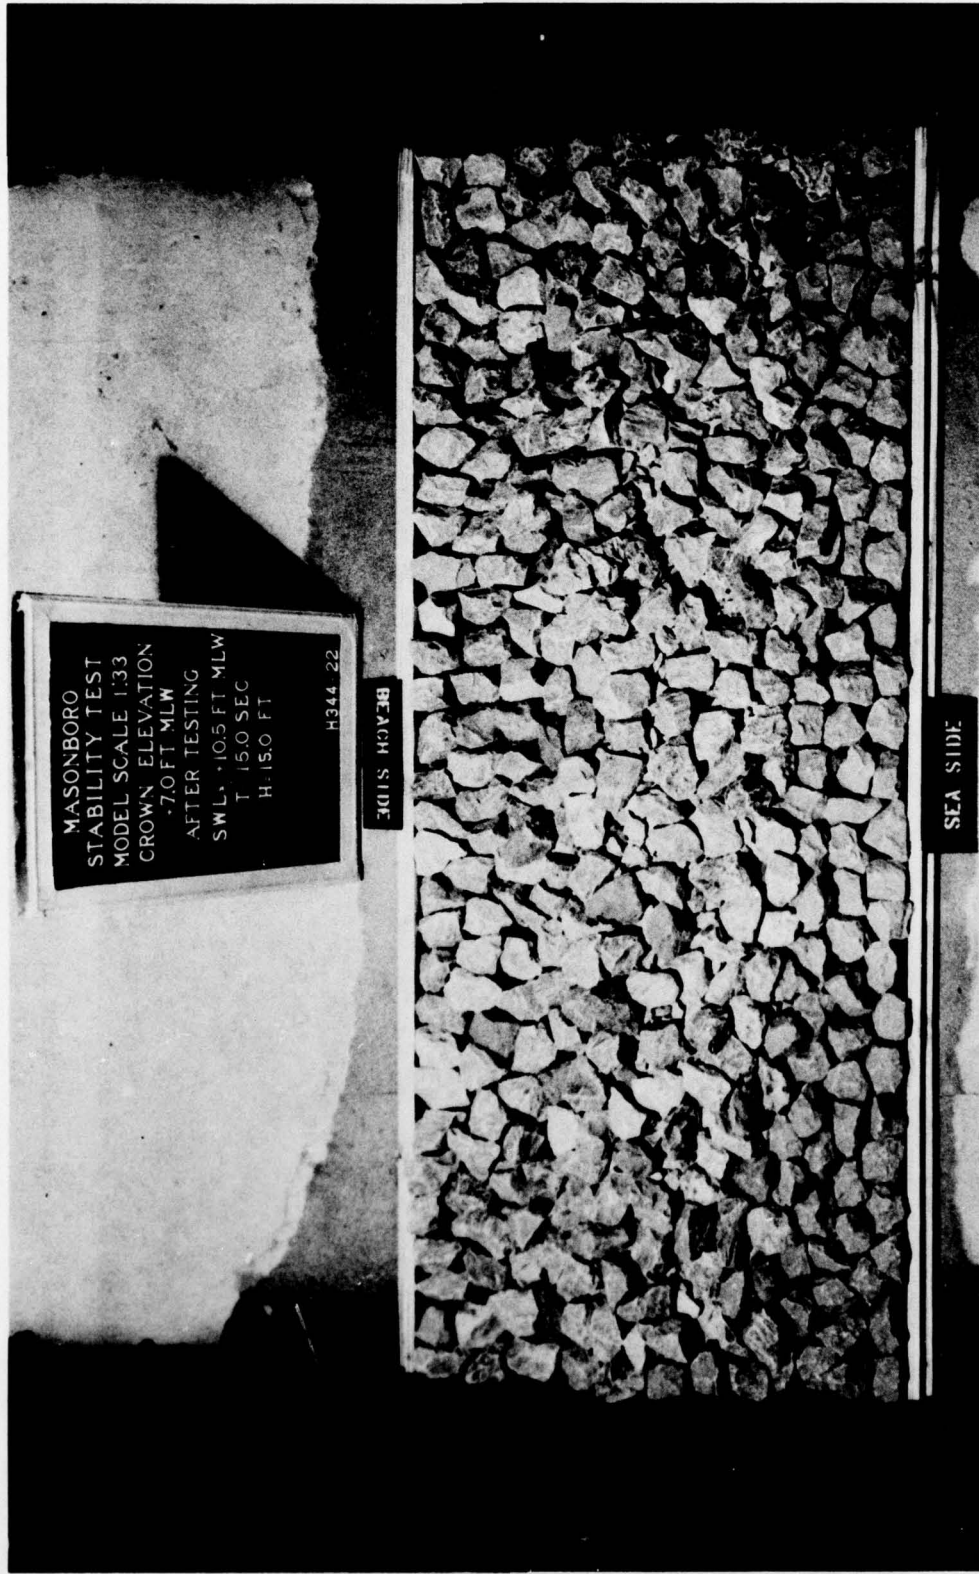
MASONBORO  
STABILITY TEST  
MODEL SCALE 1:33  
CROWN ELEVATION  
-7.0 FT MLW  
AFTER TESTING  
SWL, +10.5 FT MLW  
T, 15.0 SEC  
H, 15.0 FT  
H344-22

Photo 19. Overhead view of Plan 3A after attack of 15-sec, 15-ft waves at an swl of +10.5 ft mlw for 2 prototype hr

15. Plan 3A (Plate 6) was the same as Plan 3 except small wooden strips were placed along the seaward and beachward toes of the structure to prevent horizontal sliding of the toe armor. The structure was initially subjected to 15-sec, 13.5-ft waves at an swl of +8.5 ft mlw for 2 prototype hours. As shown in Photos 14-16, this wave condition produced minor damage to the crown with 2 armor units being displaced onto the beach side of the structure. The swl was then raised to +10.5 ft mlw and the structure was subjected to 15-sec, 15-ft waves for 2 prototype hours. As can be seen in Photos 17-19, the structure's crown received moderate to extensive damage with the average elevation being lowered 1 to 2 ft. Seven armor units were displaced from the crown and the core stone was exposed in several areas sufficient to require 6 or 7 armor stones to cover the exposure. Finally the swl was raised to +12.5 ft mlw and the structure was subjected to 15-sec, 16.9-ft waves for 2 prototype hours. Referring to Photos 20-22, it can be seen that this condition produced extensive damage to the crown of the structure. The average crown elevation was lowered an additional 1 to 2 ft and exposure of the core stone became more pronounced, requiring up to a total of 10 or 11 armor stones, to cover the exposed areas. Repeat test verified Plan 3A's stability response.
