**SIDE-CHANNEL SPILLWAY AND OUTLET
WORKS FOR SAN ANTONIO DAM**

Hydraulic Model Investigation

Report No. 2-106
October 1978

U. S. Army Engineer District, Los Angeles
CORPS OF ENGINEERS
Los Angeles, California

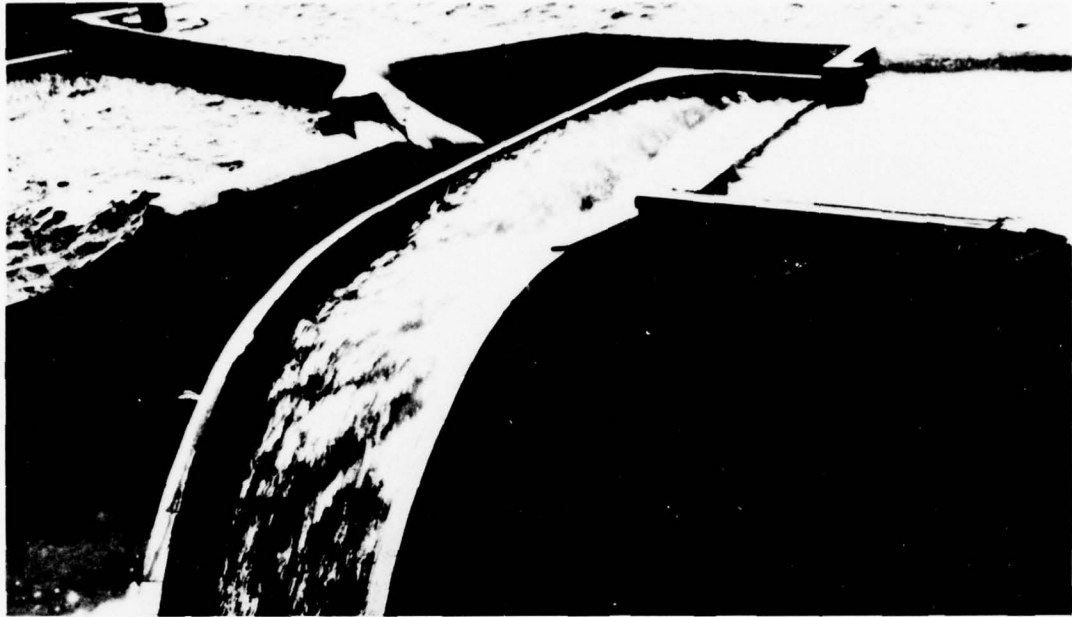
a. Upstream view

b. General view

Photo 4. Final design flow conditions, 1:48-scale
model, discharge 54,000 cfs

14. The model was tested for a discharge of 54,000 cfs, the results of which are shown in Photo 4. As previously mentioned, some improvement in the conditions of flow in the side channel was effected by the baffle blocks; however, the flow became more stable through as well as downstream from the curved transition. The water-surface profiles measured along both the right and left walls of the chute are shown in Plate 7. The profiles indicate that the wall heights provided adequate freeboard to confine the flow. The water-surface cross sections from sta 9+50 to sta 11+95.49 for a discharge of 54,000 cfs are presented in Plate 8.

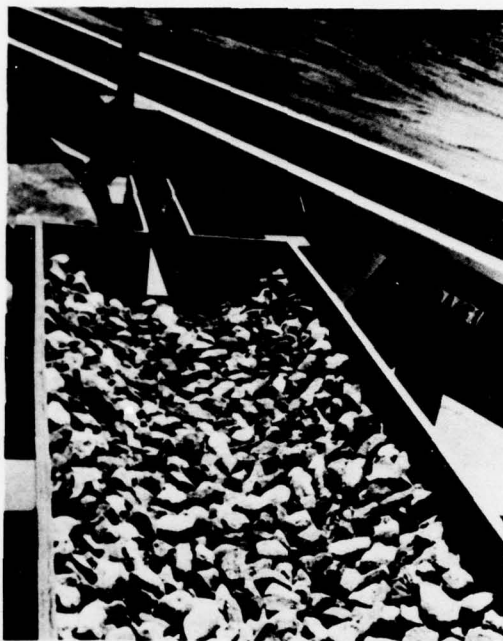
Photo A2. Close-up of diversion channel

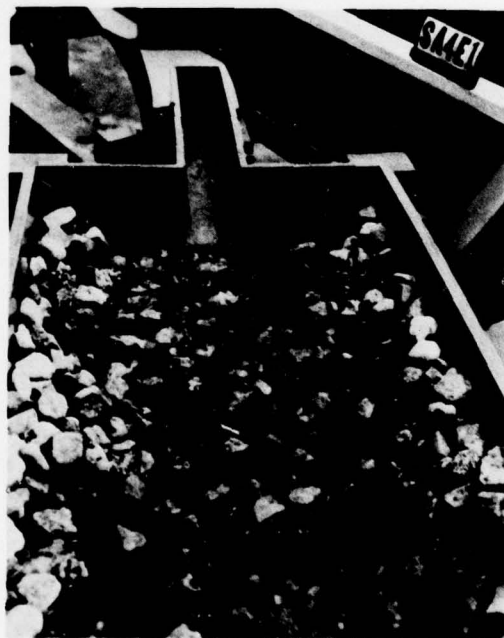
Photo A4. Looking upstream with diversion gate open at flow entering diversion channel,
 $Q = 100$ cfs

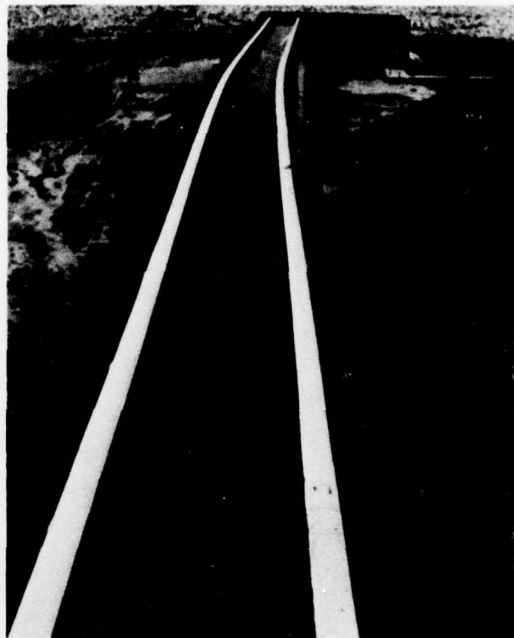
Photo A14. Looking downstream at flow slot with diversion gate open, $Q = 5,000$ cfs
