Report No. FAA-RD-78-130

**EVALUATION OF CATHODE-RAY TUBE PROTECTION
AND ANTIREFLECTIVE SURFACES FOR THE PLAN
VIEW DISPLAY**

FINAL REPORT

**U.S. DEPARTMENT OF TRANSPORTATION
FEDERAL AVIATION ADMINISTRATION
Systems Research & Development Service
Washington, D.C. 20590**

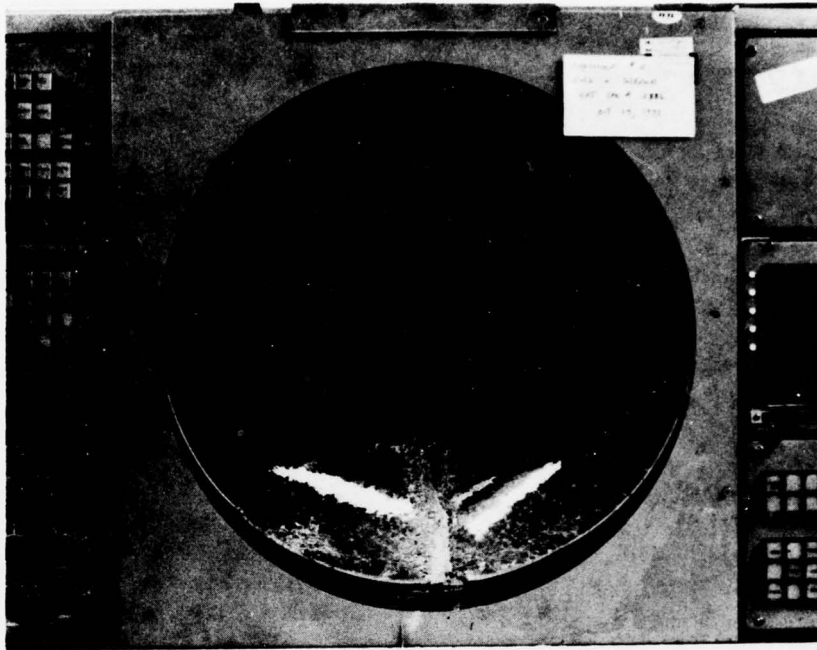
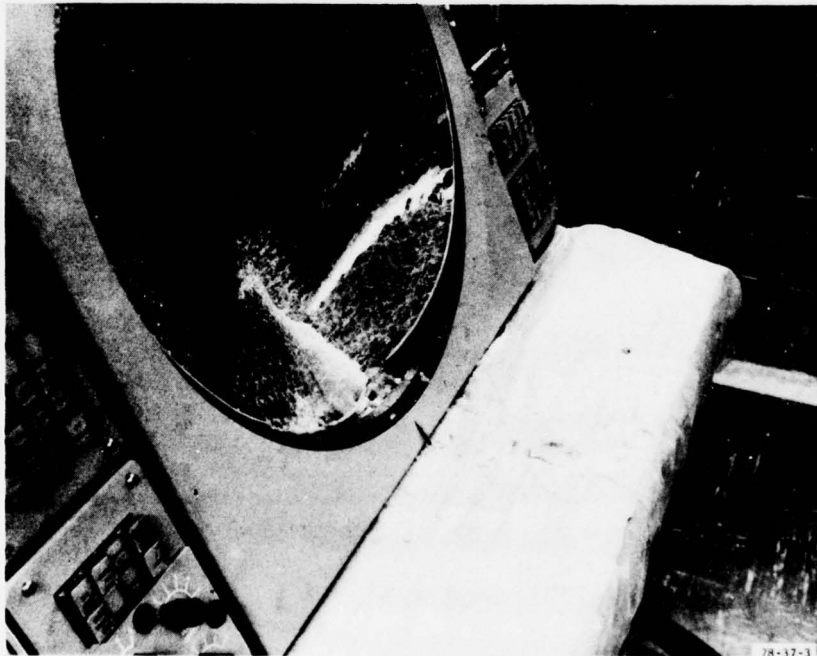
FIGURE 2. EFFECTS ON ORIGINAL-TYPE OUTER VIEWING SURFACE CAUSED BY IMPLOSION OF ORIGINAL-TYPE CRT

mushroomed on impact, necessitating substitution of a carbide-tipped punch. The use of this carbide-tipped punch, in conjunction with a can of coolant spray, produced a successful system for generating implosions on command. As the implosion testing began, about every other CRT imploded violently. Of the 43 original unmodified CRT's used in these tests, 21 imploded violently. In every case utilizing the chill and punch technique, the CRT was at least cracked across the faceplate, which resulted in it devacuating. With the eleventh CRT, a violent implosion occurred that closely duplicated the Cleveland implosion (figure 2).
