AFML-TR-78-106

EXPLORATORY DEVELOPMENT OF RESONANT METAL RADOMES

MCDONNELL DOUGLAS AERONAUTICS COMPANY-ST. LOUIS DIVISION
St. Louis, Missouri 63166 (314) 232-0232

FINAL REPORT

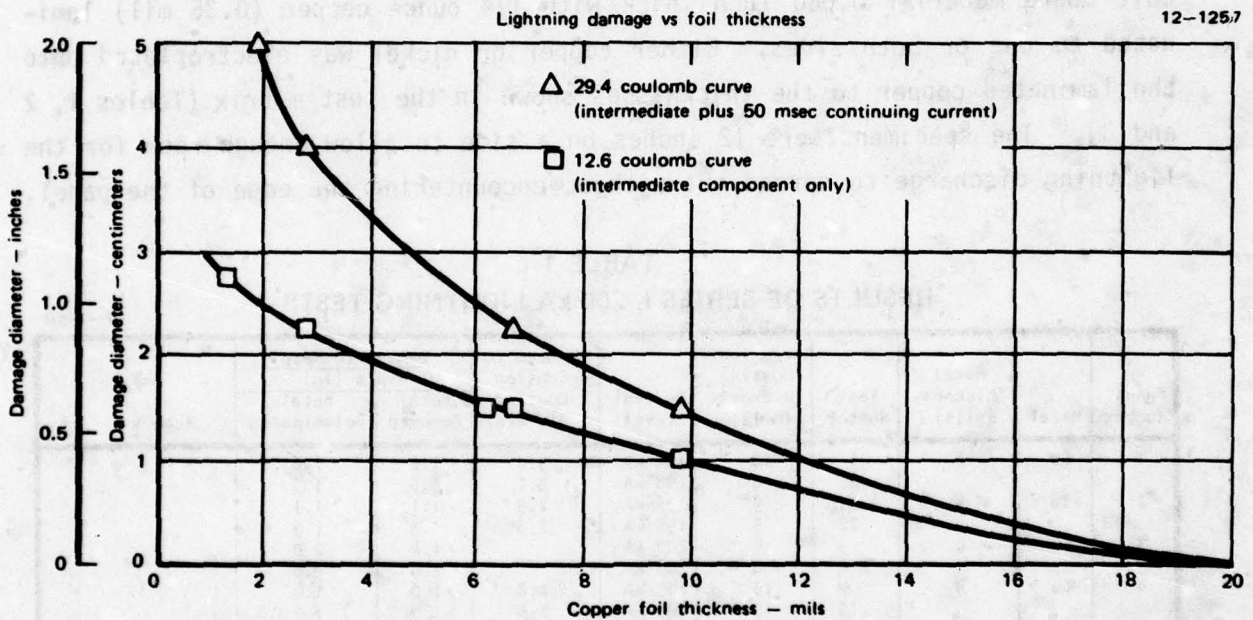
Figure 10 Intermediate and continuing current damage to copper coated fiberglass panels

To demonstrate the relative severity of the high peak current and intermediate current components, preliminary evaluation tests were conducted at the McDonnell Douglas Lightning Simulation Laboratory on copper coated fiberglass panels. These tests showed that a 145 kA pulse twice as wide as the MIL-B-5087B pulse failed to burn through a 67 mil copper coating, while an intermediate current pulse of 3 kA for about 5 milliseconds burned a 1.5 cm diameter hole in the same thickness metal coating.

high peak current pulse, b) a full 5 millisecond intermediate current pulse, and c) a 5 millisecond intermediate current pulse plus 50 milliseconds of continuing current transfer at a rate of about 400 amps. The results of these tests are summarized in Figure 10 and illustrated in Figures B-1 through B-4 of Appendix B. The data demonstrate conclusively that the new specification poses the more severe threat, requiring thicknesses up to 18 mils for uncoated metals, and even thicker coatings for overcoated systems, in order to achieve the zero damage level. These tests do demonstrate however, that the extra damage done by the intermediate and continuing current waveform only adds to the metal damage; i.e., the substrate is still protected.

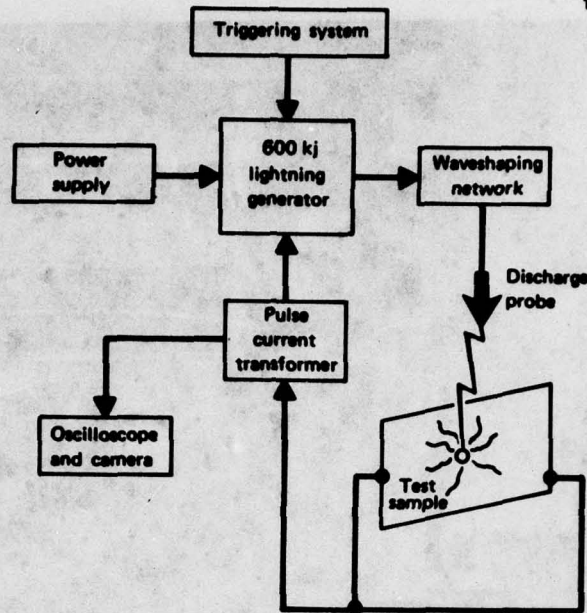
Figure 12 Simplified block diagram of lightning test setup

Test Setup - The basic test setup is schematically illustrated in Figure 12 and is pictured in Figure 13. This setup was the same throughout the testing except for the test panel holding fixture which was modified to provide a ground on two opposite sides of the panel. This was necessary for the thinner metal coatings used in the second test series, in order to center the damage and reduce edge effects noted on panels 14, 15 and 17. Additionally, it was found that the 0.060 inch panel thickness was not sufficient to contain the explosive forces generated at the strike point, so all test panels were backed by 1/4 inch phenolic sheet to simulate the strength of a radome.

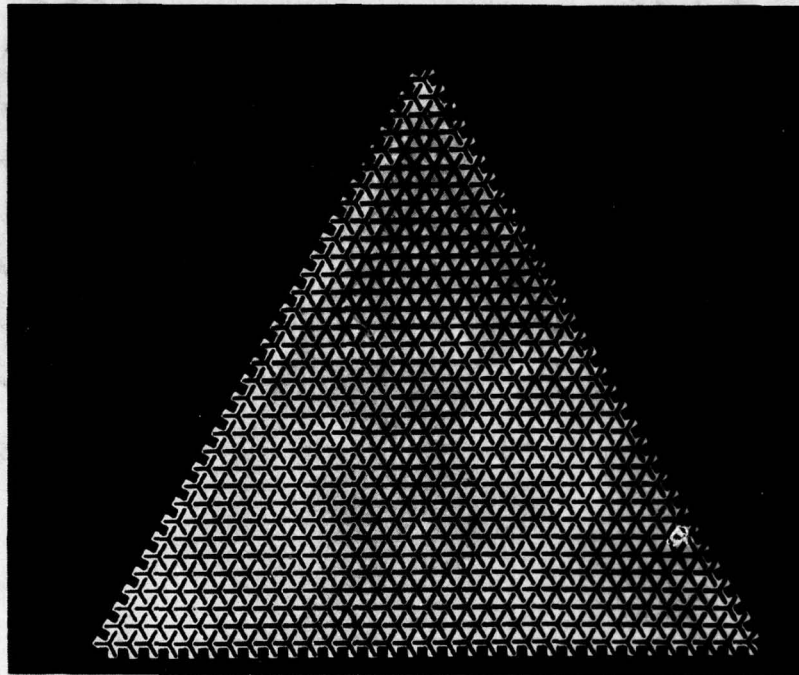
12-1289

Figure 50 Typical 60° triangle like that used on test panel No. 3.

of one of those copper triangles and Figure 51 shows how the various triangles interface with each other in the combinations actually found on the radome.
