CORPS OF ENGINEERS ANCHORAGE AK ALASKA DISTRICT  
FLOOD PLAIN INFORMATION. KENAI RIVER, PHASE I. KENAI PENINSULA --ETC(U)  
JUN 73

DEPARTMENT OF THE ARMY  
 ALASKA DISTRICT, CORPS OF ENGINEERS.  
 ANCHORAGE, ALASKA  
 FLOOD PLAIN INFORMATION  
 KENAI RIVER  
 KENAI PENINSULA BOROUGH, ALASKA  
 GENERAL MAP  
 JUNE 1973

**INDEX MAP  
FLOOD PLAIN INFORMATION  
KENAI RIVER  
KENAI PENINSULA BOROUGH  
ALASKA**

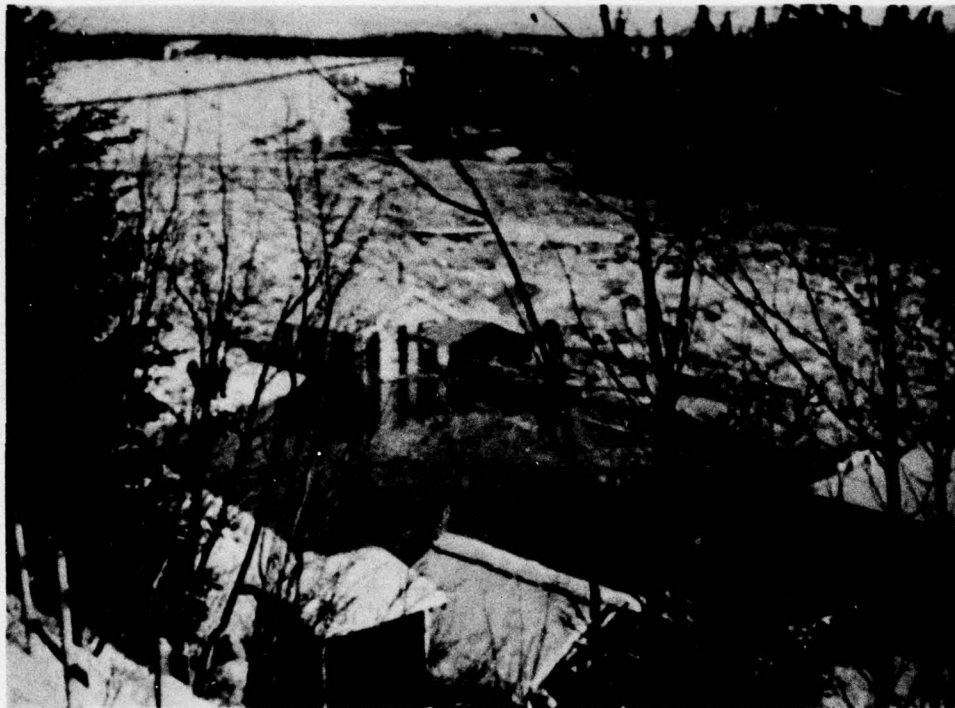
FIGURE 3 - January 1969 flood on Kenai River at Moose River.  
(Courtesy of Laura Tyson).

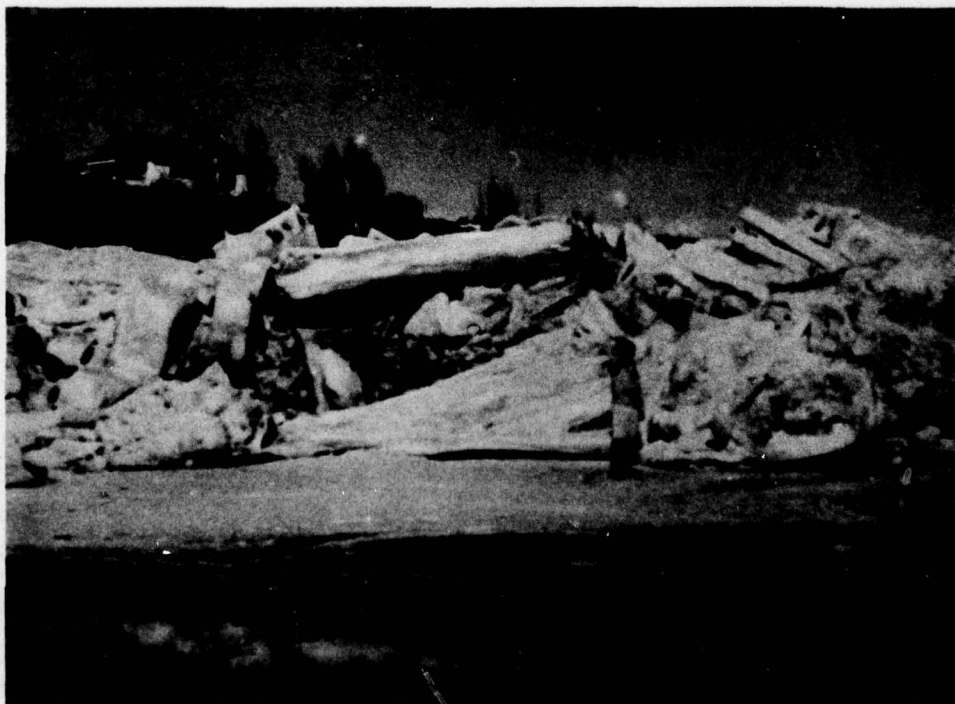
FIGURE 4 - Ice left behind at Moose River by the January 1969  
flood on Kenai River. (Courtesy of Laura Tyson).

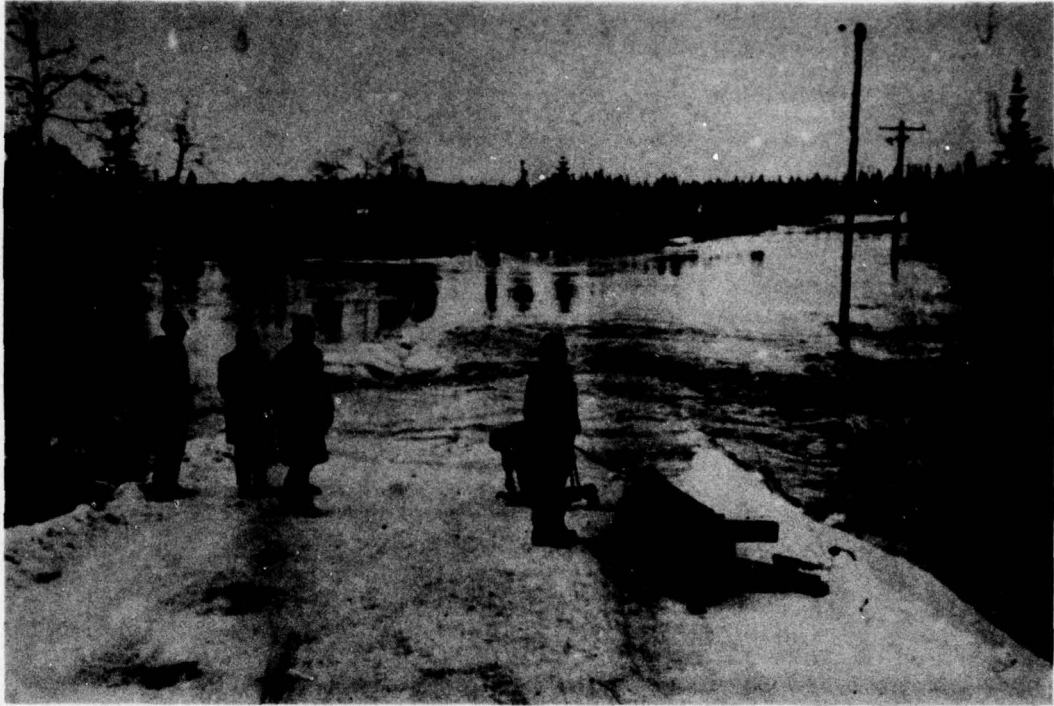
FIGURE 5 - Flooding in the Kenai - Soldotna area in January 1969.  
(Courtesy "Cook Inlet Courier").

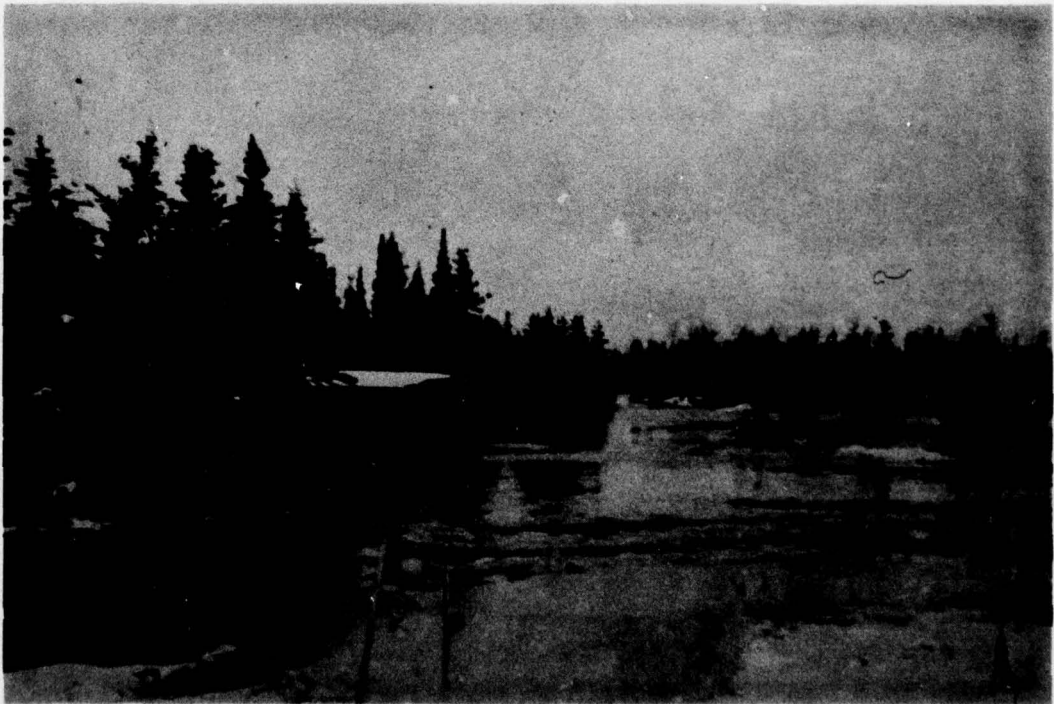
FIGURE 6 - Overbank flooding during the January 1969 flood on Kenai  
River. (Courtesy "Cook Inlet Courier").

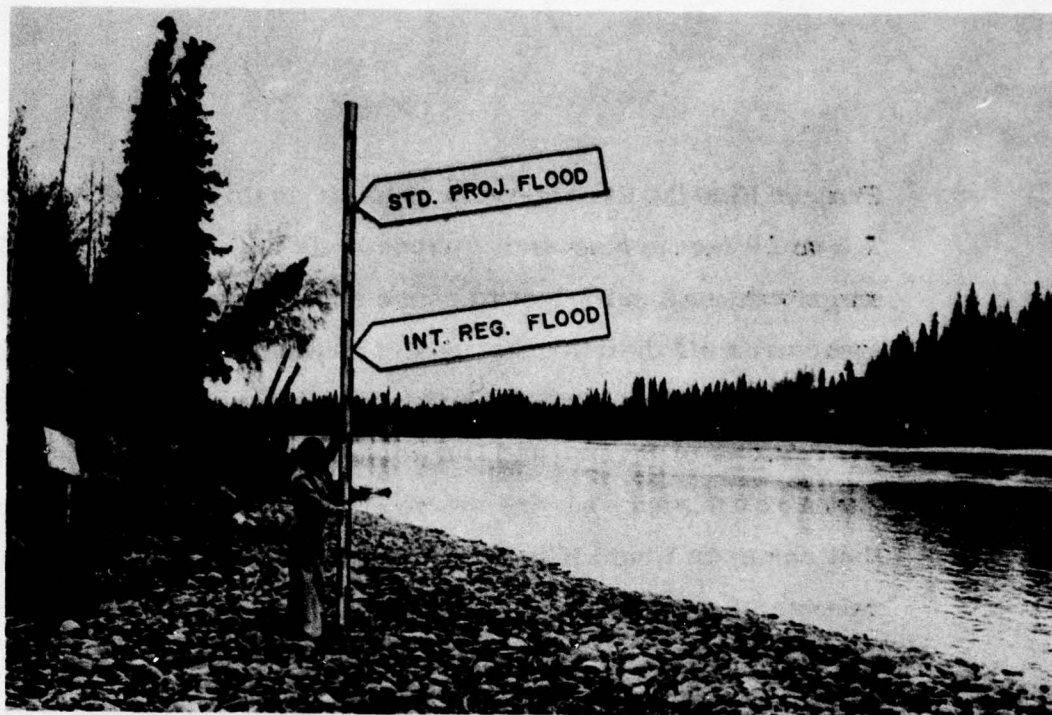
FIGURE 9 - Future flood heights on Kenai River at the Slash E Ranch.

**Photographs, Future Flood Heights** - The levels that the Intermediate Regional and Standard Project Floods are expected to reach at various locations in the study area are indicated on the following photographs:

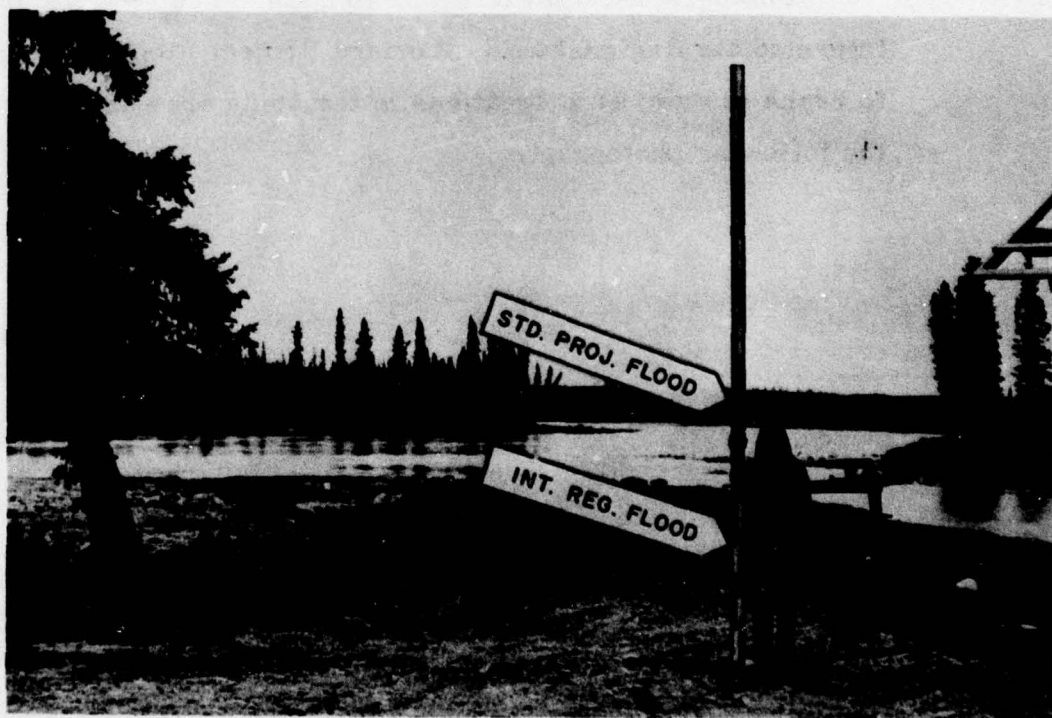
FIGURE 10 - Future flood heights at the confluence of the Kenai and Funny Rivers.

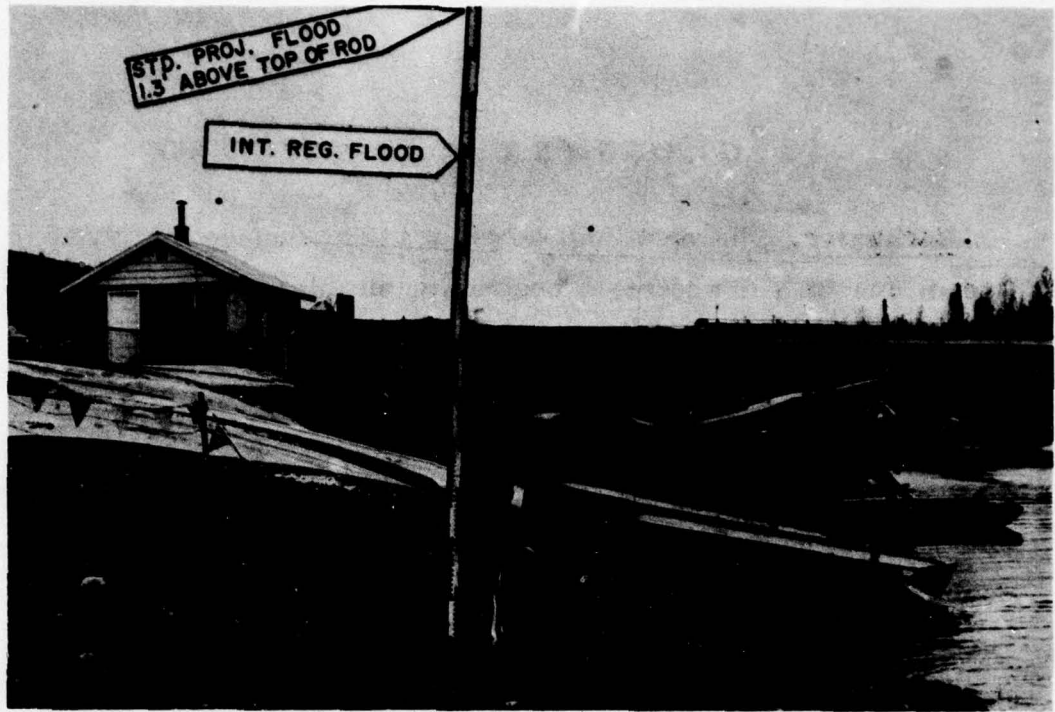
FIGURE 11 - Future flood heights at the confluence of the Moose and Kenai Rivers.

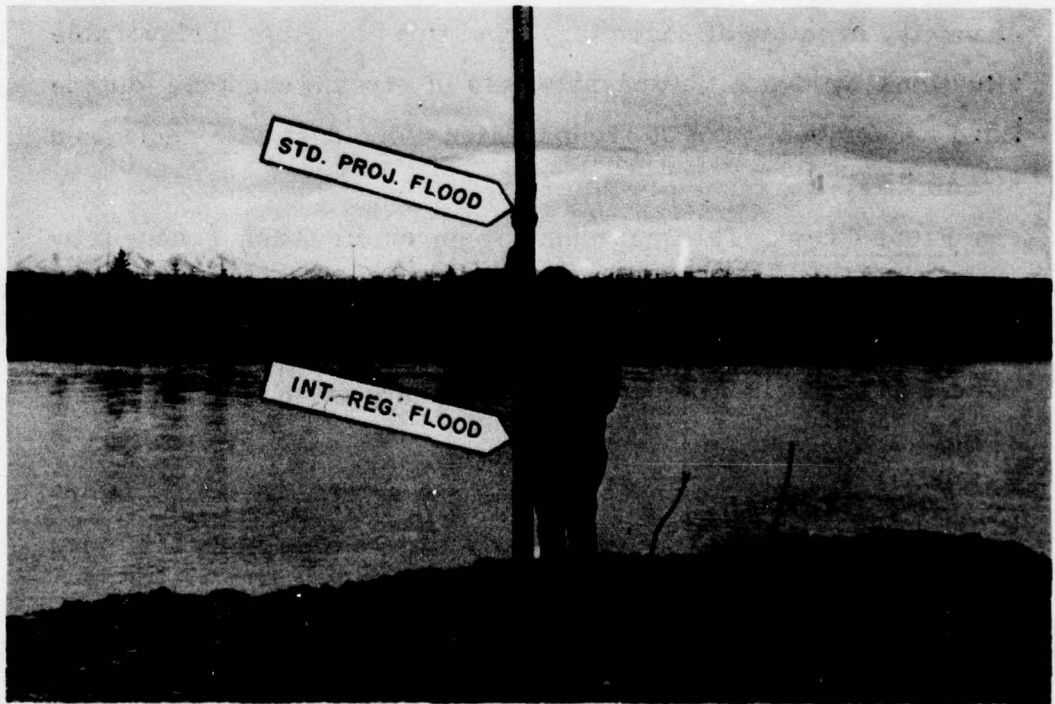
FIGURE 12 - Future flood height at Cross Section 15. Fill is about 6 feet above the water surface.
