MINISTRY OF DEFENCE LONDON (ENGLAND)
HELICOPTER ICING SYMPOSIUM, 6-7 NOVEMBER 1978, LONDON, (U)
NOV 78 T C DON

| REPORT DOCUMENTATION PAGE | | READ INSTRUCTIONS BEFORE COMPLETING FORM |
|--|--|--|
| 6. TITLE (and Subtitle) Helicopter Icing Symposium, 6-7 November 1978, London, | | 5. TYPE OF REPORT & PERIOD COVERED |
| 11. CONTROLLING OFFICE NAME AND ADDRESS NATO Army Armaments Group Panel X, Helicopter Icing Subgroup | | 12. REPORT DATE November 1978 |

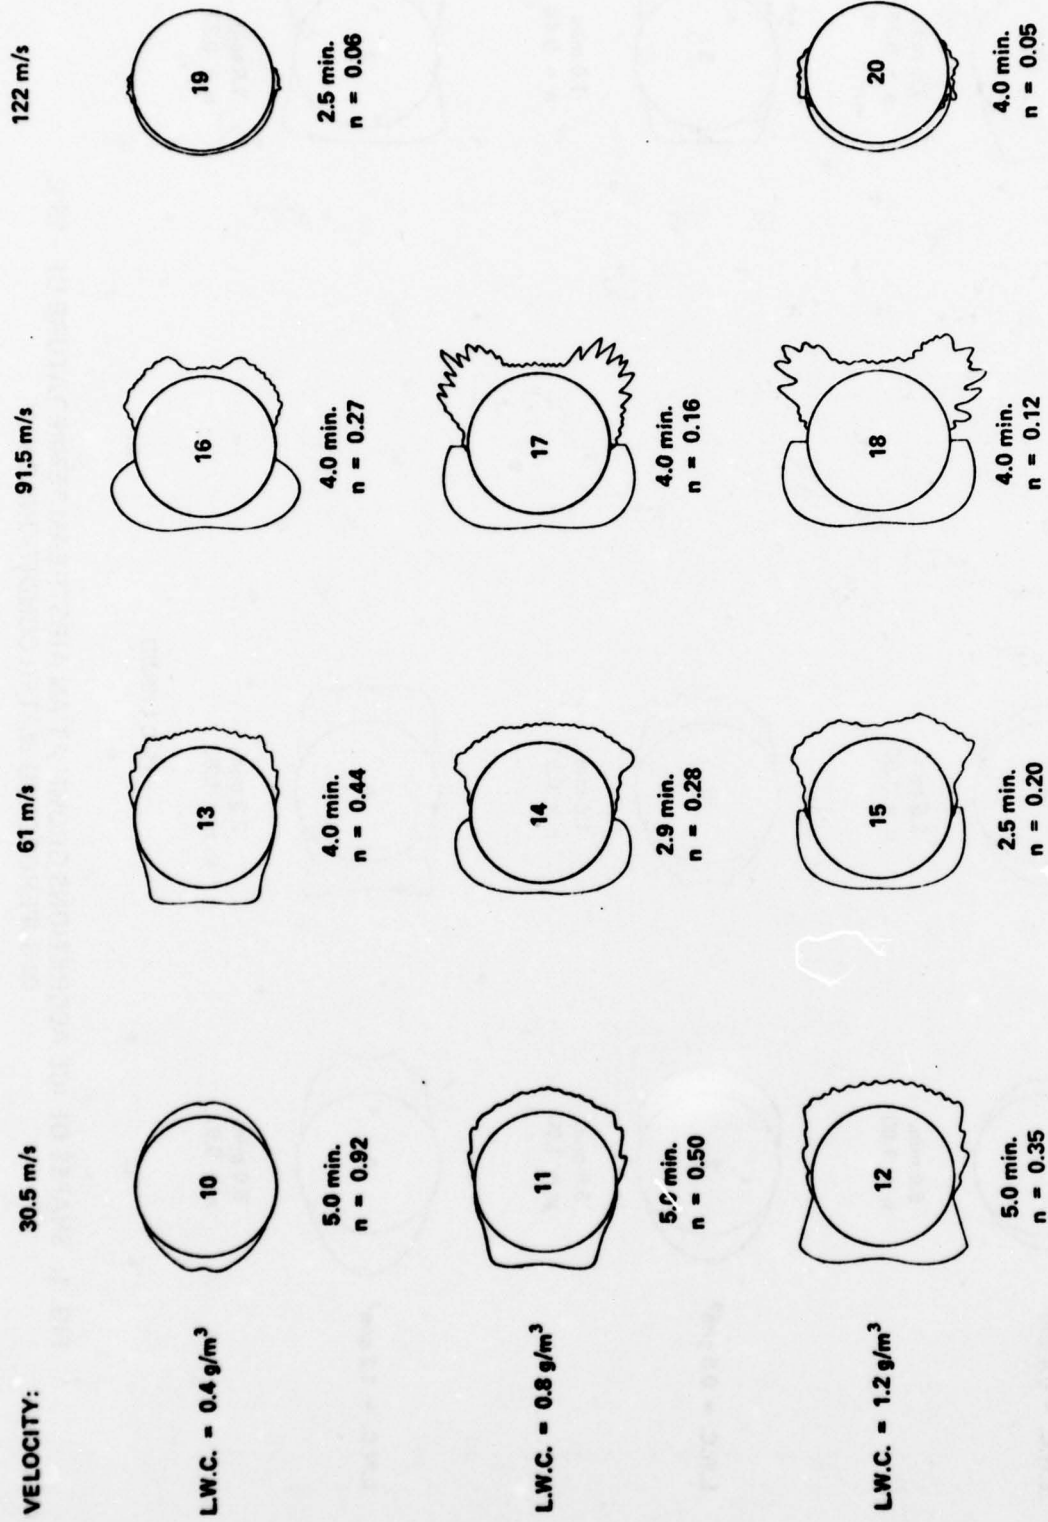
FIG. 2: SHAPES OF ICE ACCRETIONS GROWN AT AN AIRSTREAM TEMPERATURE OF -5°C
IN SUPERCOOLED WATER CONDITIONS ONLY

MODEL PREDICTIONS FACE LEFT; EXPERIMENTAL PROFILES FACE RIGHT

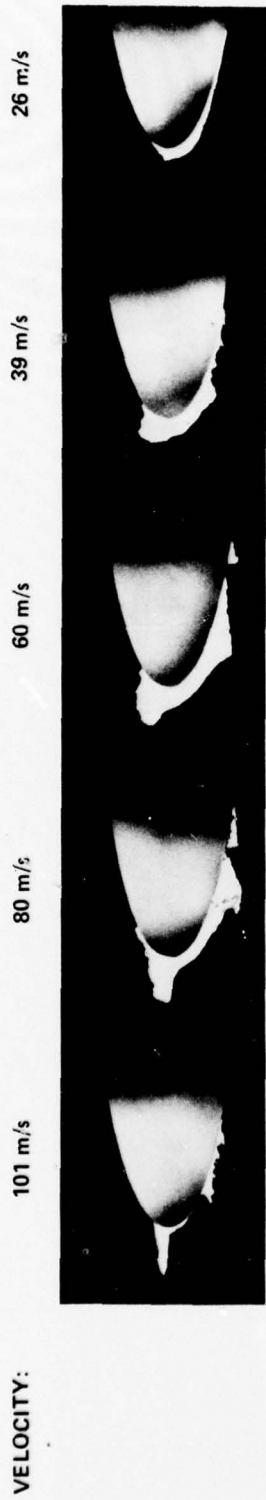
ICE ACCRETION PROFILES FROM S-55 FLIGHT IN SPRAY RIG
 TEMPERATURE: -2.5°C L.W.C.: $\sim 1.0\text{ g/m}^3$ ICING TIME: 23.4 min.

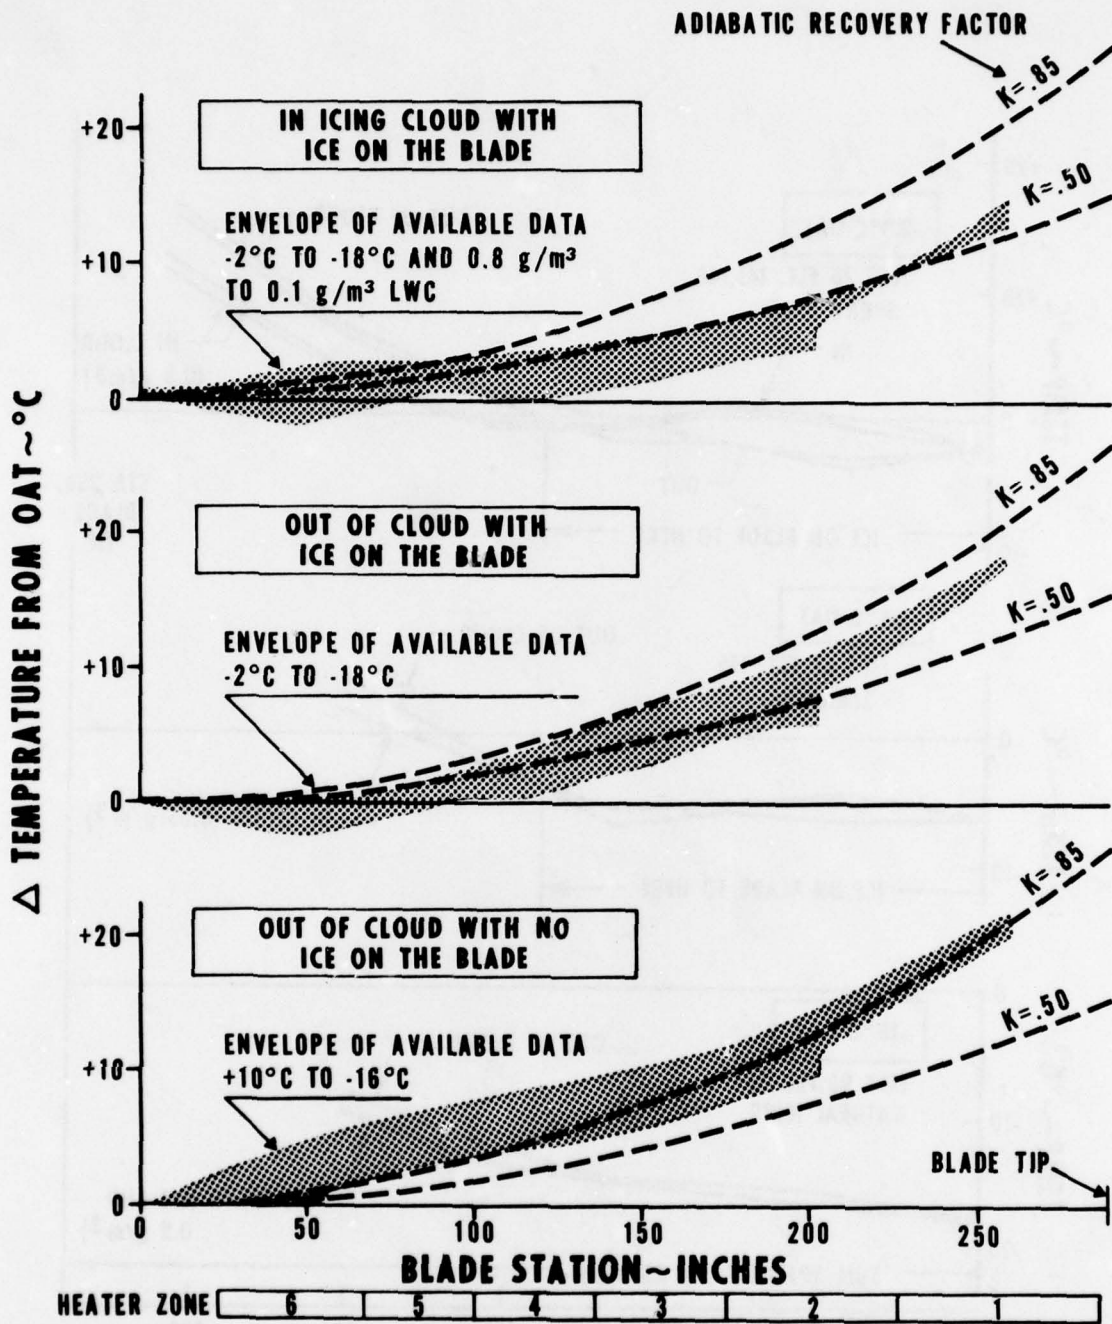
Figure 21. MAIN ROTOR BLADE SURFACE TEMPERATURE MEASURED UNDER DIFFERENT OPERATING CONDITIONS

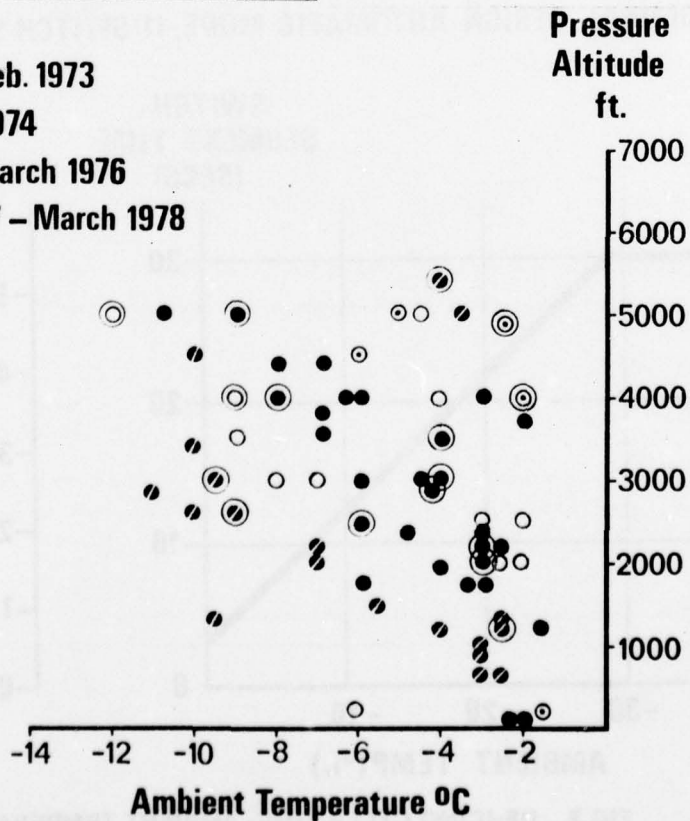
FIG.4. SUMMARY OF TESTS IN NATURAL ICING CONDITIONS

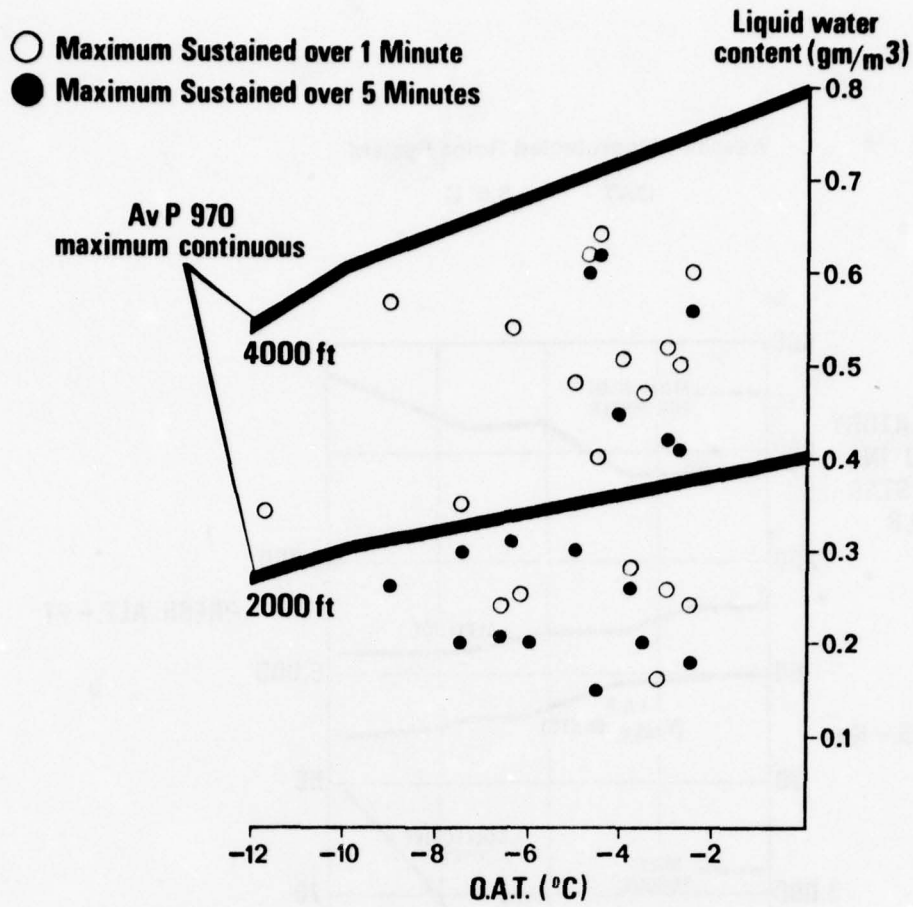
FIG.5. NATURAL ICING CONDITIONS 1977/78

WESSEX HEATED ROTOR BLADE SYSTEM
4900 FT PRESSURE ALTITUDE
80 KTS IAS
-2°/-3°C AMBIENT TEMPERATURE

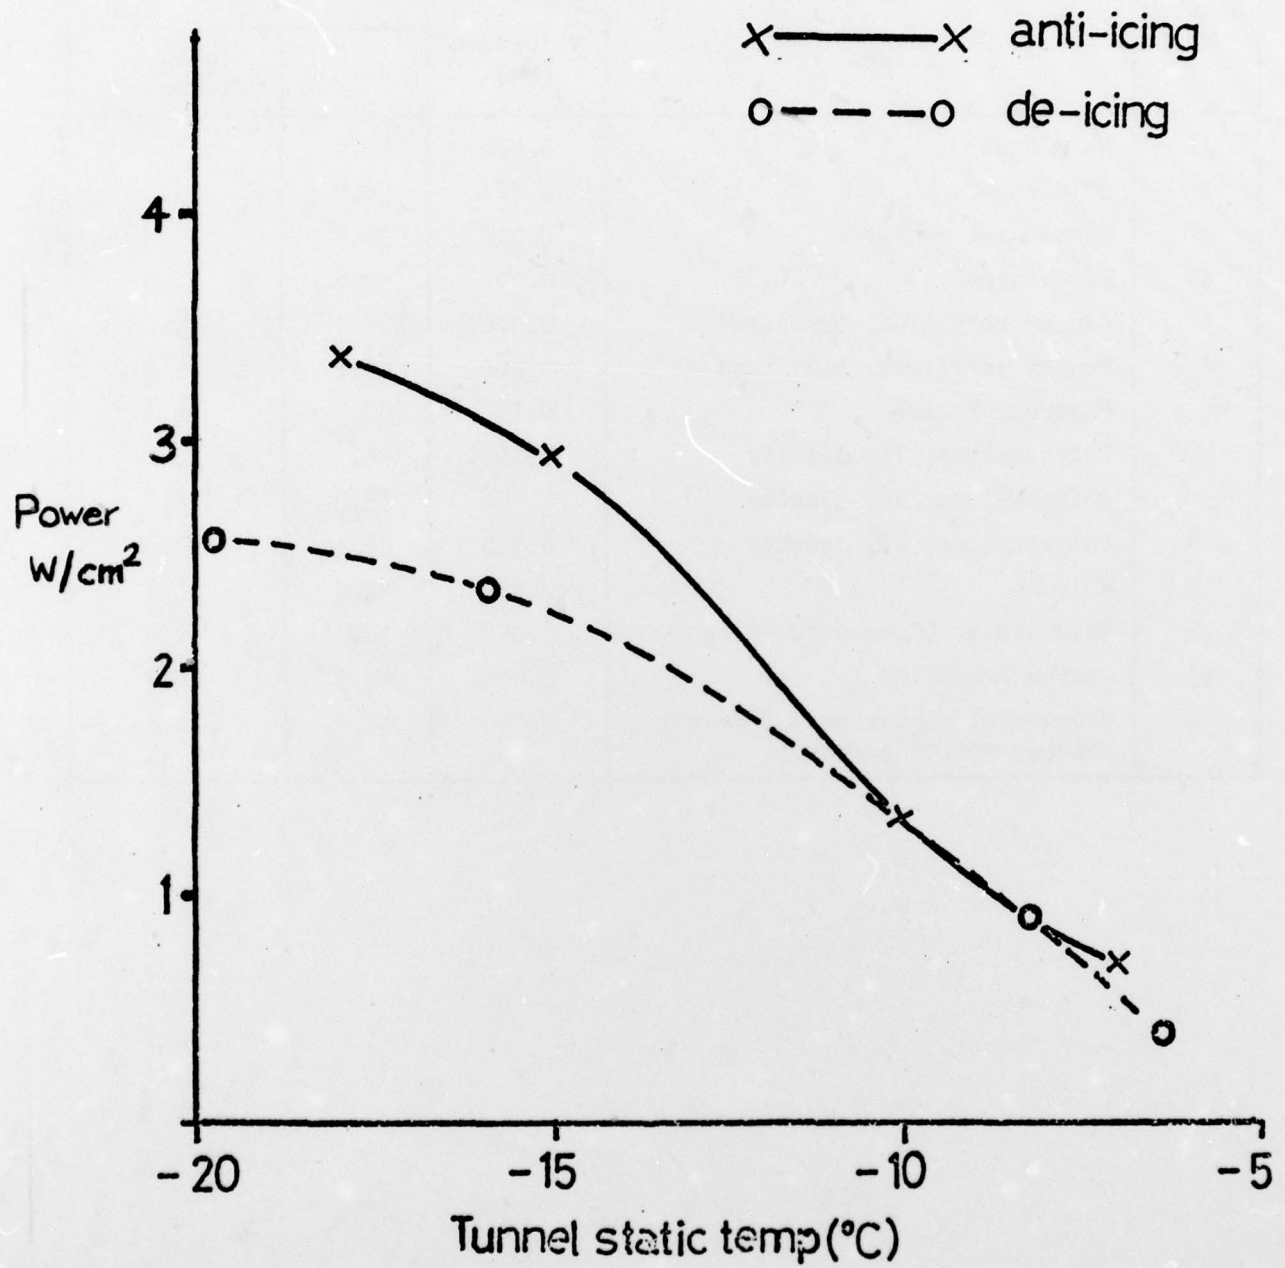
FIG.1
Anti-icing and de-icing
threshold, 50mm mat
