DTNSRDC-79/063

FATIGUE FAILURE PREDICTION BY X-RAY
DOUBLE CRYSTAL DIFFRACTOMETRY

SHIP MATERIALS ENGINEERING DEPARTMENT

June 1979

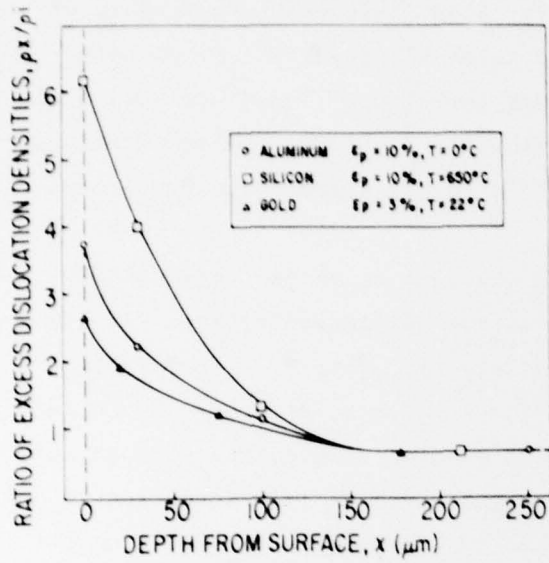
Figure 1 - Distribution of Excess Dislocations with Depth from the Crystal Surface, Expressed as the Ratio of the Density $\bar{\rho}_x$ at Each Depth to that of the Bulk $\bar{\rho}_1$.

Tensile Axis and Surface

Orientations:

Al, $\langle 100 \rangle$ and (100);

Si, $\langle 110 \rangle$ and (112);

Au, $\langle 123 \rangle$ and (311)

As shown in Figure 1, a decreasing gradient of excess dislocation density from surface to bulk was obtained for all three species. It will be noted that there was a decline by factors of 2.7 to 6.2, from a high surface dislocation density $\bar{\rho}_s$ to a constant value $\bar{\rho}_i$ at about 150 μm into the interior. Although tested to only 3% plastic strain, the gold revealed a similar gradient. This result indicates that oxide film formation is not a necessary prerequisite for the decrease of excess dislocations from the surface to the interior. A relation proposed to describe the dislocation gradient in ground alkali halide crystals¹² can be employed in this study to convert the obtained curves of Figure 1 into the linear form

where $\bar{\rho}_x$ is the excess dislocation density at the depth distance x . The linear conversion yielded a consistent material-independent slip k of about 2.85 for all three materials.

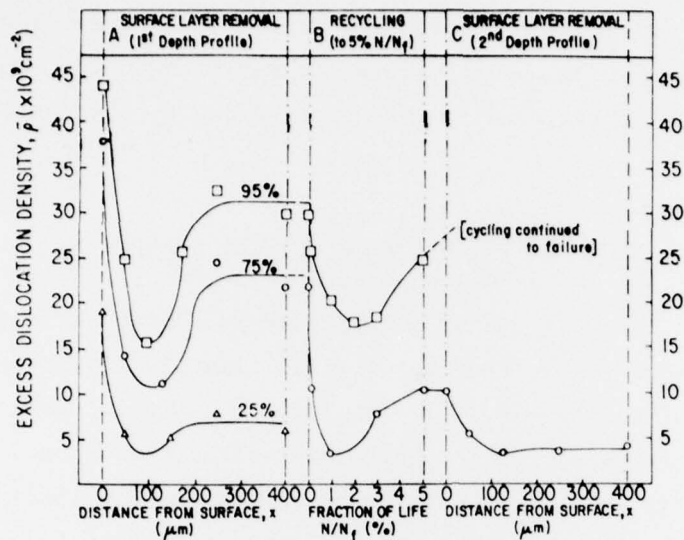
Figure 3 - Composite Diagram for Al 2024 Specimens Given Prior Fatigue to 75 and 95% of Their Life at ± 200 MPa, Followed by Surface Removal (Part A) and Recycling (Part B), and Either Continued Recycling or X-ray Analysis in Depth (Part C)

Al 2024 alloys were cycled in the push-pull mode at an amplitude of ± 200 MPa corresponding to the proportional limit in static tension. The fatigue behavior of the specimens is given in Table 1. As shown in Figure 3, Part A, the measured rocking curve halfwidths, and thus the derived excess dislocation densities, increased throughout the specimen with increased cycling. Analogous to the deformation characteristics of monotonically and cyclically deformed single crystals, the depth profile analysis of Part A in the figure revealed higher excess dislocation densities in the surface layer. After 0.15% of the fatigue life, a decreasing gradient to a constant bulk level was obtained, similar to that observed for simple tension (the first half cycle of push-pull fatigue). For 5% of the fatigue life, an increase to a bulk plateau level was again evident, as found previously for single crystal fatigue.

To test the stability of the defect structure in the grains of the bulk induced by cycling, a further experimental program was carried out. As shown in the composite diagram of Figure 3, the surface layers of previously cycled specimens were removed by electropolishing to a depth of 400 μm . The specimens given prior cycling to 75 and 95% of their life, followed by the surface removal, were then recycled at the same amplitude. The excess dislocation density declined rapidly during the initial recycling, as revealed in Part B of the figure. This remarkable experimental observation has to be attributed to the instability of the bulk structure on initial cycling when the work hardened surface is absent. After reaching a minimum at 1 to 2% of the life, the density increased again, since a new, work hardened surface layer was again being formed.

When the recycling process was interrupted after 5% to obtain a second depth profile, as exhibited in Figure 3, Part C, the analysis of the specimen given 75% prior cycling revealed an excess dislocation density over the entire cross section nearly equal to the value of the undeformed, virgin specimen. The instability of the bulk dislocation

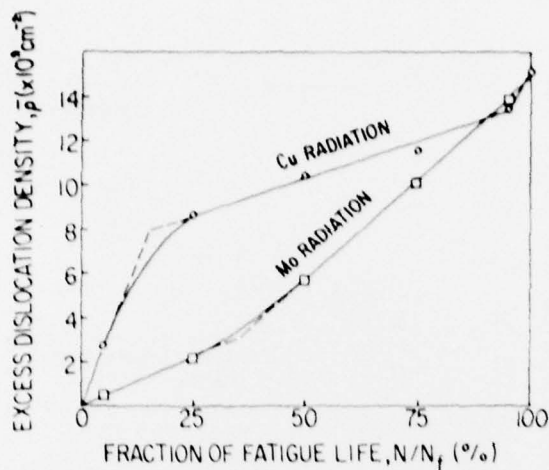
Figure 5 - Comparison of Excess Dislocation Densities Measured During the Fatigue Life by Analysis with Copper and Molybdenum Radiations. Maximum Penetration Distances: $\text{CuK}\alpha$, 37 μm ; $\text{MoK}\alpha$, 350 μm

By carrying out halfwidth measurements as a function of the life fraction, utilizing deeply-penetrating molybdenum radiation, grains at depths up to 350 μm could be analyzed. Figure 5 shows a comparison of the excess dislocation densities obtained by analysis with Cu and Mo radiations, which differ in maximum penetration by an order of magnitude. Unlike the rapid saturation of the dislocation density for surface grains, as sampled by Cu radiation, analysis with Mo radiation provided a much steeper and nearly linear increase. At failure, the terminal dislocation density was identical to the critical excess dislocation density $\bar{\rho}^*$ measured using Cu radiation. This steeply inclined dependence of $\bar{\rho}$ with fatigue life permits a much more accurate prediction of the final failure. Referring to Figure 3, Part A, it may be seen that this result derives from the gradual increase of the plateau value of $\bar{\rho}$ in the bulk as a function of fatigue life, as compared to the rapid saturation at the surface layer. Only the Mo radiation was able to disclose the gradual increase of $\bar{\rho}$ in the interior.
