AIRBORNE EVALUATION

OF THE PRODUCTION

AN /ARN-133 LORAN-C NAVIGATOR

Final Report

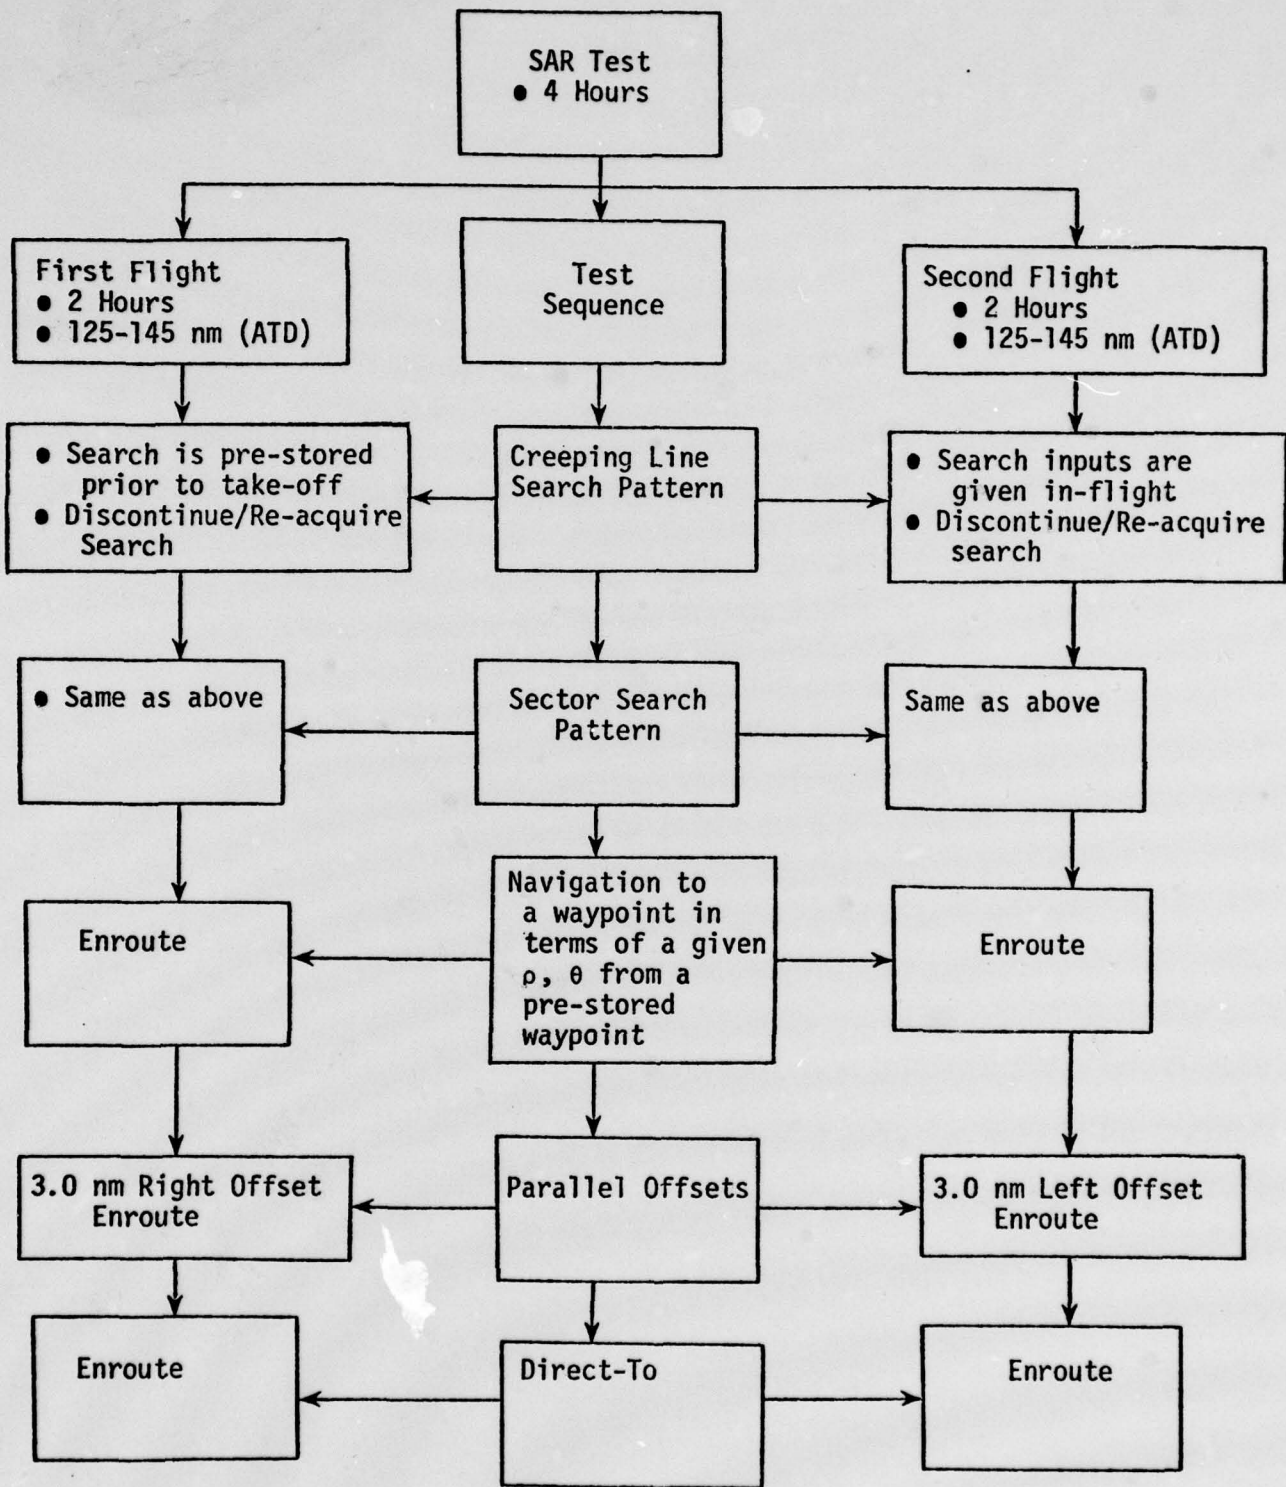
Figure B.22 SAR Flight Test Program

Table B.22 presents the specific set of data that must be entered into the Loran-C Navigator in order to execute the desired Creeping Line and Sector Search patterns. Figure B.23 and B.24 provide detailed waypoint location information for the Creeping Line and Sector Search patterns, respectively. These are presented for documentation purposes.
