AFML-TR-79-4081

# ENVIRONMENTAL DURABILITY OF THE WELDBOND, FPL, AND PABST JOINING SYSTEMS

Northrop Corporation  
Aircraft Group  
3901 West Broadway  
Hawthorne, California 90250

FINAL REPORT FOR PERIOD DEC 1977 - MAY 1979

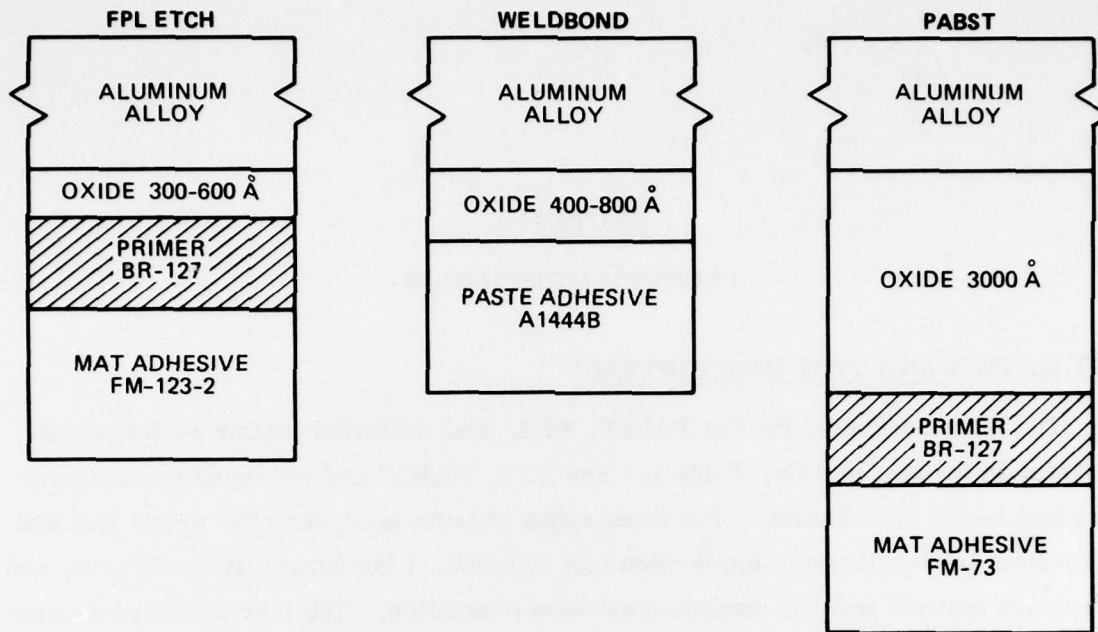
A schematic representation of these systems is shown in Figure 1. The FPL system utilizes a thin (300 to 600 angstroms) boehmite layer ( $\alpha\text{Al}_2\text{O}_3 \cdot \text{H}_2\text{O}$ ), which is formed during the FPL process. This bonding system also includes the BR-127 primer and the FM 123-2 mat adhesive. The weldbond system also utilizes a thin (400 to 800 angstroms) boehmite layer applied by anodizing, but this system does not include a primer. A chromated paste adhesive, Goodrich A1444B, is used for the weldbond system so that the welds can be made through the adhesive. The PABST adhesive system utilizes a much thicker (approximately 3,000 angstroms) boehmite layer and includes the BR-127 primer and the FM-73 mat adhesive. In order to evaluate these three joining systems, three different types of tests, including the wedge test, the constant load-salt water immersion test, and the surface scratch test, were used. Four different environmental exposures were used: (1) 95 to 100 percent relative humidity at 120F, (2) 5 percent salt fog at 95F, (3) 3.5 percent salt water at room temperature, and (4) the McDonnell Douglas sea coast beach site at El Segundo, California. Four material combinations were evaluated for this program: 2024-T3 alclad bonded to 7075-T6 bare, 2024-T3 bare bonded to 7075-T6 bare, 2024-T3 bare bonded to 2024-T3 bare, and 7075-T6 bare bonded to 7075-T6 bare.

FIGURE 1. SURFACE/ADHESIVE SYSTEMS FOR FPL, WELDBOND, AND PABST JOINING PROCESSES

microscope (SEM) analysis on bent specimens was used to determine the thickness of the oxide layer and to provide assurance that the proper surface treatment was achieved. The SEM samples were processed at the same time as the test panels. Typical anodized layers for each material are shown in Figures 3, 4, and 5 for all three surface treatments. The thicknesses of the oxide layers were within the range noted in Figure 1.

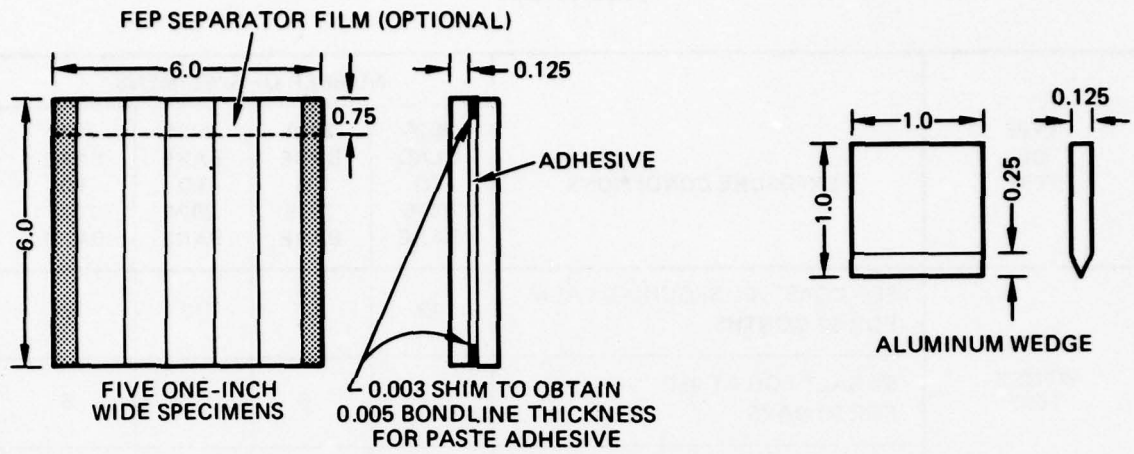
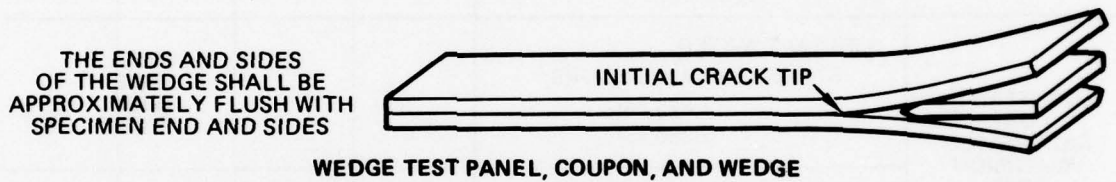
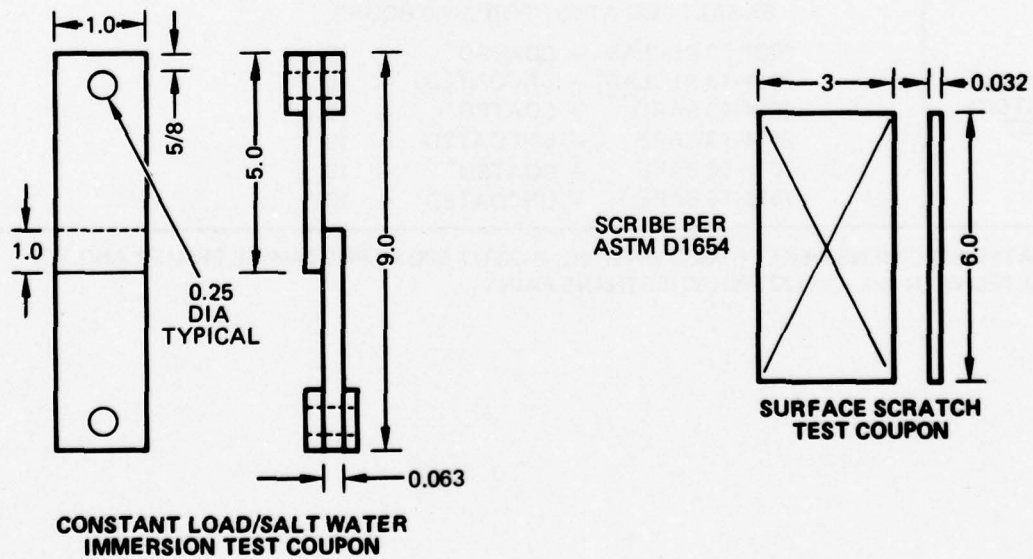
NOTE: ALL DIMENSIONS ARE IN INCHES

FIGURE 2. TEST COUPON CONFIGURATIONS

On the day the specimens were to be exposed, an aluminum wedge was driven into one end of the specimen, as shown in Figure 2. A 3X magnifying glass was used to determine the initial crack length and a scribe mark was made on the edge of the specimen. The initial crack length and the adhesive bondline thickness were measured and recorded. A high stress was created at the initial crack tip along the bondline across the one-inch wide specimen. During exposure to the corrosive environment, the crack progressed uniformly toward the bottom end of the wedge specimen. The progression of the crack, or crack-growth, was easily measured by placing a steel ruler along the edge of the specimen using the initial crack length scribe mark as the reference line. Measurements were made to the nearest 0.01 inch.

A sketch of the constant load-salt water immersion specimen is shown in Figure 2. For this test specimen, a sheet thickness of 0.063 inch was used. Doublers of the same thickness were also used at the ends of the specimen to prevent failure at the pin loading holes.

The third test, which was used to evaluate the general surface corrosion behavior of the three joining systems, was the surface scratch test. The test specimen is shown in Figure 2. Three-inch x 6-inch panels were used for this test. Half of the specimens were uncoated and half were primed and top coated as shown in Table 1. An "X" was scribed on the surfaces of these panels with a Stanley knife, as defined in ASTM standard D 1654, "Evaluation of Painted or Coated Specimens Subjected to Corrosive Environments." The test panels were exposed to 5 percent salt fog at 95F for 2,000 hours. Alodined control specimens for each of the alloys were also exposed. Periodically, the specimens were examined for evidence of corrosion at the scratch and on the surface.

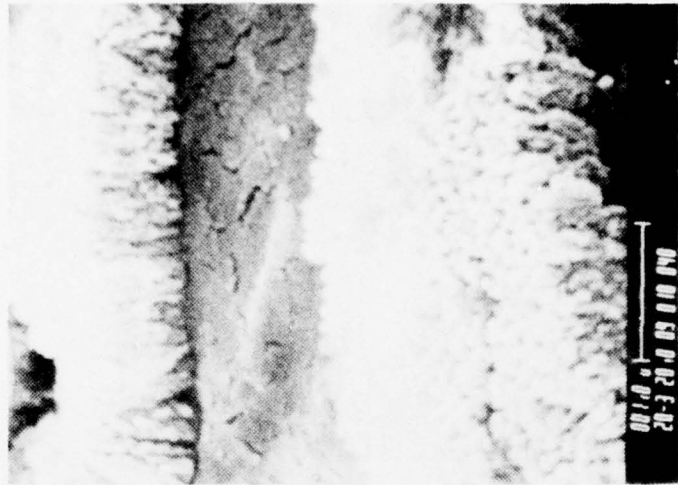
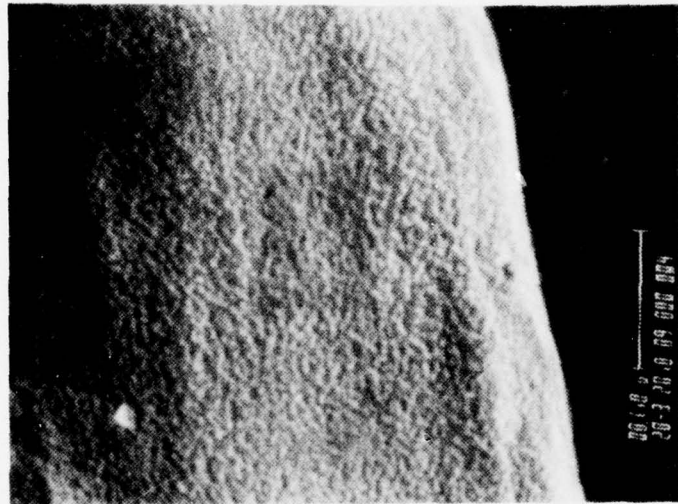
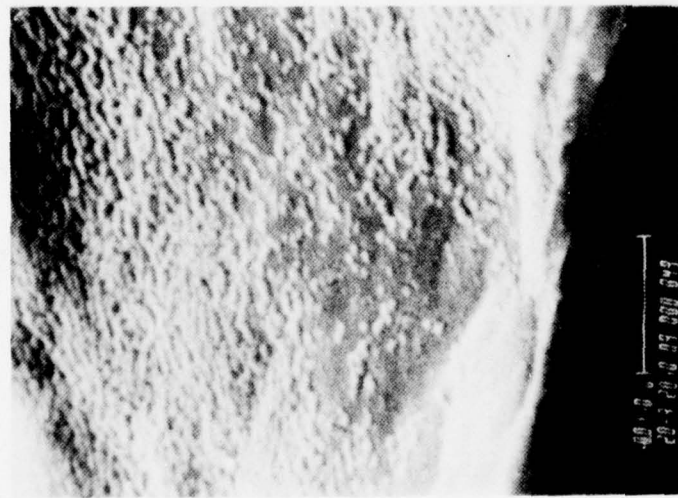
PABST SURFACE TREATMENT

WELDBOND SURFACE TREATMENT

FPL SURFACE TREATMENT

FIGURE 3. TYPICAL ANODIZED LAYER ON 2024-T3 ALCLAD

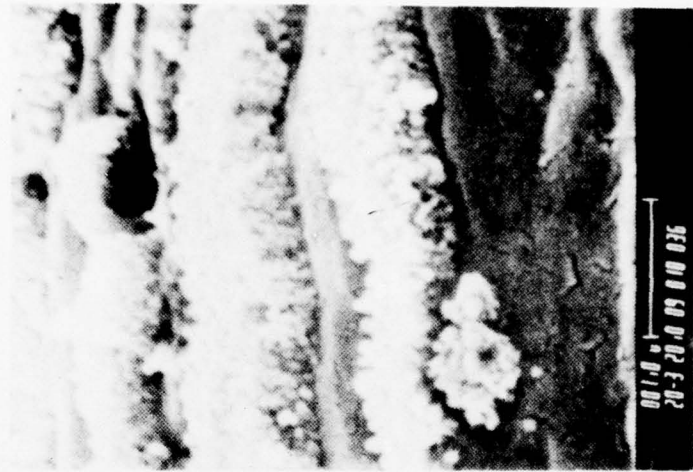
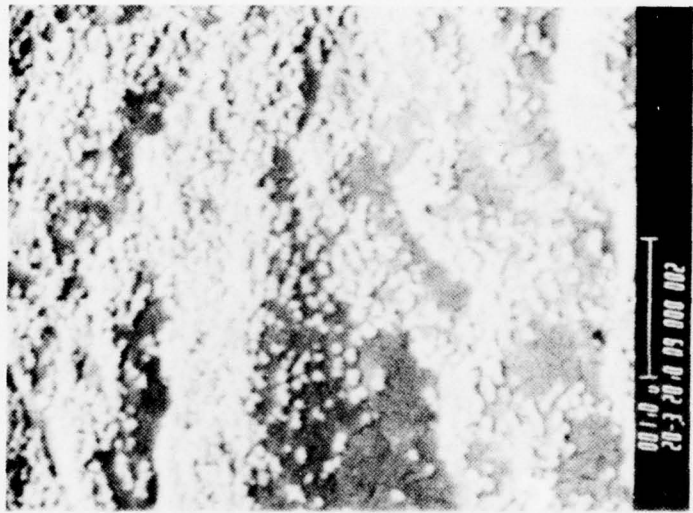
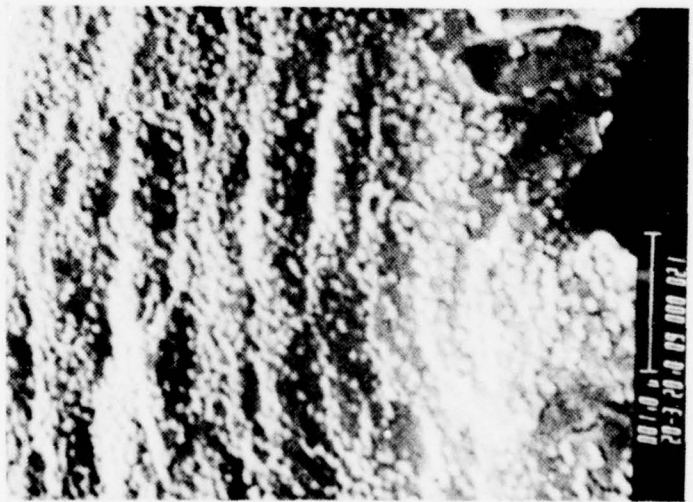
FIGURE 4. TYPICAL ANODIZED LAYER ON 2024-T3 BARE

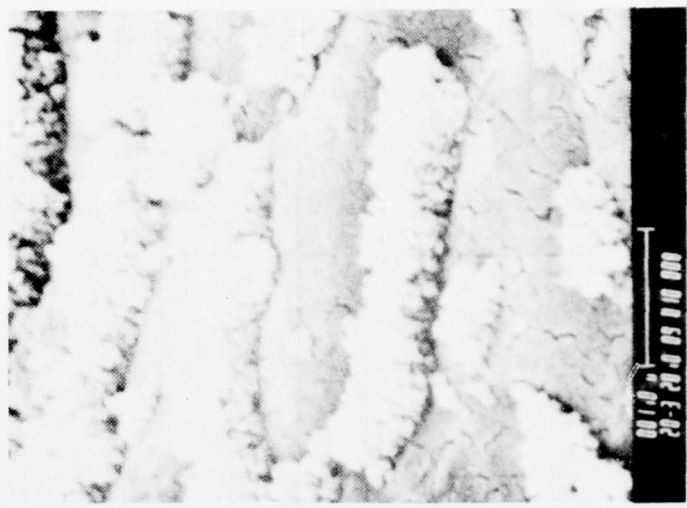
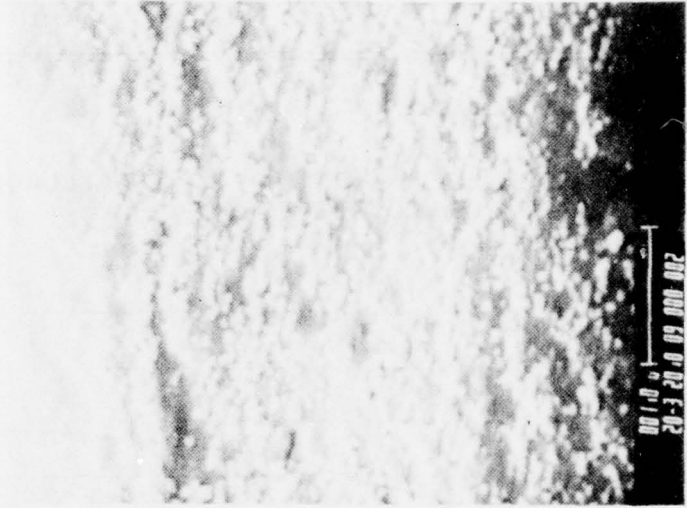
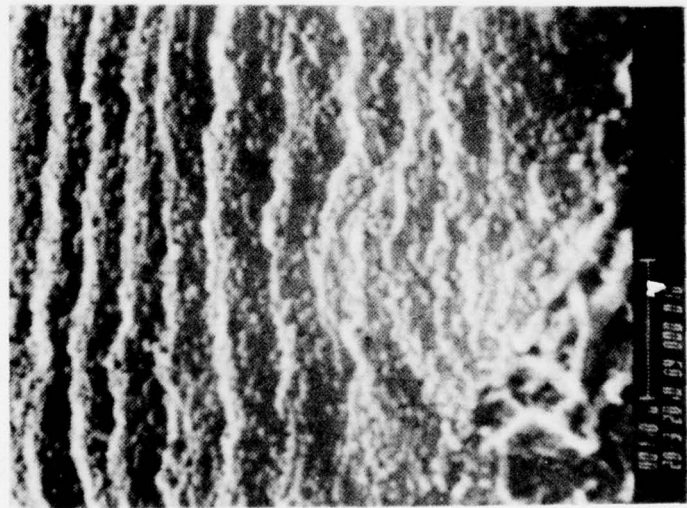
FIGURE 5. TYPICAL ANODIZED LAYER ON 7075-T6 BARE

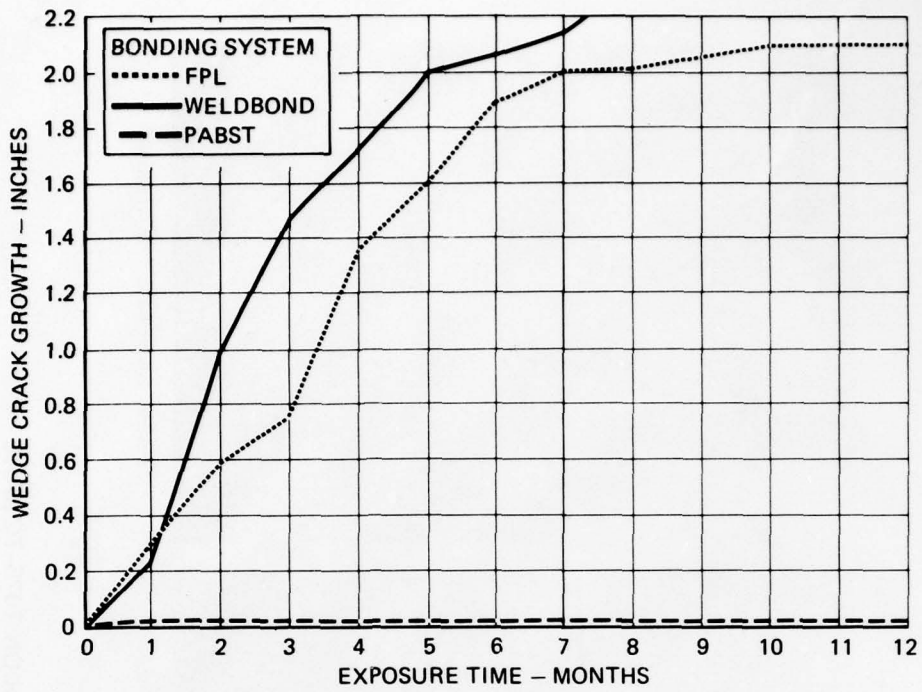
**FIGURE 6. AVERAGE WEDGE CRACK GROWTH OF 2024-T3 ALCLAD/7075-T6 BARE – SEA COAST EXPOSURE**

The average wedge crack growth for the sea coast exposure is presented in Figures 6, 7, 8, and 9 for the three bonding systems and the four material combinations. For all four material combinations, the wedge crack-growth rate was higher for the weldbond system than for the FPL bonding system and the PABST bonding system. However, the FPL system had a crack-growth rate very similar to the weldbond system with a delay time of only approximately one month to reach the same crack growth as the weldbond system. Therefore, although the relative ranking of durability shows the FPL system to be better than the weldbond system, from a practical point of view the two systems have essentially the same durability for a sea coast exposure with a crack-growth greater than 1 inch in three or four months for three of the four material combinations, and approximately 0.8-inch crack growth for 2024-T3 bare bonded to 2024-T3 bare after 10 months exposure. In contrast, the PABST bonding system showed essentially no crack growth (less than 0.04 inch) after a 12 month sea coast exposure

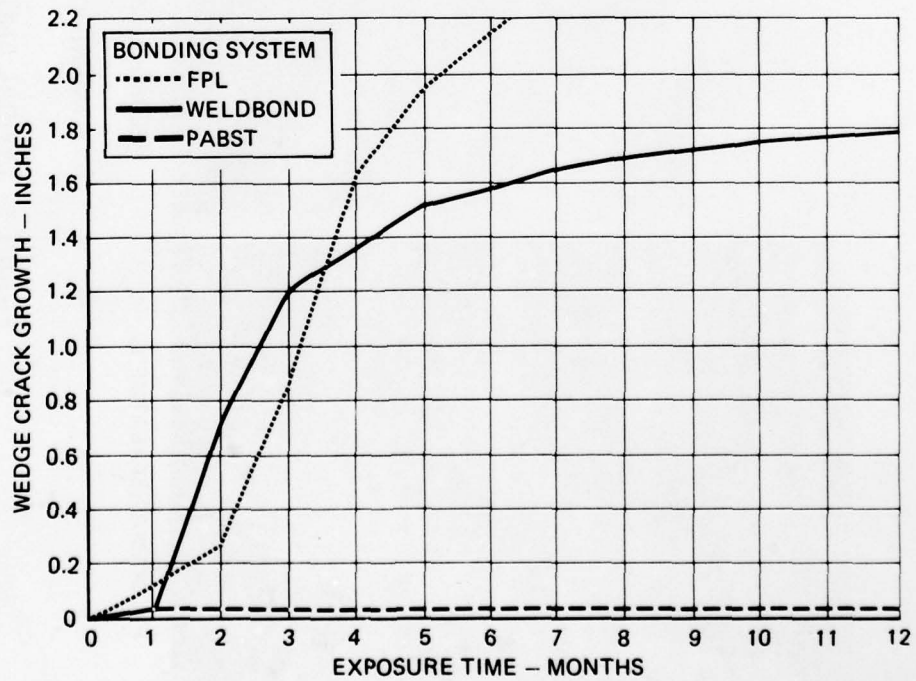
**FIGURE 7. AVERAGE WEDGE CRACK GROWTH OF 2024-T3 BARE/7075-T6 BARE – SEA COAST EXPOSURE**

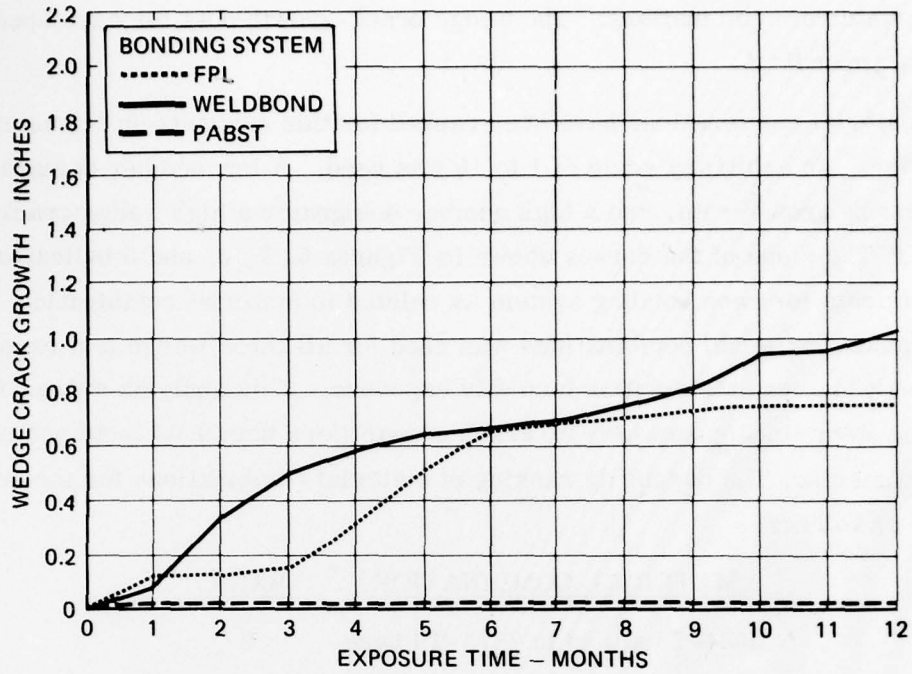
**FIGURE 8. AVERAGE WEDGE CRACK GROWTH OF 2024-T3 BARE/2024-T3 BARE – SEA COAST EXPOSURE**

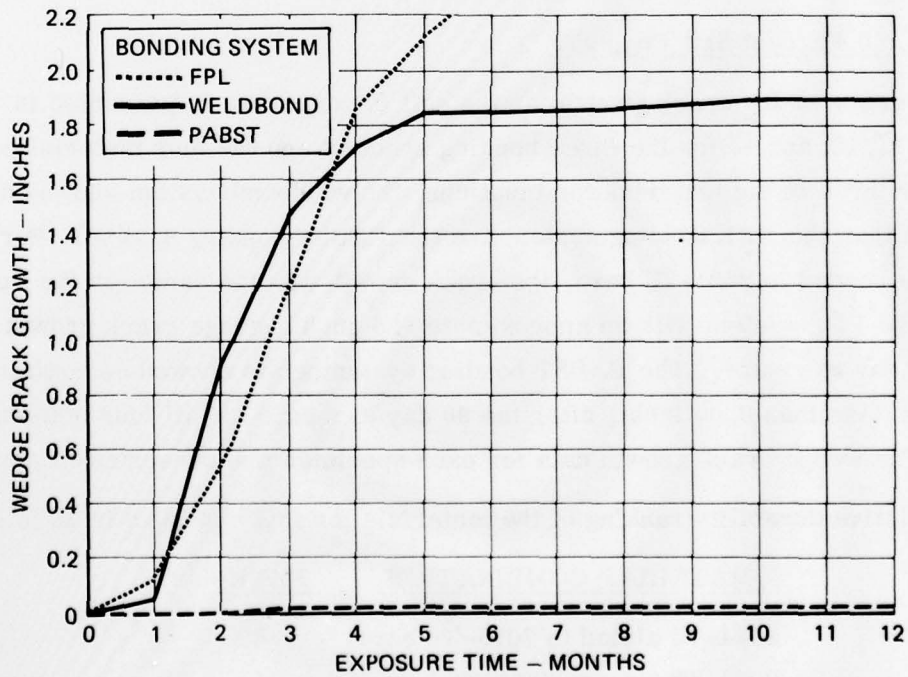
**FIGURE 9. AVERAGE WEDGE CRACK GROWTH OF 7075-T6 BARE/7075-T6 BARE – SEA COAST EXPOSURE**

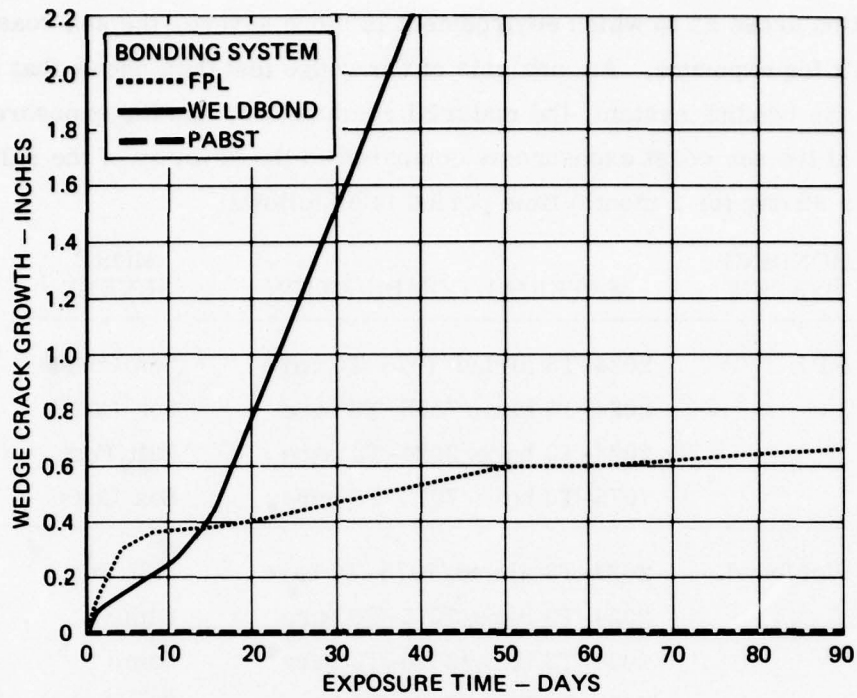
**FIGURE 10. AVERAGE WEDGE CRACK GROWTH OF 2024-T3 ALCLAD/7075-T6 BARE – SALT FOG EXPOSURE**

The average wedge crack growth for the salt fog exposure is presented in Figures 10, 11, 12, and 13 for the three bonding systems and the four material combinations. For three of the material combinations, the weldbond system showed a faster crack growth than the FPL bonding system and the PABST bonding system. For 2024-T3 bare bonded to 2024-T3 bare, the crack growth was the same for the weldbond system and the FPL system with an approximate 0.5-inch average crack growth at the end of the 90 day exposure. The PABST bonding system again showed essentially no crack growth (less than 0.03 inch), after the 90 day exposure for all four material combinations. The wedge crack growth data for each specimen are presented in Appendix A.

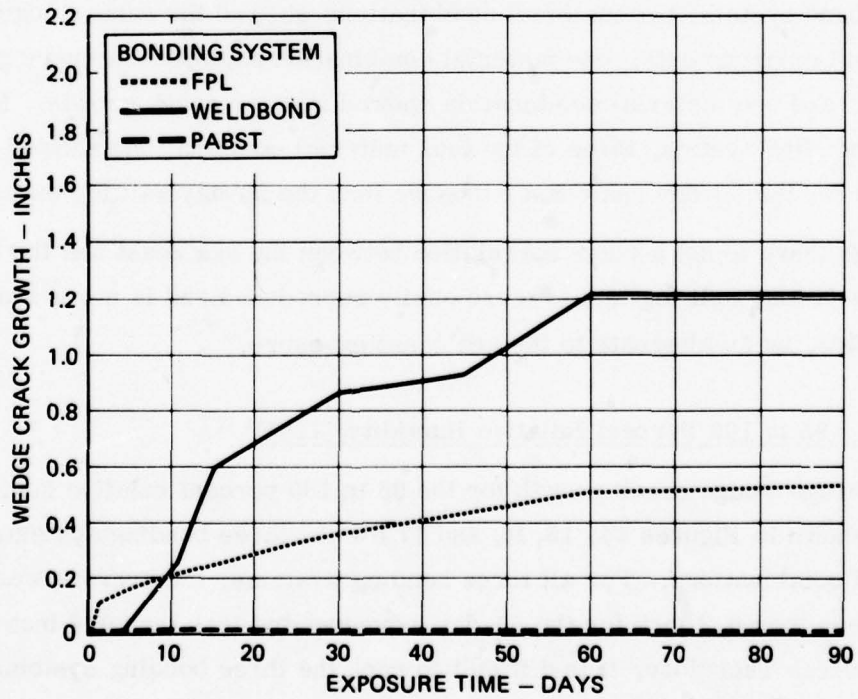
**FIGURE 11. AVERAGE WEDGE CRACK GROWTH OF 2024-T3 BARE/7075-T6 BARE – SALT FOG EXPOSURE**

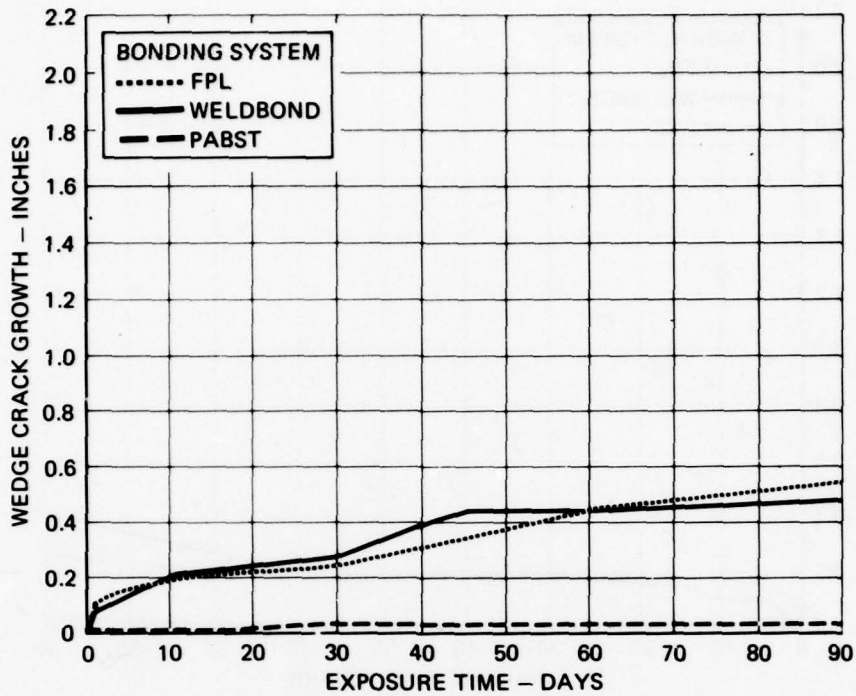
**FIGURE 12. AVERAGE WEDGE CRACK GROWTH OF 2024-T3 BARE/2024-T3 BARE - SALT FOG EXPOSURE**

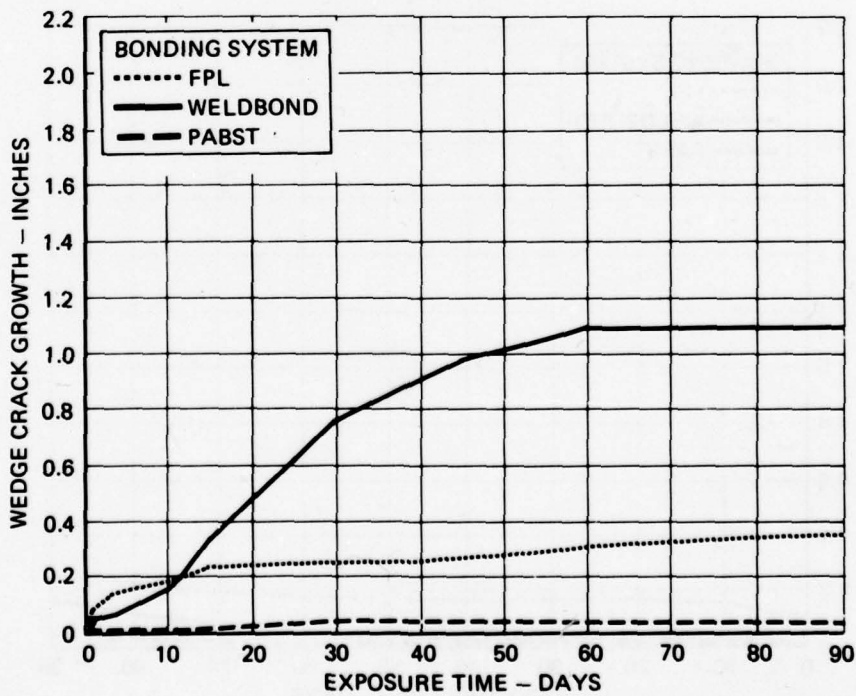
**FIGURE 13. AVERAGE WEDGE CRACK GROWTH OF 7075-T6 BARE/7075-T6 BARE - SALT FOG EXPOSURE**

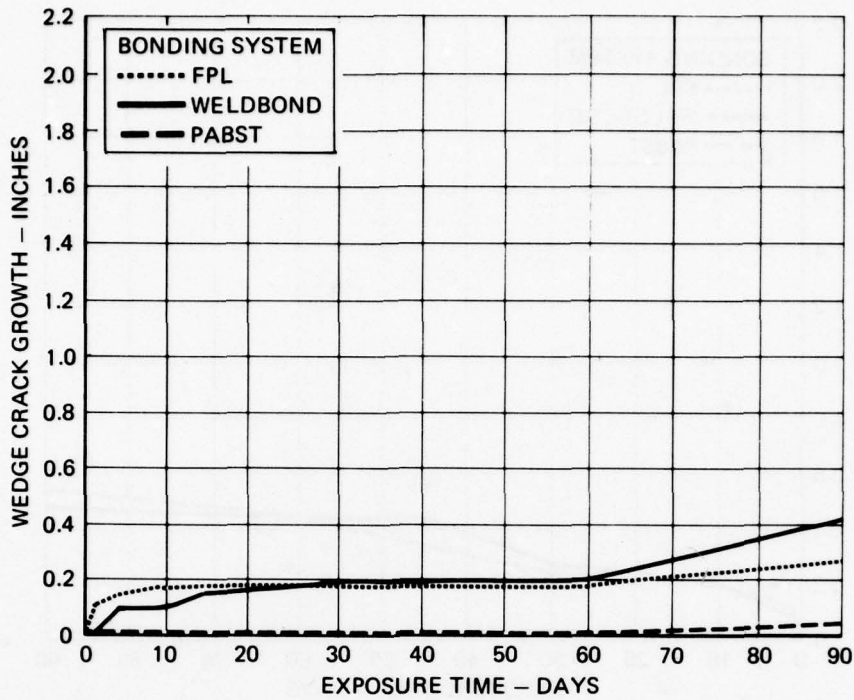
**FIGURE 14. AVERAGE WEDGE CRACK GROWTH OF 2024-T3 ALCLAD/7075-T6 BARE – 95-100 PERCENT RELATIVE HUMIDITY**

The average wedge crack growth for the 95 to 100 percent relative humidity exposure is shown in Figures 14, 15, 16, and 17 for the three bonding systems and the four material combinations. For all three bonding systems, the average wedge crack growth was less than 0.2 inch for the 60-day exposure and less than 0.4 inch for the 90-day exposure. Therefore, it is difficult to rank the three bonding systems or the

material combinations shown in Figures 14, 15 and 16. The PABST bonding system had only very slight improvement in durability over the other two bonding systems. In fact, for 7075-T6 bare bonded to 7075-T6 bare, the average crack-growth was equal for the weldbond and the PABST bonding system. The wedge crack-growth data for each specimen are presented in Appendix A.

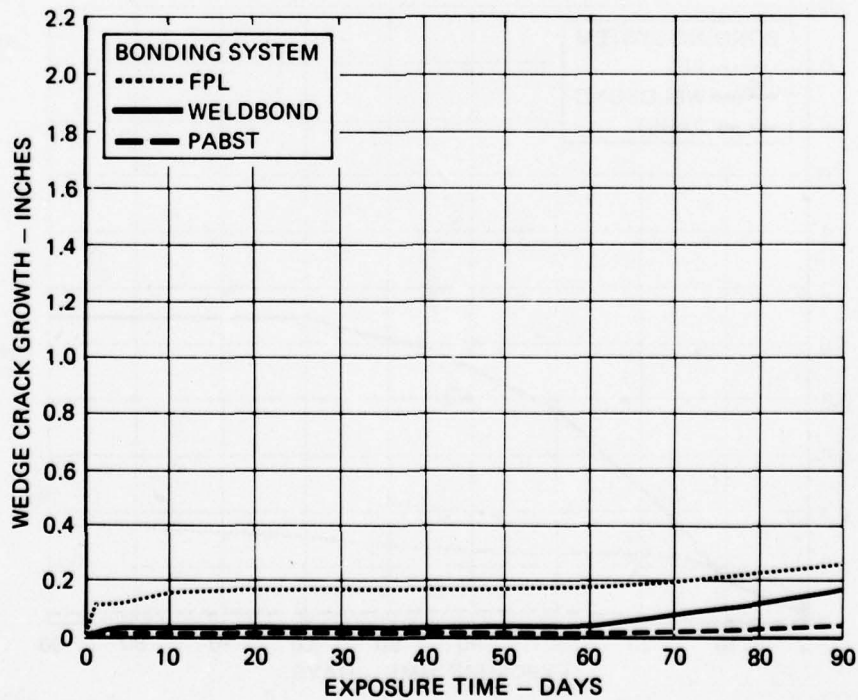
**FIGURE 15. AVERAGE WEDGE CRACK GROWTH OF 2024-T3 BARE/7075-T6 BARE – 95-100 PERCENT RELATIVE HUMIDITY**

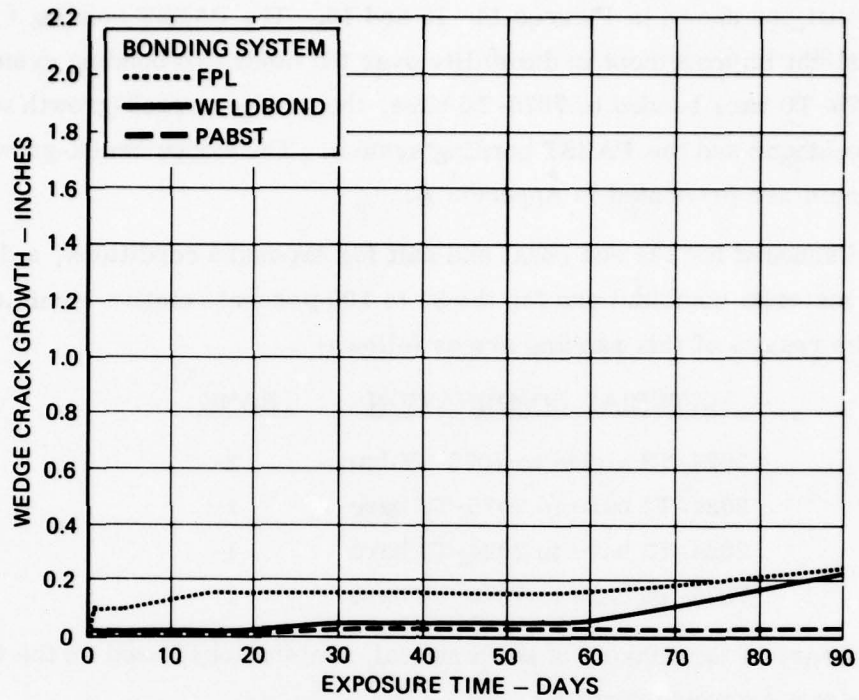
**FIGURE 16. AVERAGE WEDGE CRACK GROWTH OF 2024-T3 BARE/2024-T3 BARE – 95-100 PERCENT RELATIVE HUMIDITY**

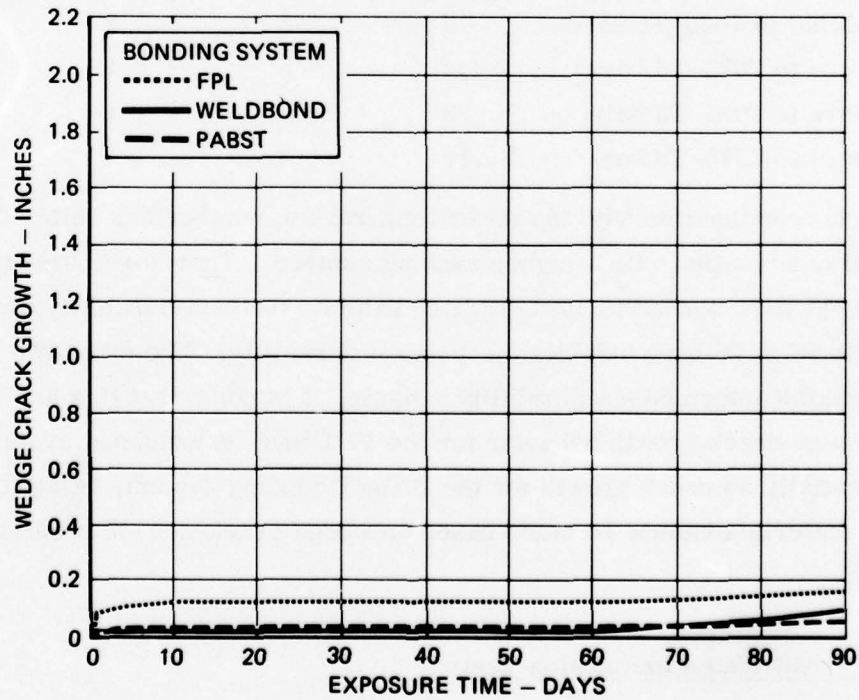
**FIGURE 17. AVERAGE WEDGE CRACK GROWTH OF 7075-T6 BARE/7075-T6 BARE – 95-100 PERCENT RELATIVE HUMIDITY**

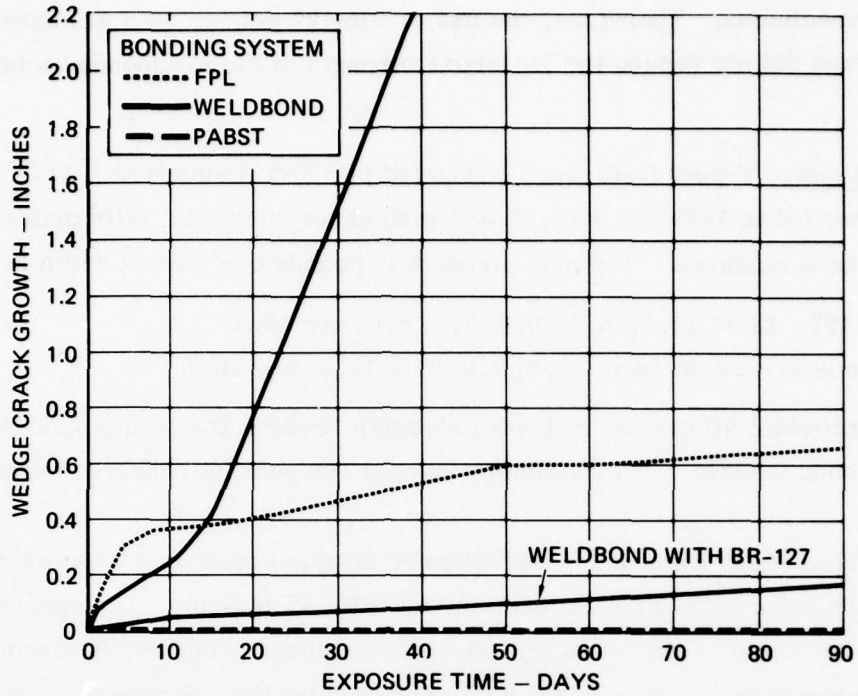
FIGURE 18. AVERAGE WEDGE CRACK GROWTH OF 2024-T3 ALCLAD/7075-T6 BARE INCLUDING WELDBOND/BR-127 — SALT FOG EXPOSURE

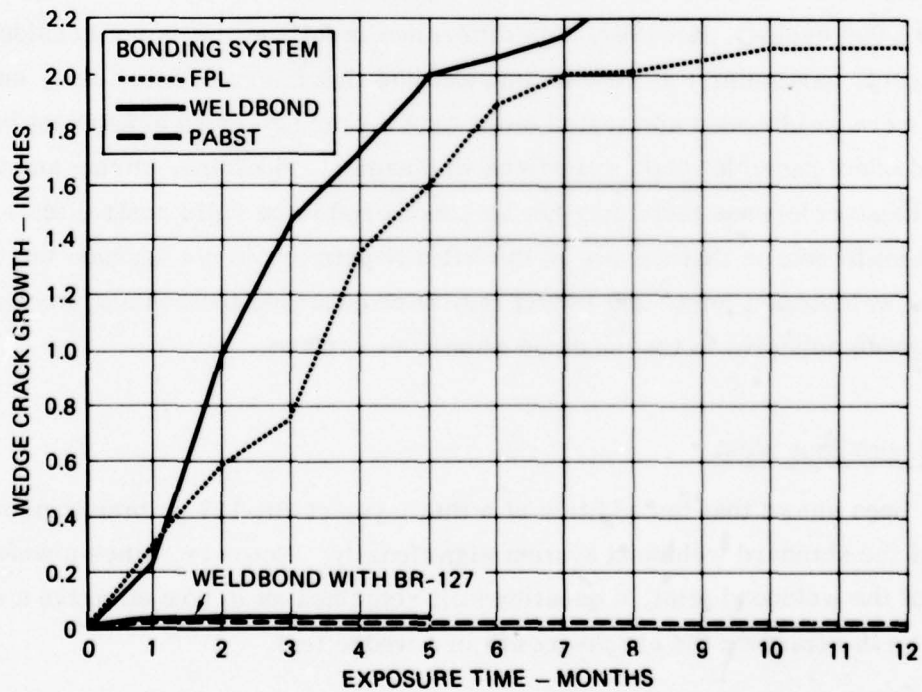
FIGURE 19. AVERAGE WEDGE CRACK GROWTH OF 2024-T3 ALCLAD/7075-T6 BARE INCLUDING WELDBOND/BR-127 — SEA COAST EXPOSURE

The results of the sea coast wedge tests are shown in Figure 19. For this exposure condition, the durability of the weldbond/BR-127 system is essentially equal to the durability of the PABST system after 5 months exposure, i. e., average wedge crack growth of 0.04 and 0.01 inch respectively. A crack growth less than 0.05 inch is considered to be negligible. The degree of improvement for the weldbond/BR-127 system is tremendous when compared to the 2.0-inch crack growth for the unprimed weldbond system and the 1.60-inch crack growth of the FPL bonding system for the same 5 month exposure time.

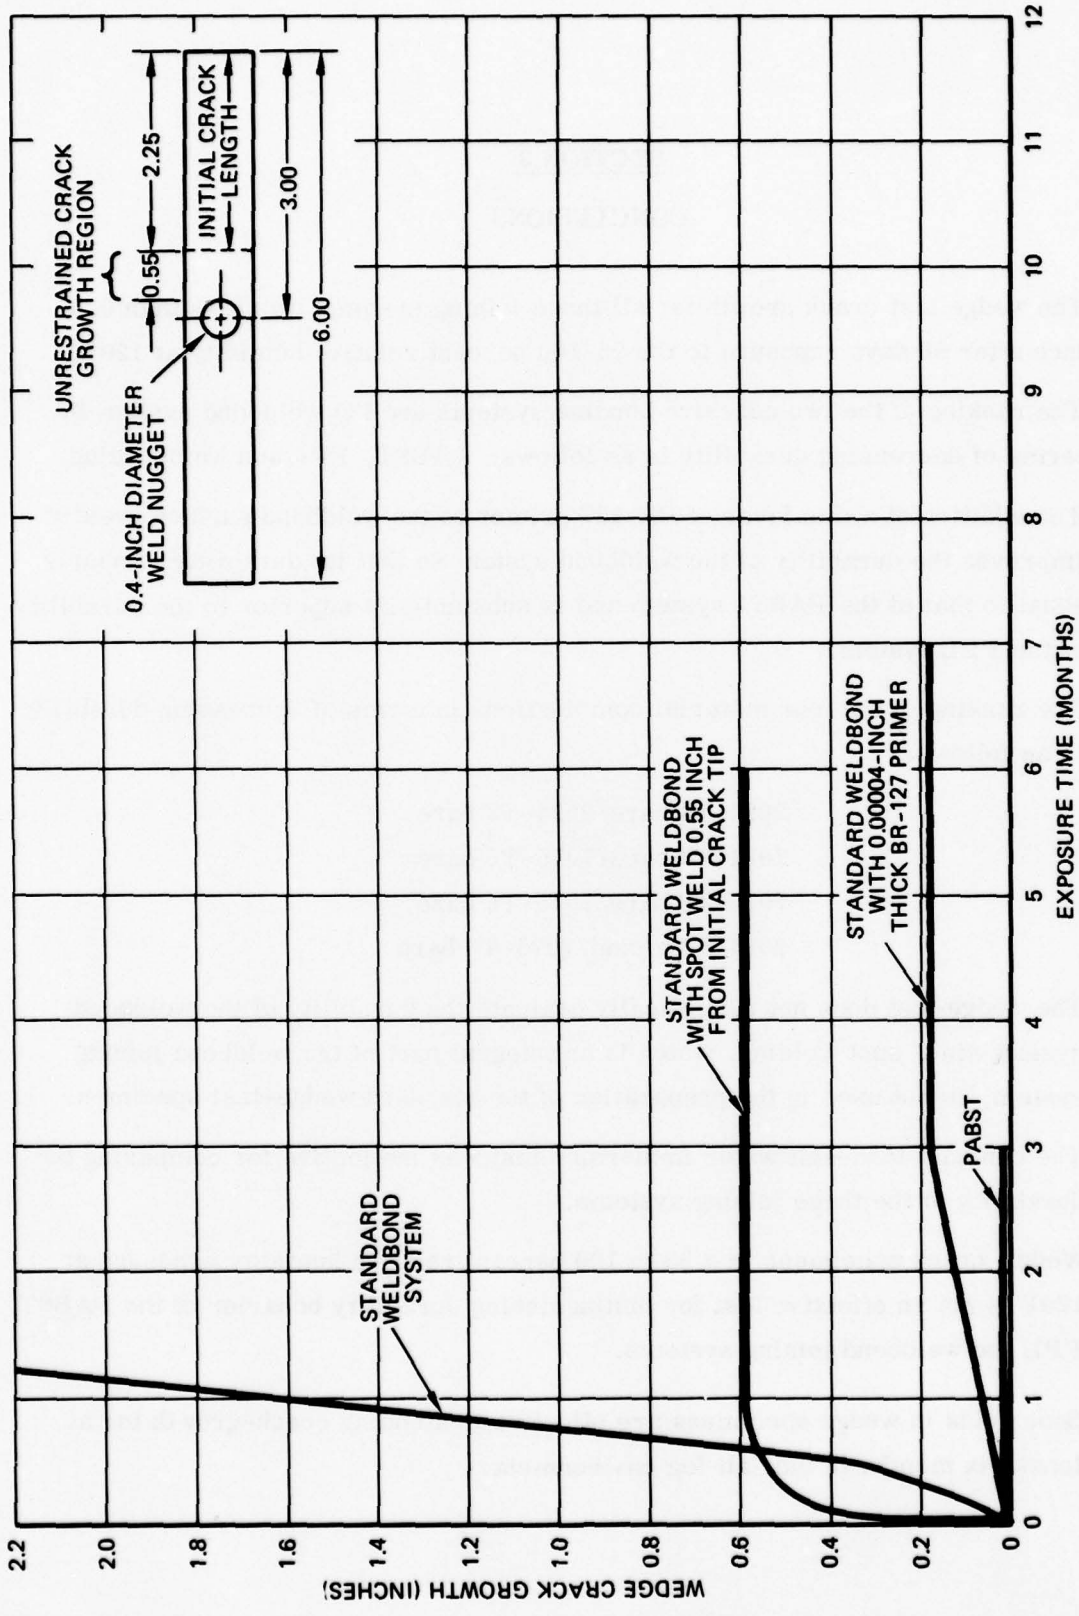
FIGURE 20. AVERAGE WEDGE CRACK GROWTH OF 2024-T3 ALCLAD/7075-T6 BARE WELDBOND WITH SPOT WELD - SALT FOG EXPOSURE

welds were centered 3 inches from the end of the 6-inch specimen as shown in Figure 20. The average initial crack length was 2.25 inches, therefore, the edge of the spot weld nugget was approximately 0.5 inch from the initial crack tip created by the wedge. These specimens were exposed to the 5 percent salt fog environment.

The results of these wedge tests are shown in Figure 20 along with the wedge test results for the standard weldbond system, the weldbond system with BR-127, and the PABST system for comparison purposes. After 13 days the crack had progressed up to the edge of the weld nugget, i. e., 0.52 inch. After 183 days (6 months) the crack progressed only a small additional amount to 0.60 inch. The spot weld restrained the wedge crack-growth for at least six months of exposure to the salt fog after the crack tip reached the nugget. Therefore, the weldbond system, which utilizes spot welds is very effective in retarding crack-growth that might occur along the adhesive bonded joint with the standard weldbond surface preparation.
