RESEARCH  
PAPER  
FPL 335

U. S. Department of Agriculture  
Forest Service  
Forest Products Laboratory

## Abstract

# PERFORMANCE OF MEDIUM-DENSITY HARDBOARD IN PALLETS

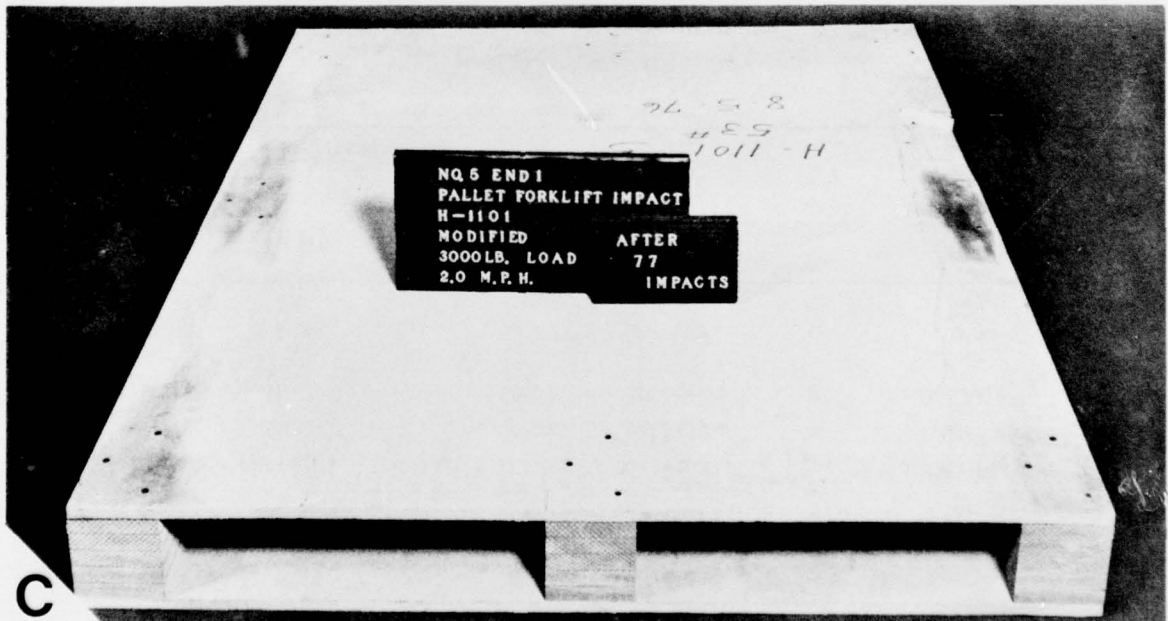
Figure 6.—Typical shear failure patterns of hardboard panels: A. along leading edge, B. along edges of one foot of the load, and C. showing a shear failure in a top deck.

The thickness of the deck also proved to be the principal factor in pallet serviceability. In this regard, it was clear that a hardboard deck thickness of 3/4 inch or more yielded pallet handling resistance behavior that was much superior to that of the lumber controls in all instances. The use of an impact panel enhanced this increase even more. Typical failure patterns, depending on deck thickness and impact loading method, are shown in figure 6. Shear failure of the hardboard deck occurred when the forks of a conventional forklift truck impacted and handled pallets with either 1/2- or 3/4-inch decks as shown in figure 6A.<sup>5</sup> Similar pallets, with 1-inch-thick hardboard deck however, did not fail when impacted and handled by a forklift truck either operated conventionally or with an impact panel attached. If the forklift truck was equipped with an impact panel, a differ-

ent type of failure eventually occurred, figure 6B. In this situation failure usually involved inadequate panel shear strength at the vertical load supports. The more extensive nature of such shear failure is illustrated typically by the top view of a pallet shown in figure 6C. Failure usually occurred near the boundaries for the supports for the load—i.e., where shear stresses were largest.
